AIRPROX REPORT No 2023191

Date: 28 Jul 2023 Time: 1401Z Position: 5627N 00315W Location: 7NM West of Dundee

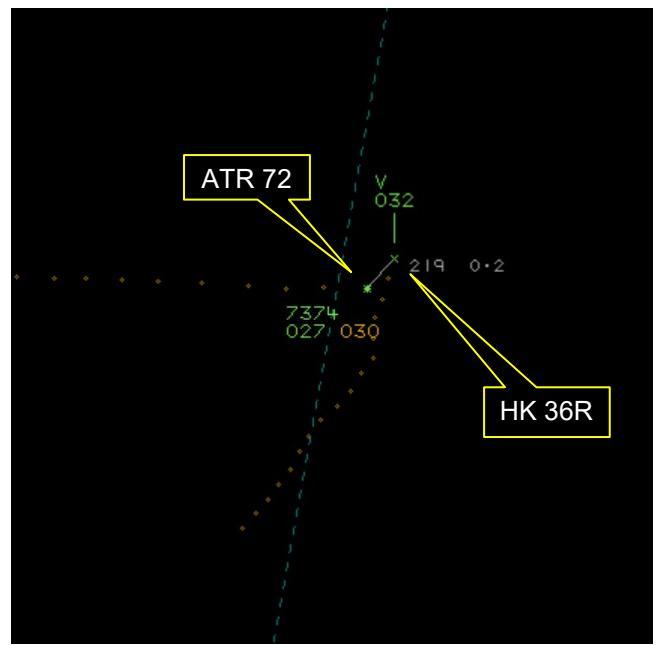
Figure 1 – CPA 1401:16 500ft V/0.2NM H

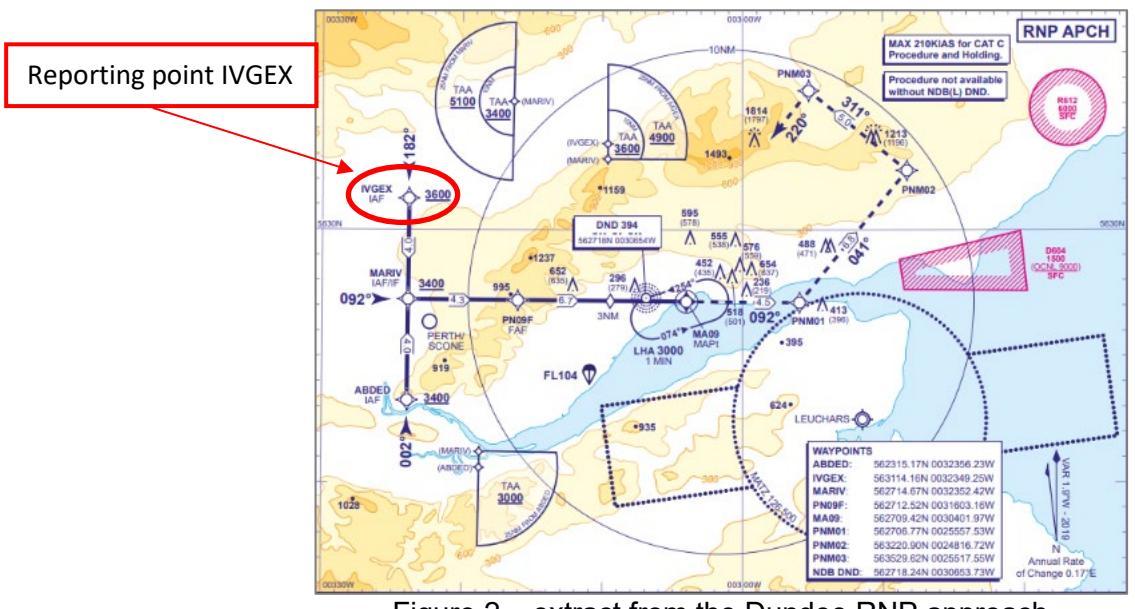
Figure 2 – extract from the Dundee RNP approach
