## AIRPROX REPORT No 2024042

Date: 30 Mar 2024 Time: 1406Z Position: 5100N 00150W Location: 4.5NM SSW Salisbury

# PART A: SUMMARY OF INFORMATION REPORTED TO UKAB

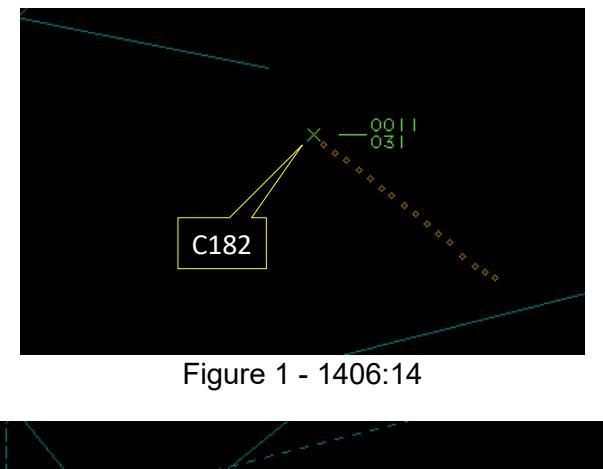
An analysis of the NATS radar replay was undertaken and the C182 was positively identified from Mode S data. Four seconds before CPA, the C182 transponder squawk changed from the Bournemouth Frequency Monitoring Code (0011) to the VFR conspicuity code (7000) (Figure 1). The Standard Cirrus was not observed on radar.

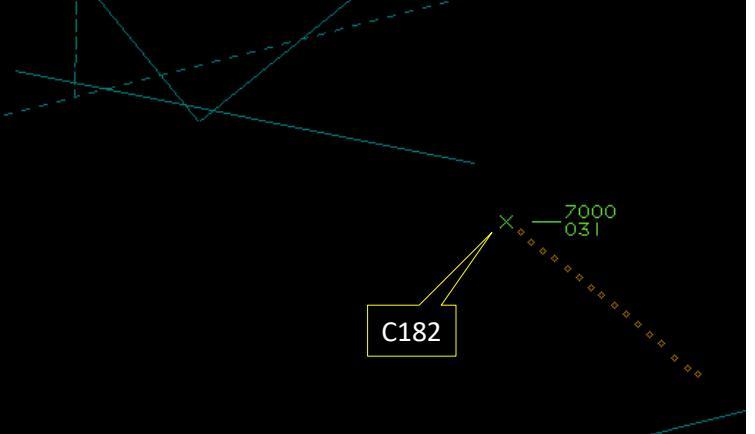
Figure 2 – CPA at 1406:18

Both pilots kindly supplied GPS track data for their respective flights. It was by combining the various data sources that the diagram was constructed and the separation at CPA determined.
