AIRPROX REPORT No 2024097

Date: 24 May 2024 Time: 1057Z Position: 5209N 00154W Location: 2NM NW Bidford

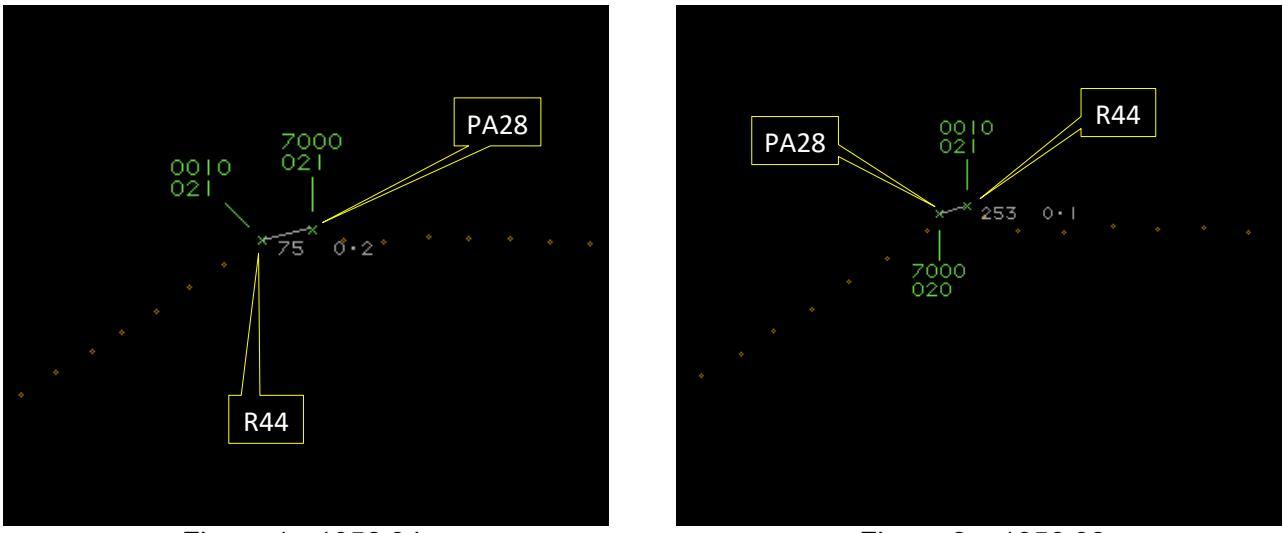
Figure 1 - 1056:34

An analysis of the NATS radar replay was undertaken and both aircraft could be positively identified from Mode S data. The moment of CPA was determined to have occurred between the radar sweeps at 1056:34 and 1056:38 (Figures 1 and 2). The aircraft were depicted on the radar replay to have been at Flight Levels. A suitable correction was applied to determine their respective altitudes. The altitude of the PA28 was observed to have changed between the radar sweeps before and after CPA. Consequently, the altitude of the PA28 has been shown as an approximation in the diagram.

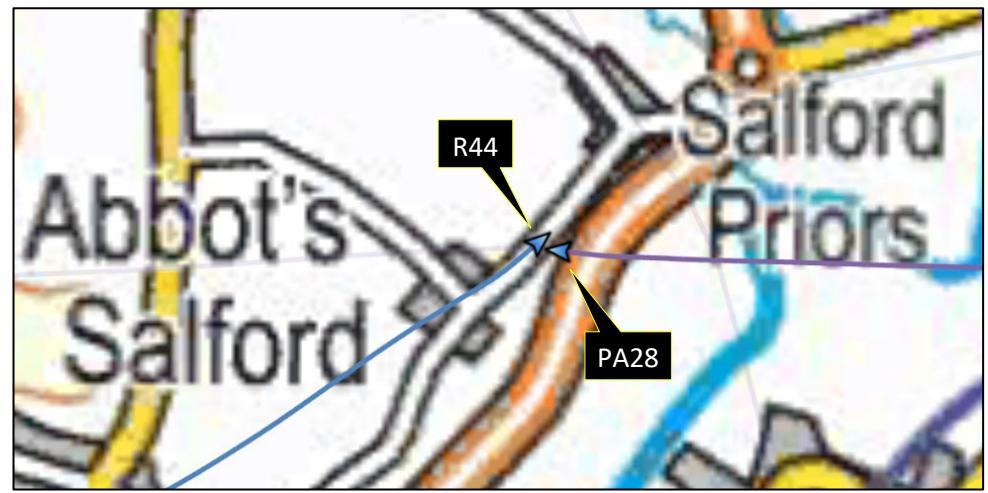
Figure 3 – Aircraft positions at CPA (GPS data)

Both pilots also supplied GPS track data for their respective flights (Figure 3). It was by combining the data sources that the diagram was constructed and the separation at CPA determined.

Members noted that the pilot of the PA28 reported that they had sighted the R44 when it had been approximately 2NM to their port-side. From the radar replay, members noted that both aircraft had been tracking in broadly straight lines and that the separation between the aircraft had been 2NM approximately 30sec before CPA. Therefore, whilst the pilot of the PA28 reported that they had visually acquired the R44, members surmised that they had subsequently lost visual contact. Consequently, and given that the separation between the aircraft had been approximately 100m (from GPS data) at CPA, members were in agreement that it had been a non-sighting (**CF5**).
