AIRPROX REPORT No 2024157

Date: 08 Jul 2024 Time: 1106Z Position: 5152N 00115W Location: EGD129

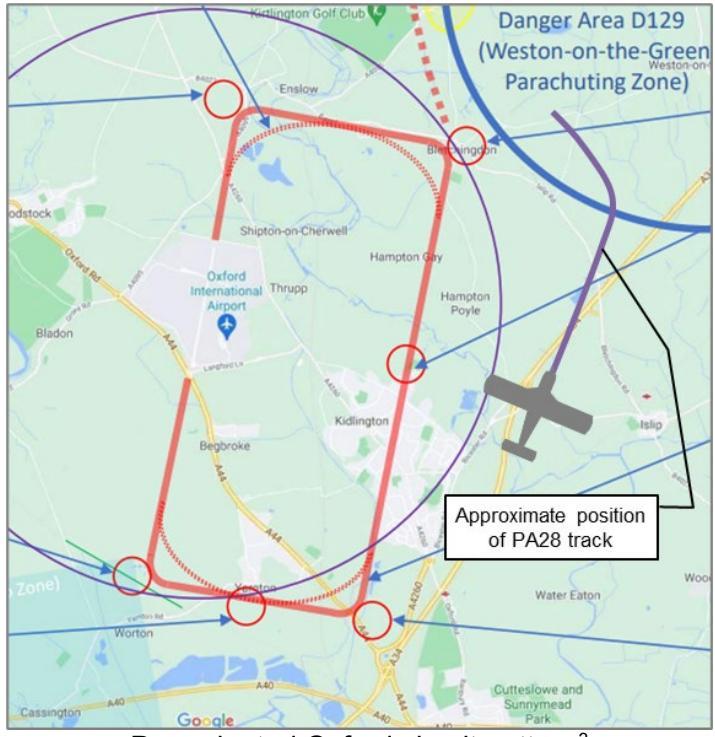
Promulgated Oxford circuit pattern³

The Board first discussed the pilots' actions and agreed that the PA28 pilot had not executed their arrival at Oxford correctly, perhaps due to a lack of prior planning. Their downwind track spacing had been much wider than that promulgated (**CF6**) which had contributed to their incursion into EGD129 (**CF5**, **CF7**). They had also not allowed for the proximity of EGD129 when planning their base turn (**CF6**) and had turned onto the base leg too late to remain clear of EGD129. The PA28 pilot had had only generic situational awareness of the Skyvan (**CF8**) in that EGD129 may have had parachuting aircraft operating within it, which in this instance had been the case, but had not acted on it. The Skyvan pilot had received a TCAS TA (**CF9**) and Traffic Information on the PA28, albeit at a late stage, but had not seen the PA28 until at about CPA, effectively a non-sighting (**CF11**), no doubt at least in part because the PA28 had been obscured by the left wing of the Skyvan in its left turn (**CF12**). The PA28 pilot had seen the Skyvan at a late stage (**CF10**) but had turned left in response to the Oxford Tower controller's instruction, albeit whilst maintaining a degree of vertical separation.

Oxford review their MATS Pt. 2 procedures to include R/T instructions for visiting pilots operating under VFR to remain clear of EGD129 when active.
