AIRPROX REPORT No 2024156

Date: 02 Jul 2024 Time: ~1615Z Position: 5106N 00202W Location: Chilmark

PART A: SUMMARY OF INFORMATION REPORTED TO UKAB

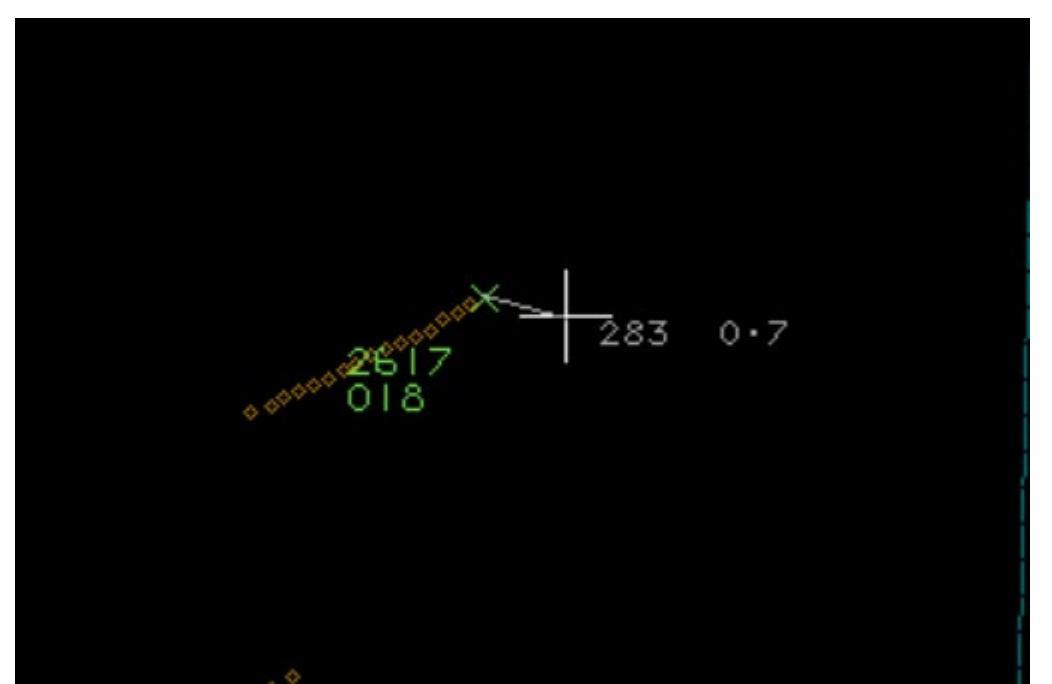
towards Boscombe at 1615, its track took it within the NOTAM boundary laterally, and the radar indicated that the aircraft was descending to 1800ft (radar QNH 1018hPa), see Figure 1.

Figure 1 - 1615:02, the white cross indicates the centre of the NOTAM

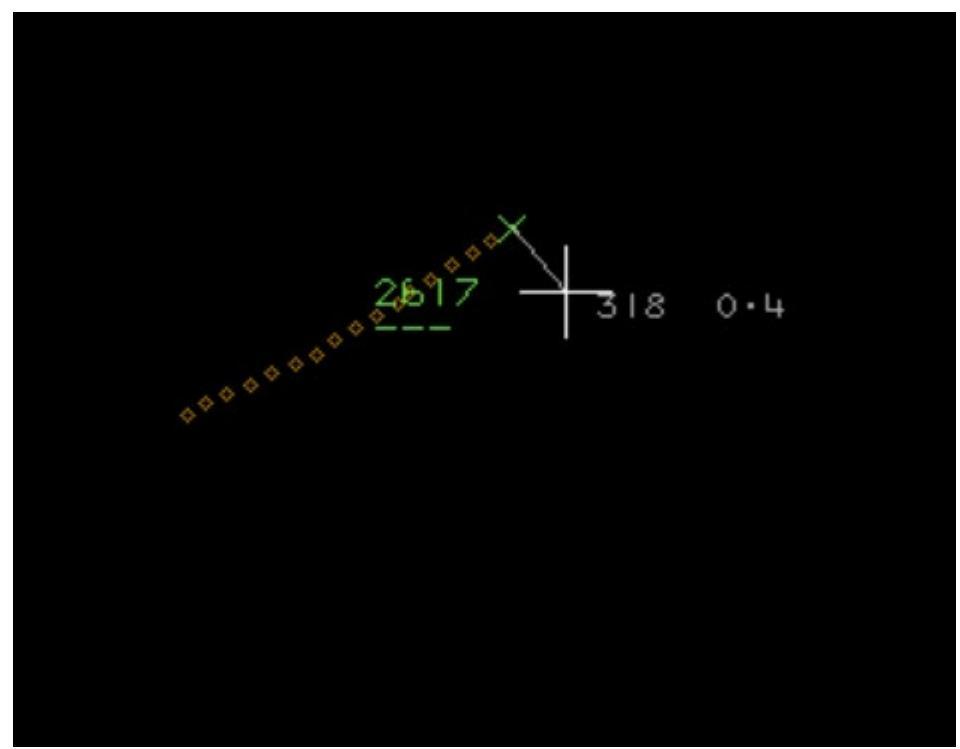
The H125 continued on heading, although the Mode C could no longer be detected by the radar and so the altitude was unknown, until 1615:28, after which the aircraft faded from the radar (Figure 2). The actual separation between the H125 and the drone could not be determined.

Figure 2 - 1615:28, H125 faded from radar on the following radar sweep

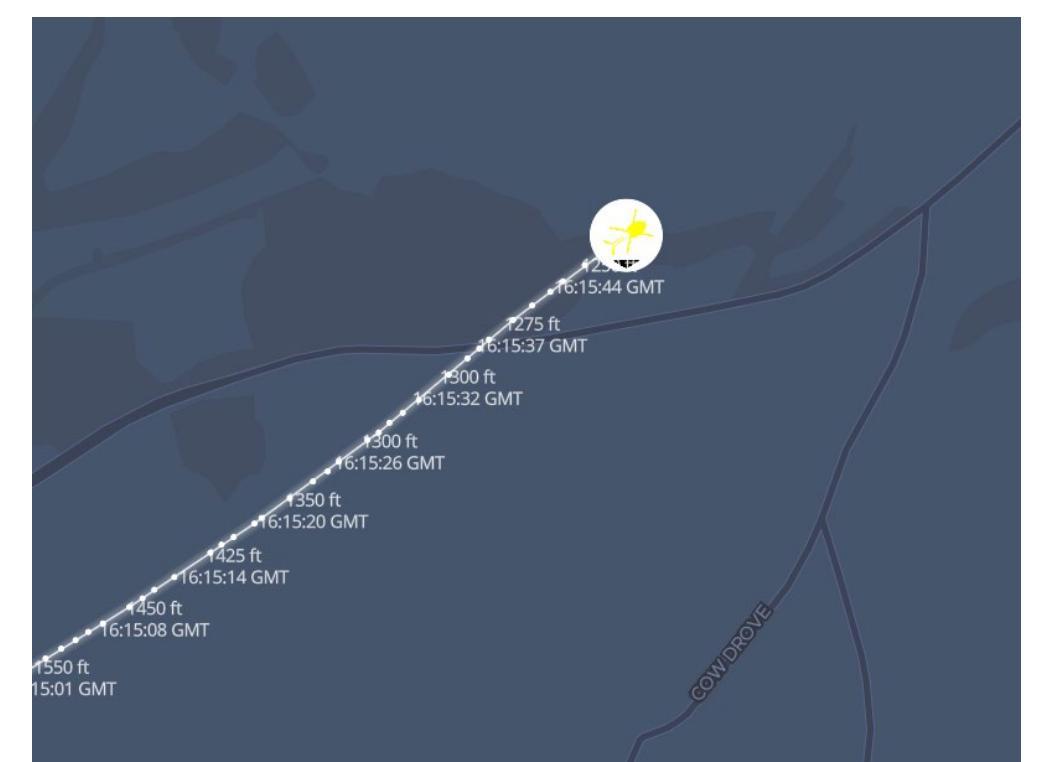
However, ADS-B derived information indicated that the H125 had been in the region of 1300ft when in the vicinity of the drone (Figure 3). Google Earth-derived information indicated terrain height in the region of 500ft in the vicinity of the drone operation.

Figure 3 – ADS-B derived information indicating that the H125 was at 1300ft (equating to approximately 1400ft AMSL).
