**AIRPROX REPORT No 2020002**

Date: 08 Jan 2020 Time: 1601Z Position: 5149N 00119W Location: Oxford Airport ATZ

**PART A: SUMMARY OF INFORMATION REPORTED TO UKAB**

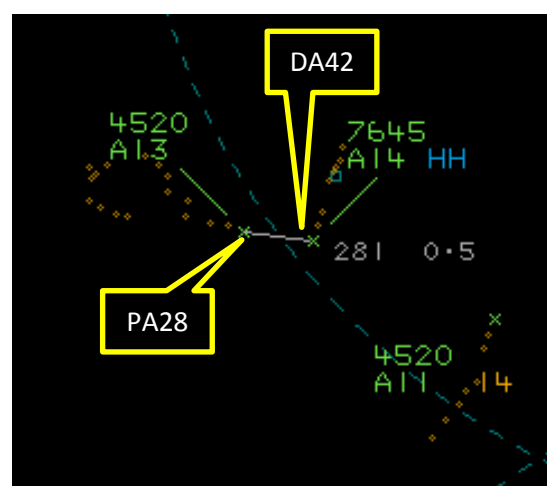
Figure 1

At 1601:33 the DA42 was on the approach and the PA28 was routing to cross the RW01 numbers; the aircraft are separated by 100ft vertically and 0.5NM horizontally (Figure 1). This appeared to be when the DA42 instructor stated that the student decided to climb to avoid the PA28.

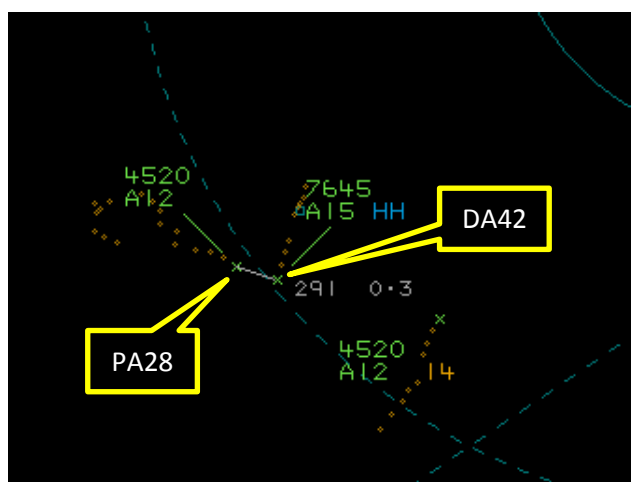
Figure 2

The DA42 can be seen to be climbing in figure 2, the aircraft were separated by 300ft vertically and 0.3NM horizontally at that time.

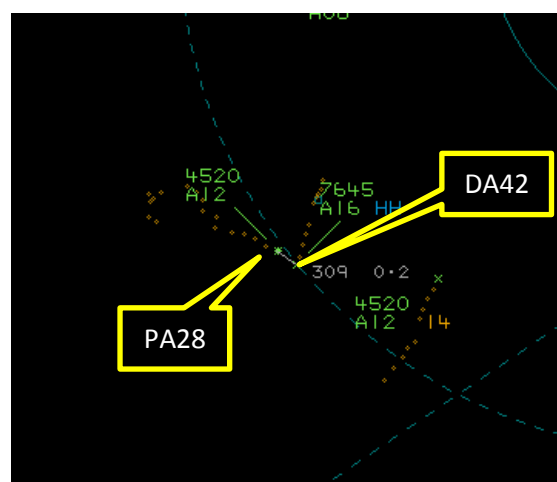
Figure 3

When the DA42 had passed in front of the PA28 the aircraft were separated by 400ft vertically and 0.2NM horizontally (Figure 3).

Finally, the Board discussed the Risk. Both pilots were visual with the other aircraft, but the Board members felt that the PA28 pilot could have ensured a greater margin of separation from the DA42 than he did. Regardless, the aircraft were separated by 300ft at CPA and there was no risk of collision, a Risk Category C.
