AIRPROX REPORT No 2019160

Date: 29 Jun 2019 Time: 0958Z Position: 5720N 00224W Location: 5nm NW ADN

PART A: SUMMARY OF INFORMATION REPORTED TO UKAB

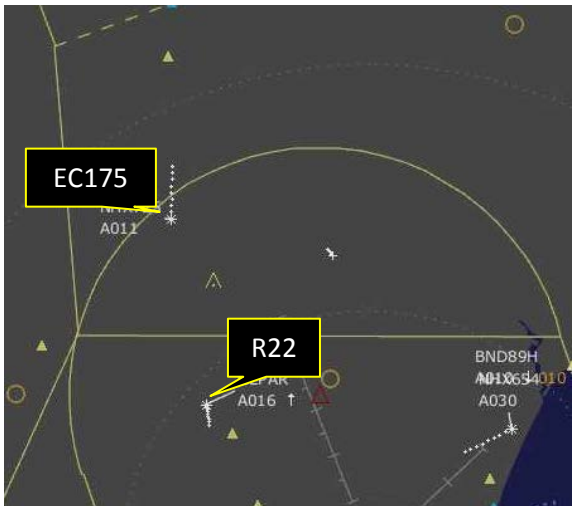
<p>0956:09 INT-S passed Traffic Information to the R22 pilot on the EC175 stating it was an EC175 just approaching west of the Oldmeldrum Mast to join the Inverurie Lane and currently at 1100ft. At this time the R22 was 1.5nm northwest of Inverurie with the EC175 6nm north of the R22, opposite direction.</p>

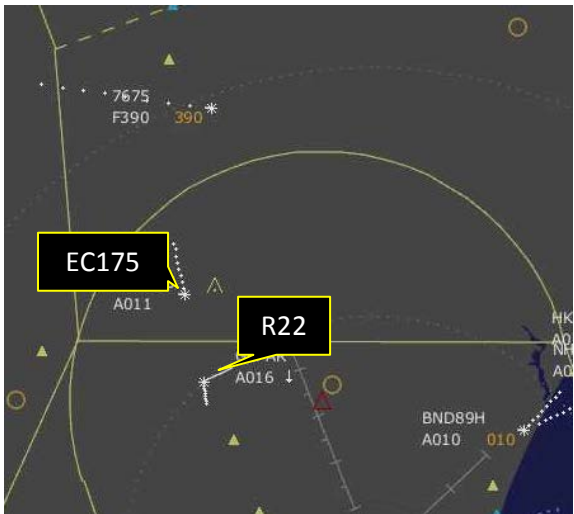
<p>0957:20 The pilot of the EC175 asked INT-S for an update on the position of the R22. INT-S advised the pilot the R22 was in his 12 o'clock, opposite direction at 3nm and 300ft above. The pilot asked INT-S "Can you tell him to stop descending, we are not visual at this time".</p>

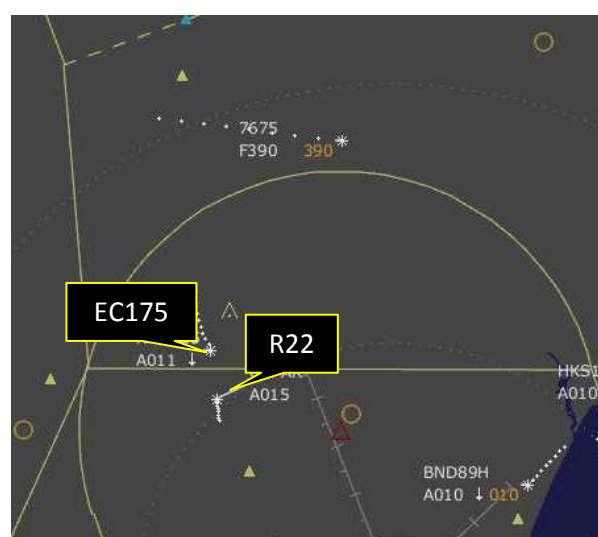
0957:52

A crossed transmission was received by INT-M where the instructor on the R22 can be heard to state he was visual with the other traffic and the pilot of the EC175 stated he was on R22's right hand side, 300ft below. The instructor on the R22 then reiterated he was visual with the other traffic.

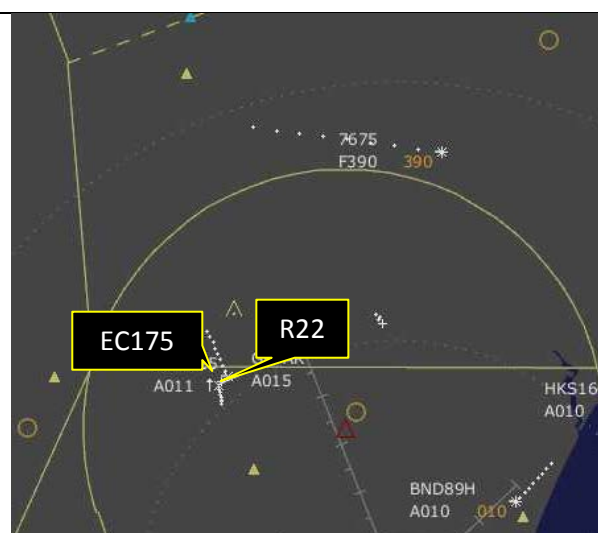
**0958:18**

The aircraft passed each other, with the closest recorded separation being 0.5nm and 400ft at this time.

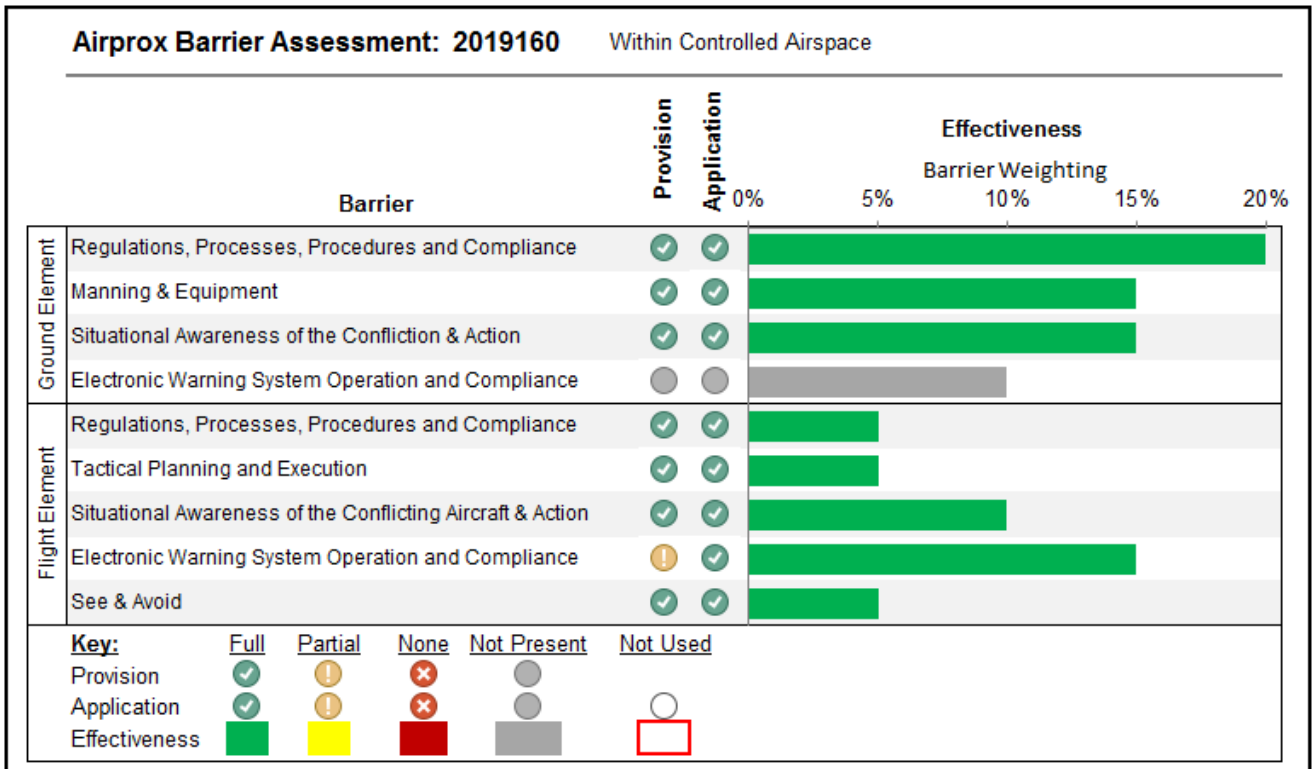
Safety Barrier Assessment⁵

In assessing the effectiveness of the safety barriers associated with this incident, the Board concluded that all the safety barriers had functioned correctly:
