AIRPROX REPORT No 2019264

Date: 07 Sep 2019 Time: 1219Z Position: 5052N 00043W Location: Goodwood airfield

PART A: SUMMARY OF INFORMATION REPORTED TO UKAB

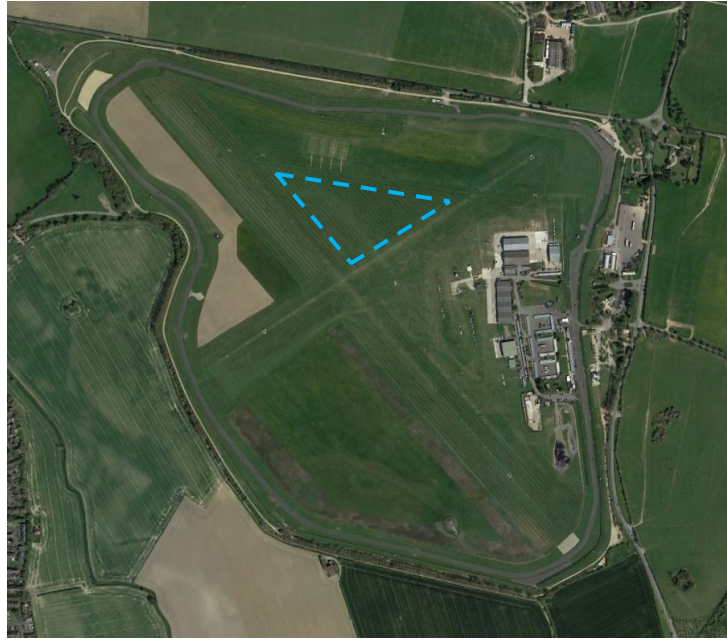
The 'Triangle' is shown at Figure 2.

Figure 2 – Overhead view of Chichester/Goodwood airfield showing the ‘Triangle’

¹ The ‘Triangle’ is the area at Goodwood between the 3 runways.

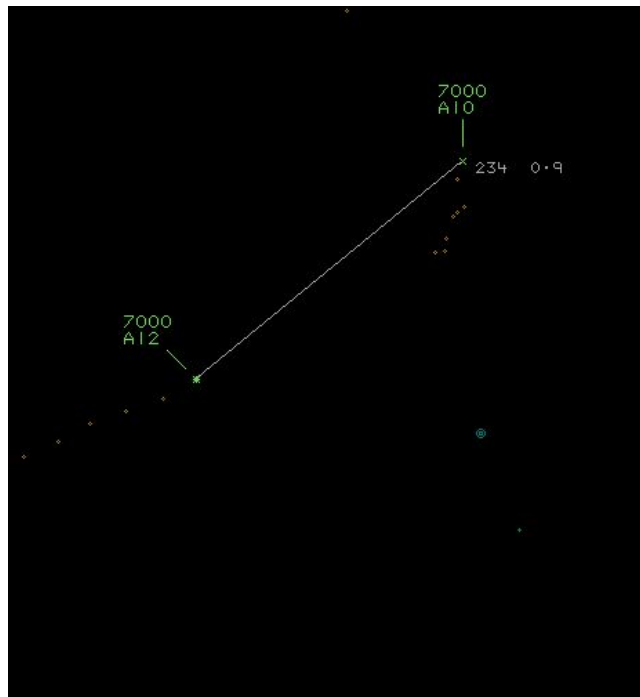
At 1218:02, the radar screenshot at Figure 3 shows the Decathlon approaching from the SW at an altitude of 1200ft; the Cabri is approximately 1nm ahead, climbing from the ‘Triangle’ on the northerly leg of the published circuit pattern at an altitude of 1000ft (Goodwood airfield elevation is 110ft).

Figure 3 – NATS radar screenshot at 1218:02

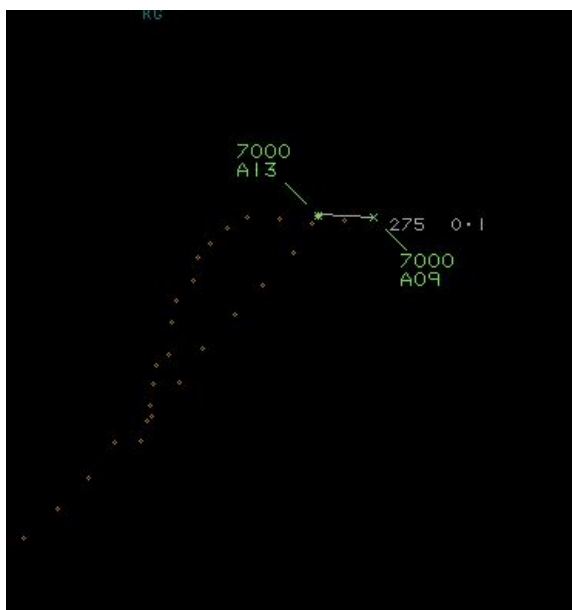
In Figure 4, the Decathlon pilot has positioned his aircraft on a tight crosswind join for RW32RH and crosses behind the Cabri, which is now on the easterly leg of the published rotary-wing circuit pattern. The aircraft are separated by approximately 0.1nm and 400ft.

Figure 4 - 1219:02

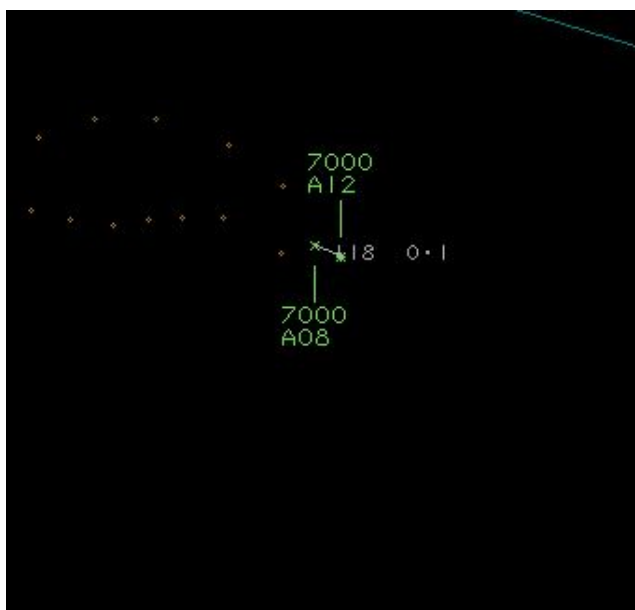
Figure 5 - 1219:30 (CPA)

CPA occurs shortly after the Decathlon pilot has turned onto the downwind leg for RW32RH as he passes almost overhead the Cabri (see Figure 5). The helicopter is at the most north-easterly point of the Goodwood circuit pattern and the Decathlon is following the published ground track for fixed-wing aircraft at Goodwood; this is the point at which the two published circuit patterns coincide.
