AIRPROX REPORT No 2017089

Date: 10 May 2017 Time: 1545Z Position: 5138N 00112W Location: 4nm W Benson airfield

PART A: SUMMARY OF INFORMATION REPORTED TO UKAB

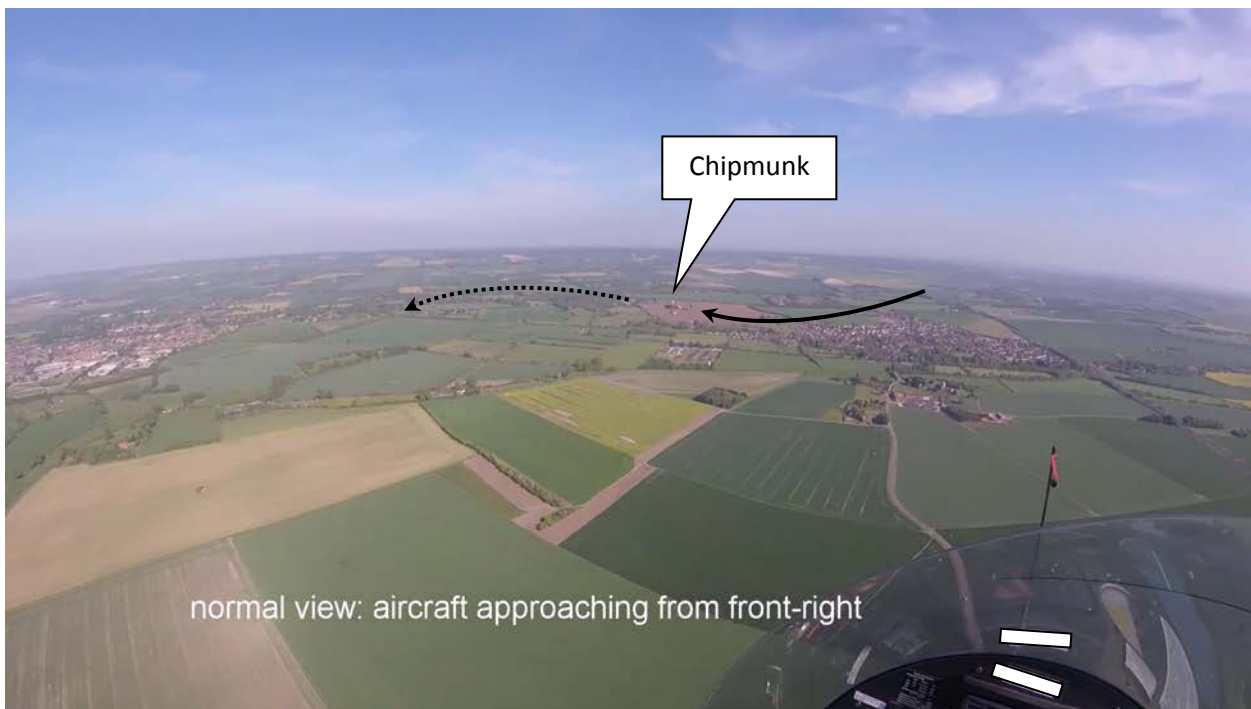
THE GYROPLANE PILOT reports that he saw the other aircraft in his 2 o'clock about 1km away. He thought at first that they were on a collision course, but it quickly became evident that it was going to pass in front of him. He elected to bear slightly to the right to widen the gap between them, to further increase the expected minimum distance. The pilot was wearing a 'Go-pro' camera and Figure 1 is taken from the video.

Figure 1 showing the Chipmunk from the Gyroplane

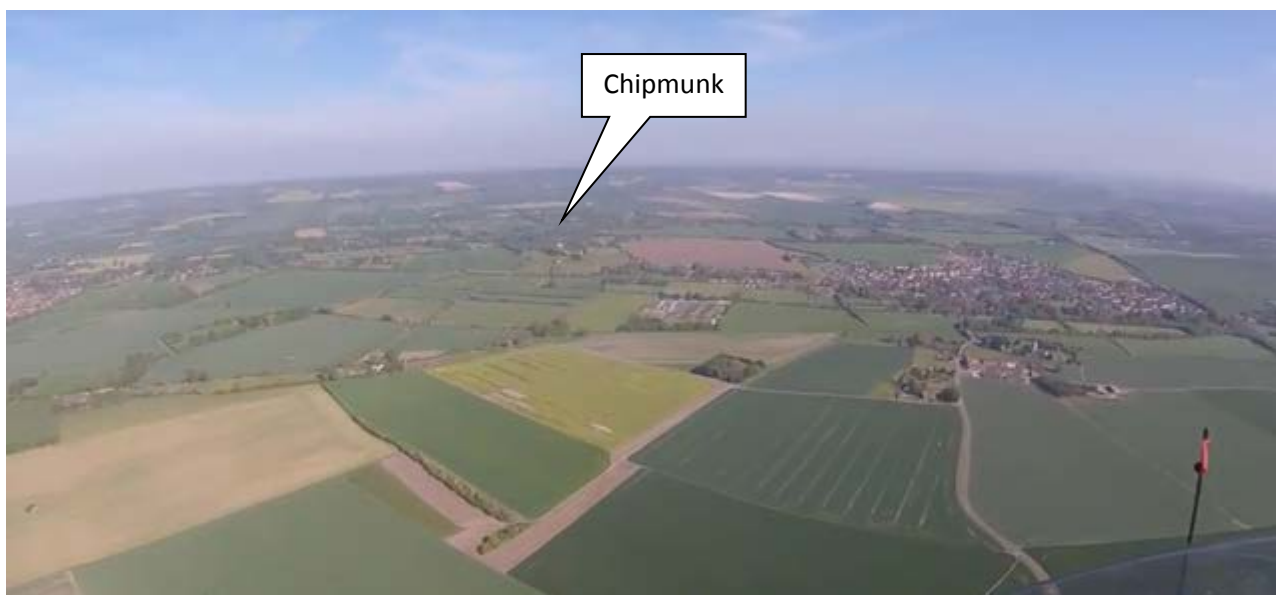
Figure 2 showing the Chipmunk from the Gyroplane

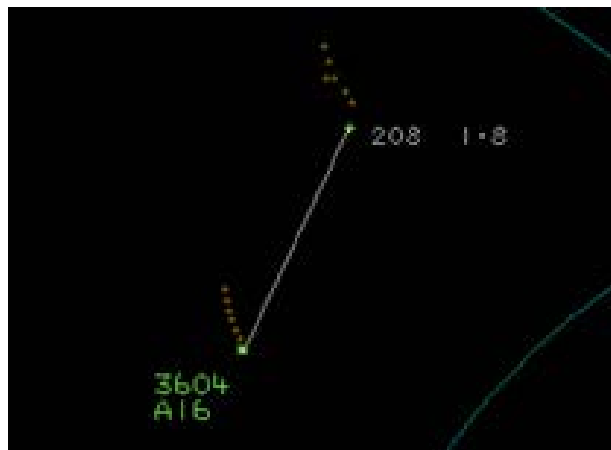
At 15:37:47, the Gyrocopter pilot free-called Benson Zone and was give Basic Service for routing into Chiltern Park Aerodrome. At 15:40:18 (Figure 3), the Chipmunk formation free-called Benson Zone requesting Basic Service inbound to North Moreton.

Figure 3: Geometry at 15:40:18 (Chipmunk no SSR observed; Gyrocopter 3604)

Figures 3-7 show the positions of the Chipmunk formation and Gyrocopter at relevant times in the lead-up to and during the Airprox. The screen shots are taken from a replay using the All Swanwick radar, which is not used by Benson ATC; therefore, is not necessarily representative of the picture available to the controller. The radar screen shots show the lead aircraft in the formation (a Bulldog) not the proximity between the Chipmunk and the Gyroplane.

The lead aircraft in the Chipmunk formation was the squawking aircraft, the Airprox Chipmunk had his transponder set to standby. Therefore the radar data on the NATS radar does not show the Airprox: the radar pictures shown, and CPA quoted, is from the lead aircraft which had landed by the time that the Gyroplane and Chipmunk came into proximity. For this reason the exact separation between these 2 aircraft is not known.

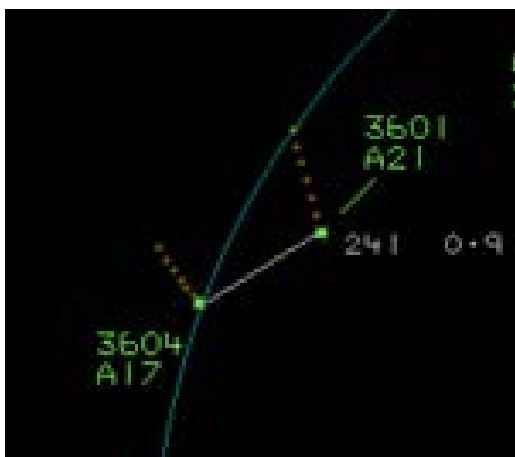
At 15:42:14 (Figure 4), the Benson Zone controller passed TI to the Chipmunk formation as west, 1nm, tracking south, a few hundred feet below, helicopter inbound to Chiltern Air Park. The Chipmunk pilot reported visual with the Gyrocopter.

Figure 4: Geometry at 15:42:14

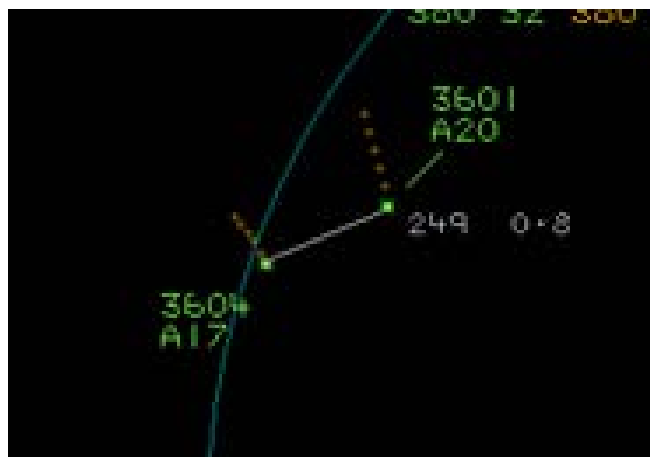
Figure 5: Geometry at 15:42:25

At 15:42:25 (Figure 5), the Gyrocopter pilot stated, “report visual also aircraft in formation...” It is not certain whether this statement meant that he was visual or would report visual with the formation.

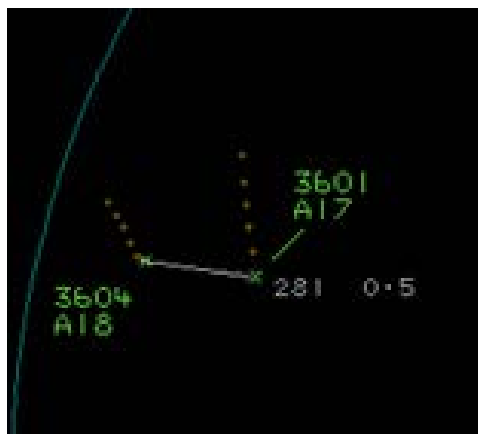
At 15:42:55 (Figure 6), the Chipmunk formation and Gyrocopter passed at CPA of 0.5nm and approx 100ft separation, with the formation then completing an anti-clockwise orbit over the next 2 minutes (Figure 7).

Figure 6: Geometry at 15:42:55

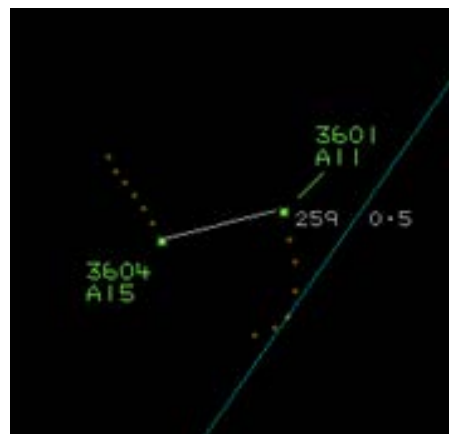
Figure 7: Geometry at 15:44:54

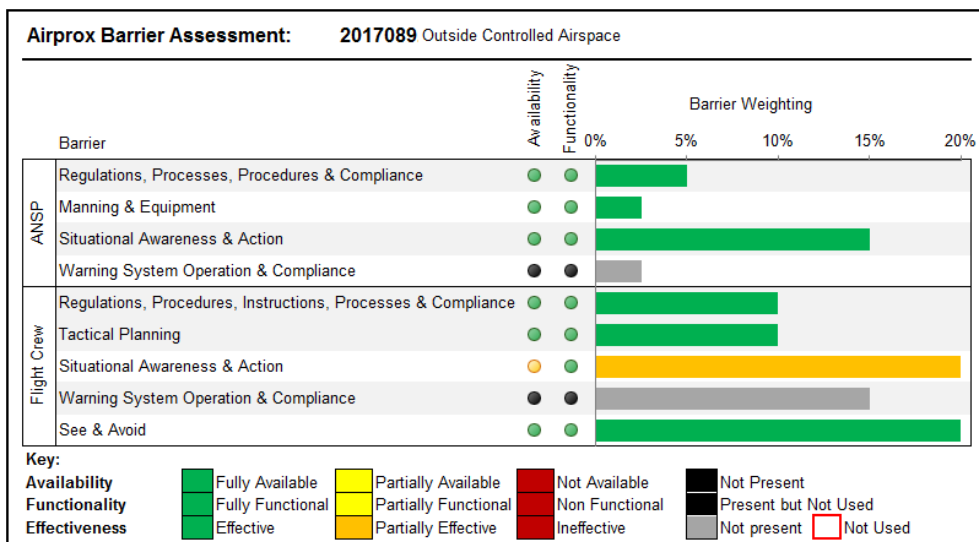
Situational Awareness & Action was assessed as **effective** because the Benson controller gave Traffic Information to both pilots.

Situational Awareness & Action was assessed as **partially effective** because it was thought that if the Gyroplane pilot had known where North Morton was he should have given it a wider berth; if he did not know where it was, he could have asked the controller.

Warning System Operation and Compliance was assessed as **not present** because neither aircraft had a CWS.

See and Avoid was assessed as **effective** because the Gyrocopter pilot saw the Chipmunk in enough time to take timely and effective avoiding action.
