AIRPROX REPORT No 2015067

Date: 21 May 2015 Time: 1427Z Position: 5145N 004W Location: Halton

PART A: SUMMARY OF INFORMATION REPORTED TO UKAB

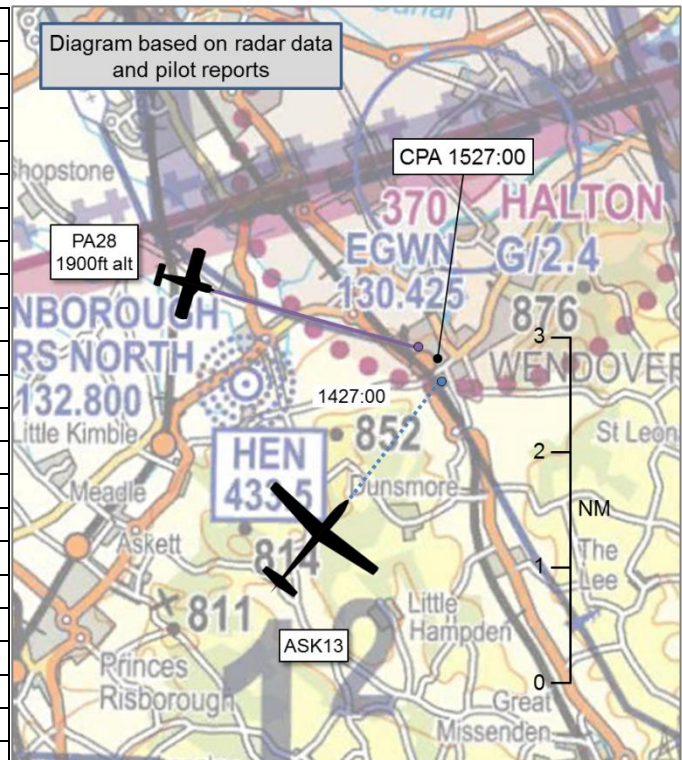
Recorded	Aircraft 1	Aircraft 2
Aircraft	ASK13	PA28
Operator	HQ Air (Trg)	Civ Pte
Airspace	London FIR	London FIR
Class	G	G
Rules	VFR	VFR
Service	AGCS	Basic
Provider	Halton	Oxford
Altitude/FL	NK	1900ft
Transponder	Not fitted	A, C, S
Reported		
Colours	Red/White	Orange
Lighting	None	HISL
Conditions	VMC	VMC
Visibility	30km	10km
Altitude/FL	2200ft	2000ft
Altimeter	QFE (1017hPa)	NK
Heading	060°	104°
Speed	40kt	110kt
ACAS/TAS	FLARM	Not fitted
Alert	Nil	N/A
Separation		
Reported	<100ft V/0m H	100-200ft V
Recorded	NK

THE ASK13 PILOT reports soaring around the edge of the Halton ATZ on a heading of approximately 060° after being released from an aero tow at 2000ft. After crossing the railway line, an unknown aircraft passed directly under his aircraft from his 7 o'clock position with less than 100ft vertical separation. He stated that it appeared that the unknown aircraft was following the railway line.

THE PA28 PILOT reports inbound to Stapleford from the west, maintaining 2000ft to keep below the London TMA. At the time of the incident he was in receipt of a Basic Service from Oxford, and was flying straight and level, squawking an assigned code. He recalls seeing two aircraft around the time of the incident: one, a white glider at a similar height but half a mile away; and another, possibly a glider 100-200ft above, fairly close but behind him in his 7 o'clock position.

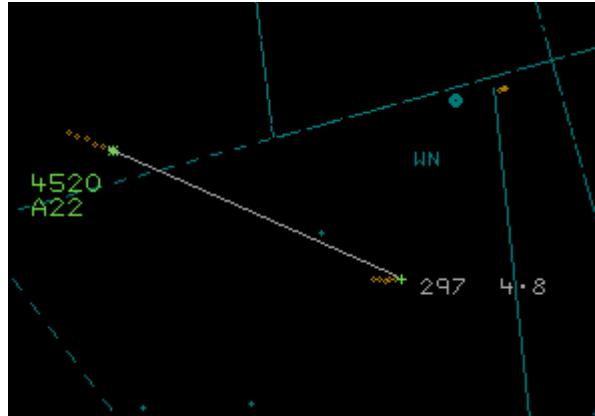
Figure 1 - 1425:00

The pilot of the glider was receiving an Air/Ground service from Halton Radio. The pilot of the PA28 was receiving a Basic Service from Oxford Radar. RAF Halton is 22nm to the ESE of Oxford Airport. A review of the area radar recording at 1425:00 showed the PA28 17nm to the ESE of Oxford, tracking ESE towards a primary radar contact, 4.8nm directly ahead of the PA28. (Figure 1.)

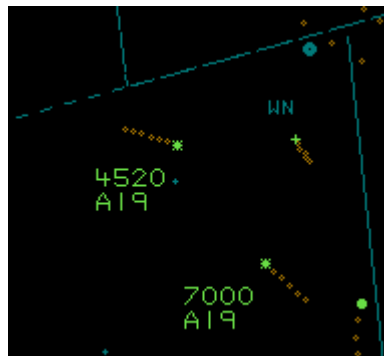
Figure 2 - 1426:30

At 1426:30 that same primary radar contact had passed clear of the PA28's track. (Figure 2.)

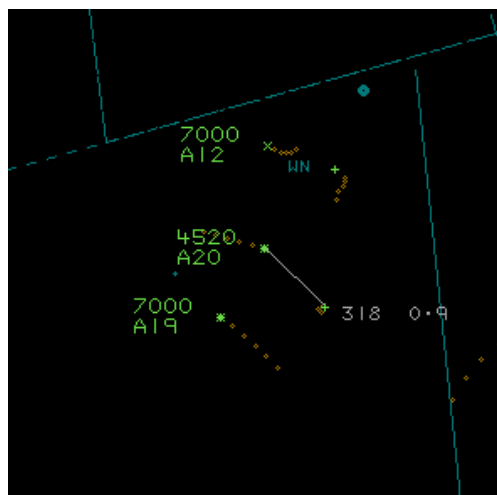
Figure 3 - 1427:00

At 1427:00 a new primary contact appeared, <1nm to the south east of the PA28. (Figure 3.)

Based on both pilot reports, correlated with the area radar recordings, it is considered highly likely that the primary contact in Figure 3-6 was the glider which reported the Airprox.

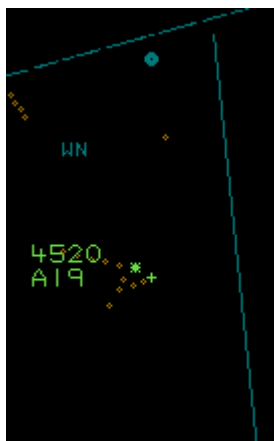
Figure 4 - 1427:27

At 1427:27, the distance between the PA28 and the new primary radar contact was <0.1nm, with both tracks converging. (Figure 4.)

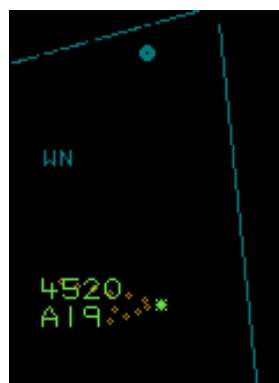
Figure 5 - 1427:34

At 1427:34 both the PA28 and the primary radar contact merged. (Figure 5.)

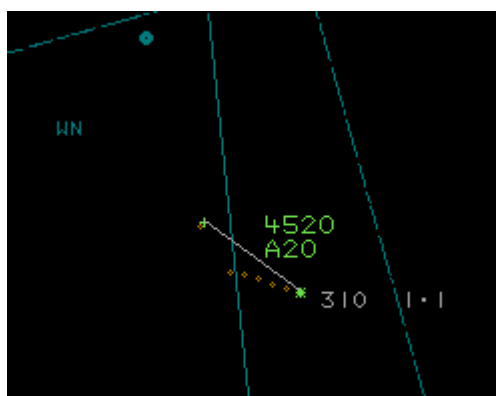
Figure 6 - 1428:16

At 1428:16, the primary radar contact reappeared 1.1nm to the NW of the PA28. (Figure 6.)
