AIRPROX REPORT No 2014029

Date/Time: 23 Mar 2014 1145Z

Position: 5330N 00031W
(Hibaldstow Parachuting Site)

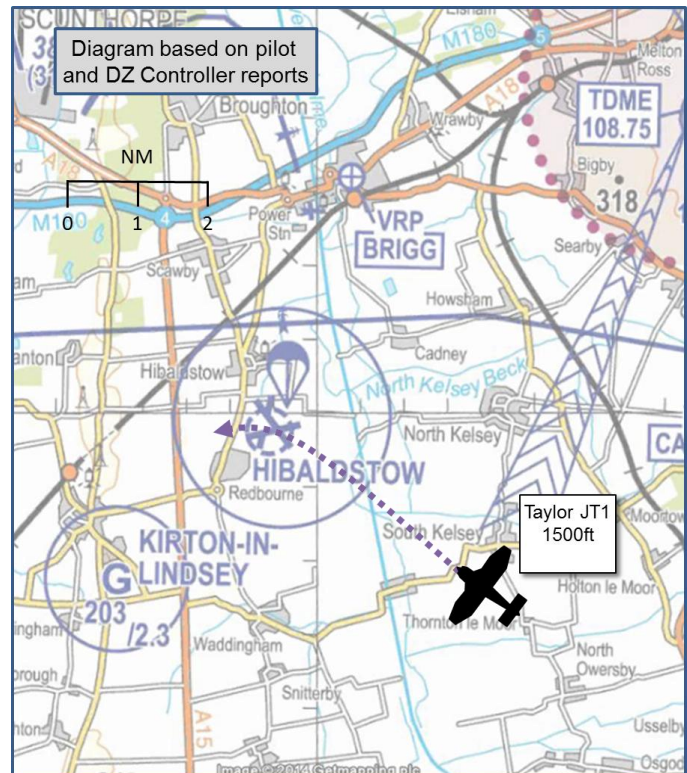
THE HIBALDSTOW DROP ZONE CONTROLLER reports that parachutists had been dropped to the northwest of the landing-zone when he saw a red single-engine monoplane fly over the aerodrome, tracking around 300° at 1500-1800ft. The aircraft then made what appeared to be an avoiding-action left turn at a range of less than 2000ft from the parachutists. The Drop Zone Controller consulted the parachutists and the paradrop aircraft's pilot after they landed but none of them had seen the Taylor JT1 as it passed.

THE TAYLOR JT1 PILOT reports flying his red aircraft at around 60kt, with no lights, radio or transponder fitted. He was VFR, clear below cloud, flying out-of-sun, and was using his GPS system and Edn 36 of the 1:500,000 chart to navigate. Due to 'shower avoidance' he had to deviate from his planned track and because he had no radio, he was intent on avoiding Humberside and Doncaster-Sheffield Airports as well as looking out for the gliding and parachuting sites marked on the chart. As he approached what he thought to be a disused airfield, with vehicles parked on the runways, he referred to his GPS, which did not show a parachute zone. As he passed over the airfield, the pilot saw several parachute canopies deployed above him in his 3 o'clock position around 400m away, and silhouetted against the cloud layer. He confirmed that there were no parachutists to his left and then executed a left turn to clear the area. After landing he checked his GPS again and confirmed that neither Hibaldstow nor Kirton-in-Lindsey were displayed on the GPS screen.

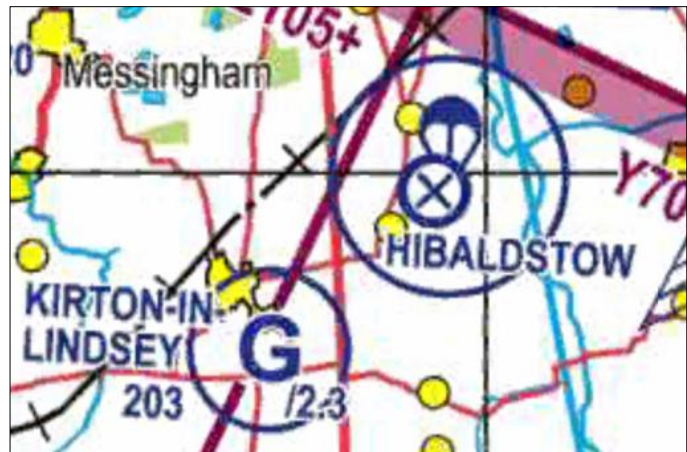
Figure 2. Extract from 1:500,000 chart Edn 36

The Hibaldstow gliding site is displayed on the 1:500,000 chart Edn 36 as a disused aerodrome and an active parachuting site (Figure 2), although the parachute symbol is partially obscured by the 'disused aerodrome' markings. The parachuting symbology shown on the chart does not oblige pilots to avoid the area of the circle, but acts as a warning to pilots that they can expect to encounter aircraft carrying out parachute support operations and/or parachutists in the air. The JT1 pilot was required to give way to parachutists in the air, which he did. As for Hibaldstow airfield itself, the Rules of the Air state that pilots flying in the vicinity of what they know, or ought reasonably to know, to be an aerodrome are required to conform to the pattern of traffic formed by other aircraft intending to land at that aerodrome or keep clear of the airspace in which the pattern was formed.¹ From his report, the pilot of the JT1 clearly believed the aerodrome he was flying over to be disused; he had not seen, or had not assimilated, the parachuting markings from the chart or GPS, and did not initially recognise the aerodrome he was overflying as Hibaldstow. The Drop Zone Controller was looking out for aircraft flying near the Drop Zone but, when he saw the JT1, the parachutists had already left their aircraft.

From his report, the pilot of the JT1 clearly believed the aerodrome he was flying over to be disused; he had not seen, or had not assimilated, the parachuting markings from the chart or GPS, and did not initially recognise the aerodrome he was overflying as Hibaldstow. The Drop Zone Controller was looking out for aircraft flying near the Drop Zone but, when he saw the JT1, the parachutists had already left their aircraft.

The Board thought that the combination of disused airfield and parachuting site symbology for Hibaldstow on the 1:500,000 chart was unclear and resolved to recommend that the CAA should consider its review. They also agreed that the CAA should consider reviewing the definition of 'disused' aerodromes in general where aerial sporting activity takes place. The nomenclature 'disused' implies no activity, whereas disused aerodromes quite often do have sporting aviation activity associated with them and the Board opined that a better nomenclature should be sought for these aerodromes.

<u>Cause:</u>	The Taylor JT1 pilot flew over a promulgated and active Parachute Dropping Site and into conflict with the parachutists.
<u>Degree of Risk:</u>	C
<u>ERC Score²:</u>	4
<u>Recommendation(s):</u>	The CAA consider reviewing the charting and definition of 'disused aerodromes' where aerial sporting activity takes place.
