## **AIRPROX REPORT No 2013033**

Date/Time: 12 May 2013 1329Z (Sunday)

Position: 5228N 00101E  
(5.1nm W of Tibenham)

Airspace: London FIR (Class: G)

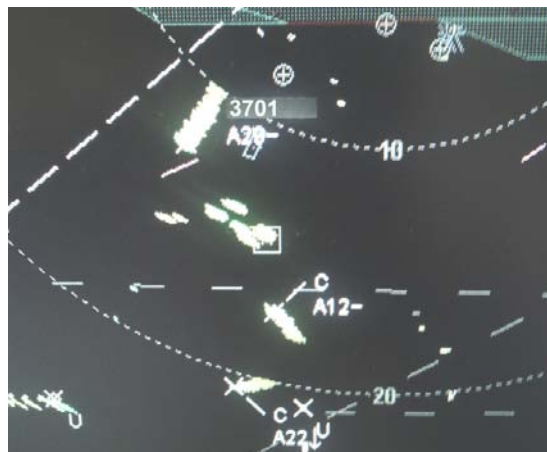
Figure 1 – Norwich Radar at 1327:53

At 1327:53 APP passed TI advising the PA31 pilot that, from the 11 o'clock position through to the left 9 o'clock at a range of 3 to 5 miles with no height information, there were believed to be gliders operating from Tibenham (Figure 1). The pilot was advised to keep a good lookout and he acknowledged this.

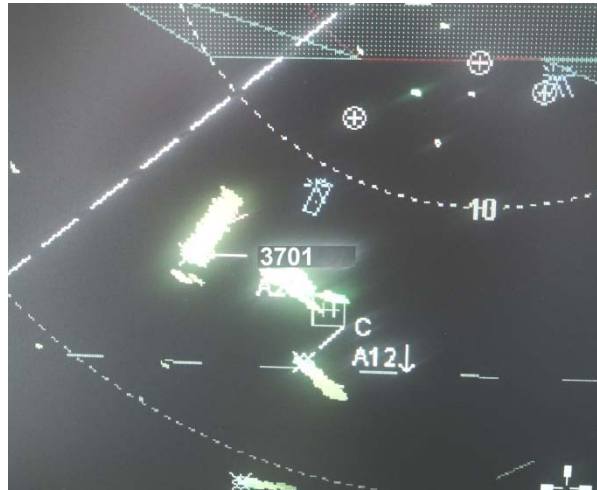
Figure 2 – Norwich Radar at 1328:47

At 1328:47, APP passed TI, “[PA31]c/s Traffic twelve o’clock half a mile two intermittent contacts no height information.” The PA31 pilot responded, “er wilco look out for traffic got him on TCAS (PA31)c/s.” The Norwich radar recording showed intermittent contacts crossing ahead of the PA31 from left to right and shortly afterwards (1329:05) all the blips were seen to merge. The PA31 pilot did not make any further comment on the other traffic in the vicinity. It was not clear which aircraft the PA31 pilot had observed on TCAS (Figure 2).
