## **AIRPROX REPORT No 2012160**

Date/Time: 1 Nov 2012 1430Z

Position: 5626N 00322W  
(RW27 Perth/Scone  
- elev 388ft)

Airspace: Perth/Scone ATZ (Class: G)

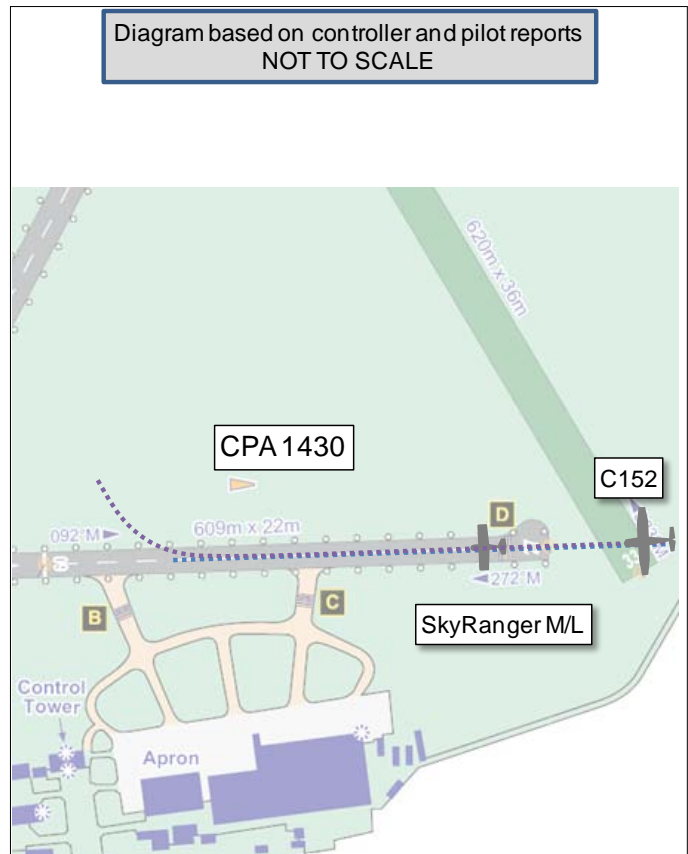
**THE A/G OPERATOR** reports that a M/L pilot reported 'Final' to 'Touch and Go' on RW27. A few seconds later a C152 pilot also reported 'Final' to 'Touch and Go' on RW27. He saw the two ac in close proximity and asked the C152 pilot if he had the M/L in sight. After a delay, and at a distance of about 200m from the threshold, the C152 pilot announced his intention to go around. The M/L pilot performed a 'Touch and Go' while the C152 pilot carried out a late go around over RW27, overtaking the M/L. He observed that the C152 'Go around' appeared to be level and at this point, directly in front of him, he advised the M/L pilot to stop climb in order to avert a collision. He estimated a vertical separation of 10ft with the C152 directly above the M/L. This incident was the culmination of several non-standard joining attempts by the C152 pilot where at no point was he able to see the other 3 ac in the cct in good time. Further confusion may have been caused because the C152 pilot appeared not to allow for the airfield elevation of 400ft.

The white ac was fitted with a fin-mounted strobe light but no SSR transponder or ACAS. He heard the subject C152 'announce itself' at approximately his position. The other pilot's radio call was confused, as if he was unsure of what to say. He saw the C152 pass underneath him to the W, 'flying very low'. He performed a standard O/H join and found the C152 was in the cct with him. When DW for a 'Touch and Go', he saw the C152 pilot 'cut the corner' at low level and do a 'Touch and Go' ahead of him. He heard 'a couple more' RT calls from the C152 pilot, not following radio procedures and sounding as if he had not worked out what to say; at one point apologising for this. He then lost track of the C152 and proceeded to do two 'Touch and Goes'. On his third approach, he announced 'final for touch and go 27' and then heard the Cessna pilot announce the same. The A/G Operator told the C152 pilot 'you are number 2'. The C152 pilot replied 'I cannot see him' and, as the M/L pilot neared the threshold, the C152 pilot said 'going around'. The M/L pilot carried on, touched down, accelerated and took off. As he started to climb out, heading 270° at 55kt, the A/G Operator told him, urgently, 'don't climb, don't climb!'. He immediately levelled off, at about 80ft, and looked up in time to see the C152 'peeling up and to the R', on to the live side of the cct, from a position directly above him. The A/G Operator told him afterwards that he assessed they were about 10ft apart at one point; it was only then that he realised 'what a close thing' this had been.

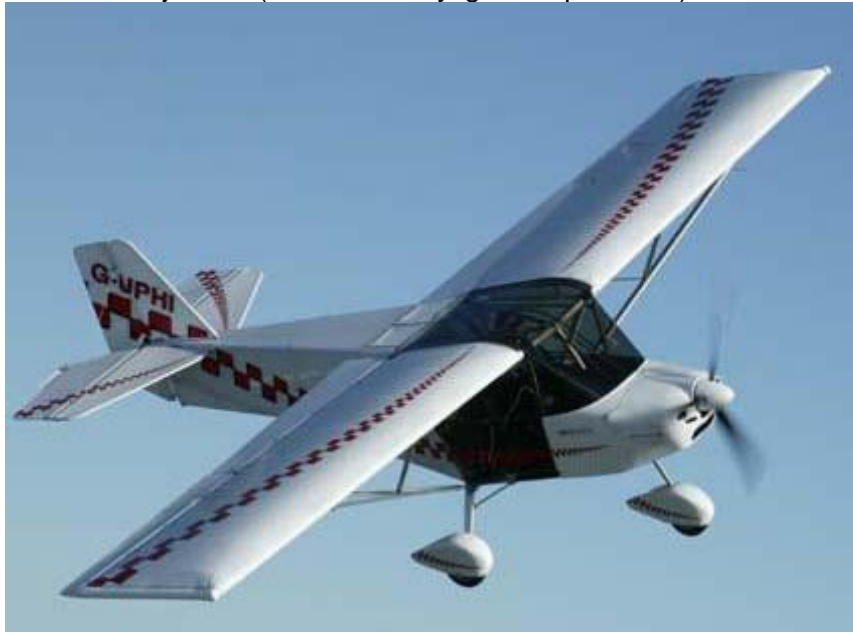
[UKAB Note(1): The SkyRanger Swift is a high-wing, tricycle undercarriage 3-axis microlight of fabric covered aluminium tube construction with a MAUW of 450kg,  $V_{ne}$  of 111kt and  $V_{so}$  of 34kt. The picture below is not of the subject ac (attribution: Flylight Airsports Ltd).
