AIRPROX REPORT No 2022085

Date: 19 May 2022 Time: 1226Z Position: 5142N 00212W Location: IVO Nailsworth

PART A: SUMMARY OF INFORMATION REPORTED TO UKAB

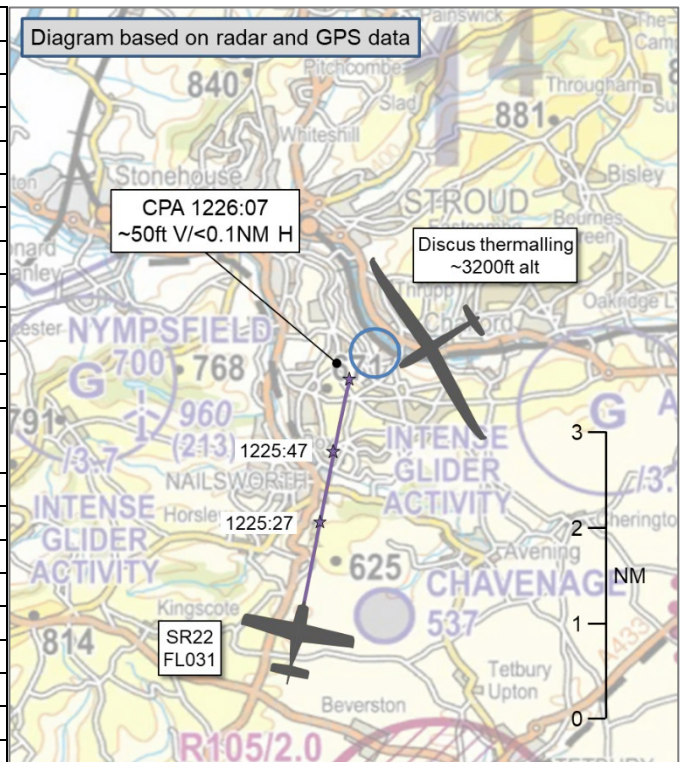
Recorded	Aircraft 1	Aircraft 2
Aircraft	Discus	SR22
Operator	Civ Gld	Civ FW
Airspace	London FIR	London FIR
Class	G	G
Rules	VFR	VFR
Service	None	Basic
Provider	N/A	Gloster
Altitude/FL	~3200ft ¹	FL031
Transponder	Not fitted	A, C, S+
Reported		
Colours	White	White, Silver
Lighting	None	Landing, Strobes, Nav
Conditions	VMC	VMC
Visibility	>10km	>10km
Altitude/FL	3027ft	3300ft
Altimeter	QNH	QNH
Heading	Circling	358°
Speed	50kt	160kt
ACAS/TAS	FLARM, SkyEcho	TCAS I
Alert	None	None
Separation at CPA		
Reported	0ft V/<100m H	Not Seen
Recorded	~50ft V/<0.1NM H

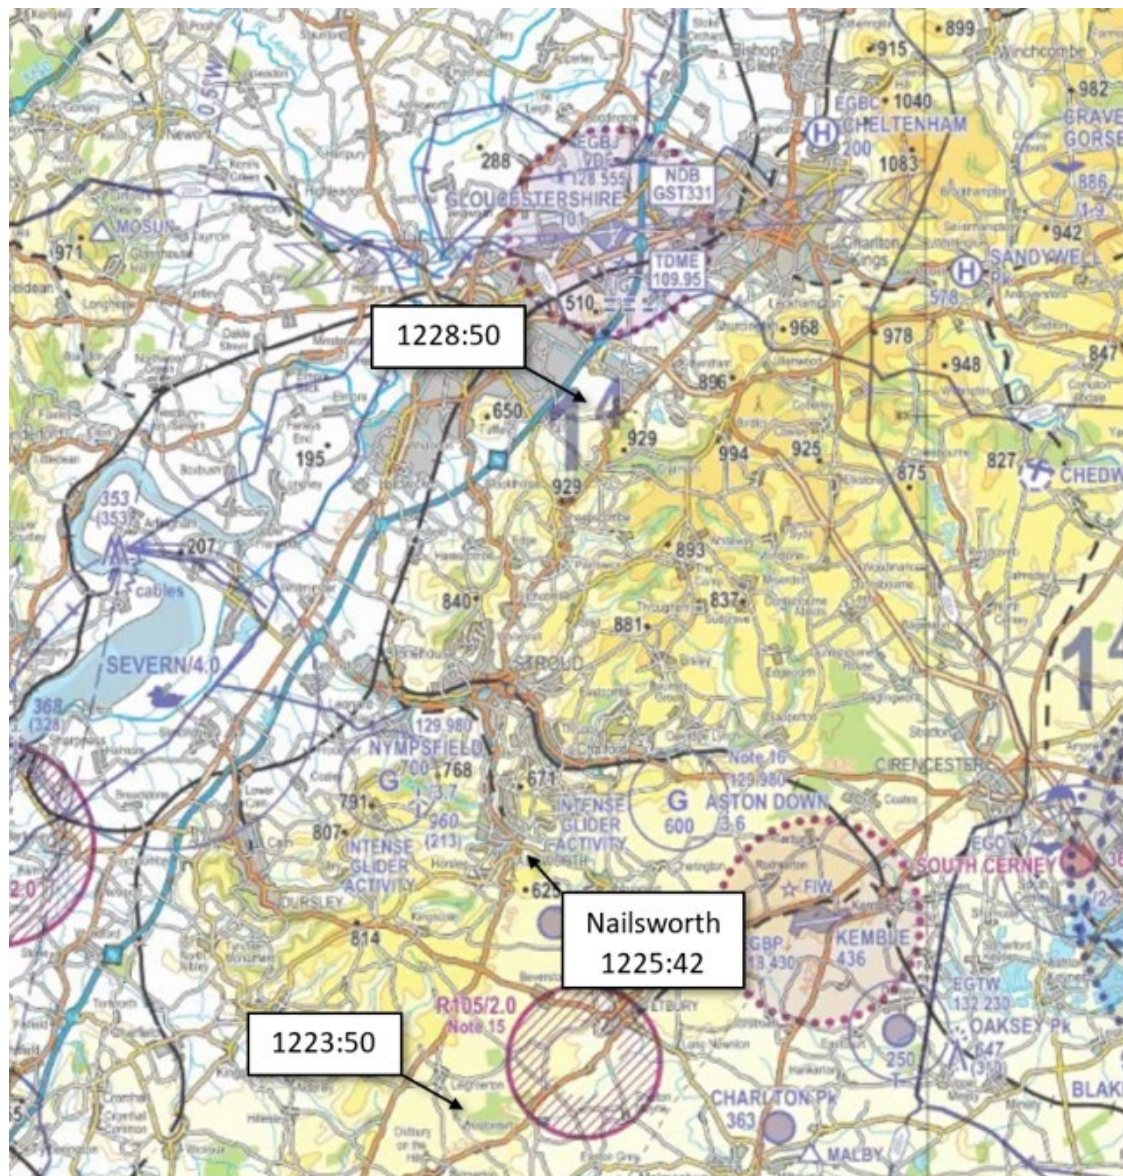
The observed track of the SR22 on the area radar replay was plotted and it was seen to pass equidistant between both Nympsfield and Aston Down Gliding sites, located to the south of Gloucestershire Airport. The graphic below is provided to show the position of the SR22 at the following times:

- 1223:50 - First call.
- 1225:42 - Overhead Nailsworth
- 1228:50 - Position at time of proximity report by pilot of Discus.

At no time during the review of the area radar replay were any contacts, primary-only or transponding, observed either in the Nympsfield or Nailsworth areas. The SR22 was transponding throughout.
