AIRPROX REPORT No 2022103

Date: 13 Jun 2022 Time: 1000Z Position: 5621N 00314W Location: IVO Errol

PART A: SUMMARY OF INFORMATION REPORTED TO UKAB

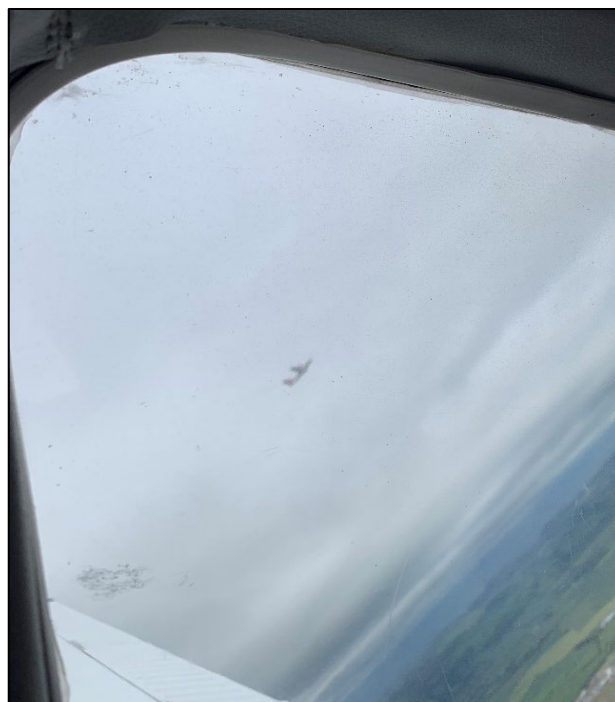
Figure 1: Photo taken by PA28 student

descent (climbing at 80kt and banking at 15°) and with a northwest heading, they spotted the ATR head-to-head tracking towards the southeast to join a visual left-hand circuit RW27. Separation at the time they first spotted the other aircraft would be +2NM. They stopped climbing immediately and as they were recovering from the left spiral descent, kept turning to the left to set a southwest heading (240°) to fly away from the ATR. As a guesstimate, the closest they got would be about 0.5NM, with the ATR always higher than them, and with the traffic in sight at all times. The ATR did not fly overhead, but to the north of their position. They noted that they might have missed some of the ATR pilot's radio calls, but both the instructor, as the PIC, and the three students onboard were expecting the ATR42 to fly the ILS approach and break right to join the visual circuit on short final RW09. Nevertheless, once they spotted the aircraft and following the actions taken, they did not feel to be in danger.

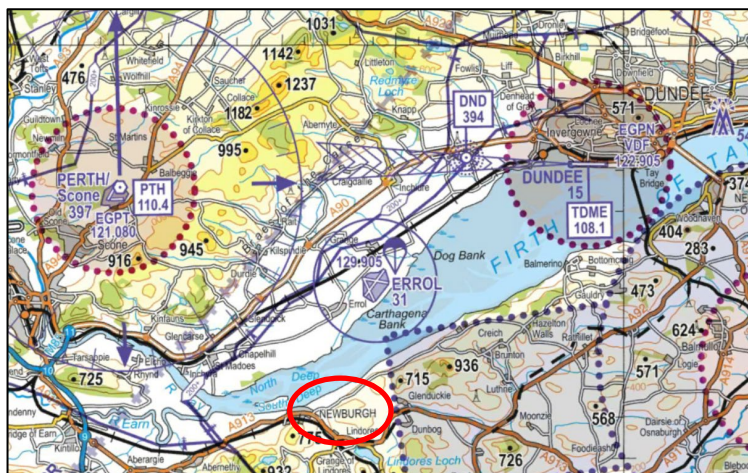
After the ATR42 had landed, the controller, at 1005:32, called the pilot of the PA28 and requested their position and altitude. The pilot reported being at Newburgh (ringed in Figure 4 below) at 1500ft. This was the first call to or from the PA28 during this period.
