AIRPROX REPORT No 2022196

Date: 26 Aug 2022 Time: 1317Z Position: 5042N 00125W Location: 7NM SW Cowes VRP

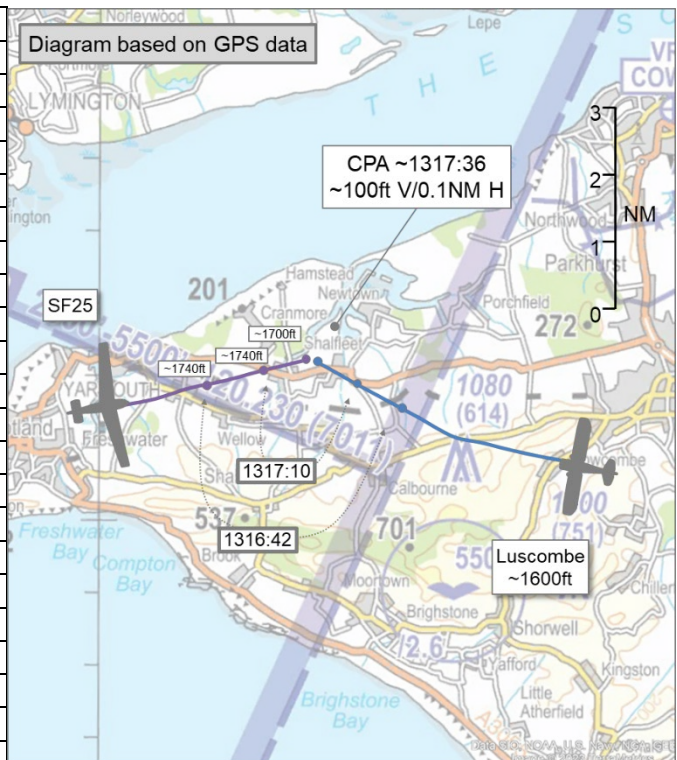
The NATS radar replay was assessed but neither aircraft could be seen. However, both pilots kindly supplied GPS data and so the separation could be assessed and the diagram at the top of the report was prepared using the GPS data.

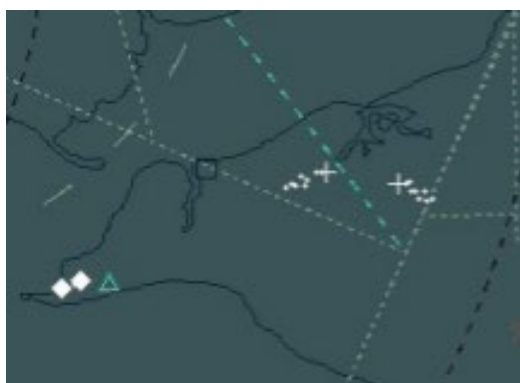
Figure 1

The recordings from this incident have been reviewed by the investigator who found that the reporting controller's MOR portrayed an accurate account of the incident. The pilot of [Luscombe C/S] had just made contact with Bournemouth Radar and was in the process of passing transit details when they encountered another aircraft in close proximity. The pilot classed the incident as an Airprox and stated on the RT that they wished to file a report. At the time [the Luscombe C/S] freecalled Bournemouth Radar, two PSR-only returns could be seen on the radar recordings, both well outside the Bournemouth CTR, in the vicinity of Newtown on the Isle of Wight. Neither aircraft displayed a callsign, squawk or any altitude information. At this time, the contact now known to be [Luscombe C/S] was seen heading in a north-westerly direction, with the other aircraft in their 11 o'clock range of 1.5NM, tracking in an east-north-easterly direction. A radar screenshot captured at this time is reproduced below with [Luscombe C/S] being the contact to the right (Figure 1).

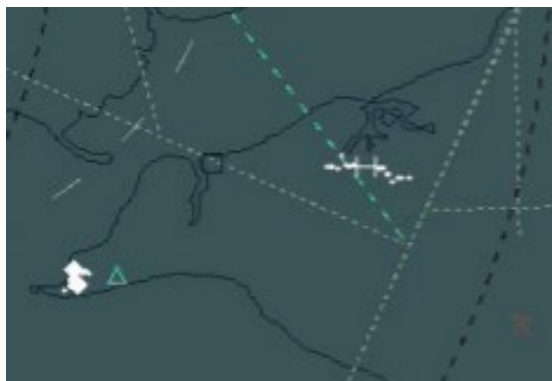
Figure 2

At 1317:19 the pilot had just begun to pass their details and it was during this initial transmission that the Airprox occurred. At 1317:19 the pilot made the following transmission: “*Afternoon [Luscombe C/S] Luscombe Silvaire, two on board, erm from [departure airfield] to a private site just south of Compton Abbas present position 4 miles east of the Needles 1700 feet 1021 intended routeing is er across the water to Lymington then err clear of your zone to the east...[long pause]...sorry standby ahh just had an Airprox [Luscombe C/S].*” At the time they paused, the two aircraft were in the positions depicted below (Figure 2). It is therefore assumed it was at this point that [the Luscombe pilot] identified the other aircraft.

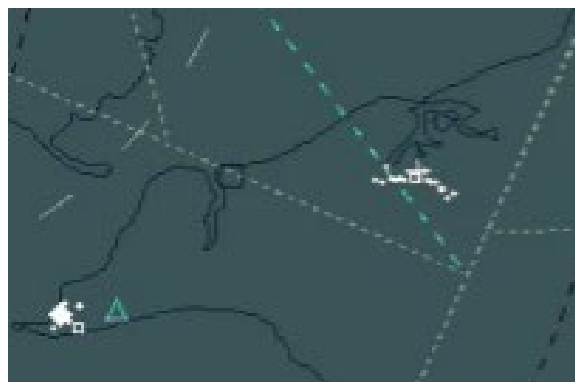
Figure 3 - CPA

The radar contacts merged at 1317:44, see Figure 3.

The radar returns then separated again with both aircraft continuing on their previous tracks. The pilot of [Luscombe C/S] reported at the time that they were flying at an altitude of 1700ft. The altitude of the other aircraft was not available due to the lack of secondary radar information.
