AIRPROX REPORT No 2023093

Date: 28 May 2023 Time: 1359Z Position: 5113N 00111W Location: 2.5NM NE Popham

PART A: SUMMARY OF INFORMATION REPORTED TO UKAB

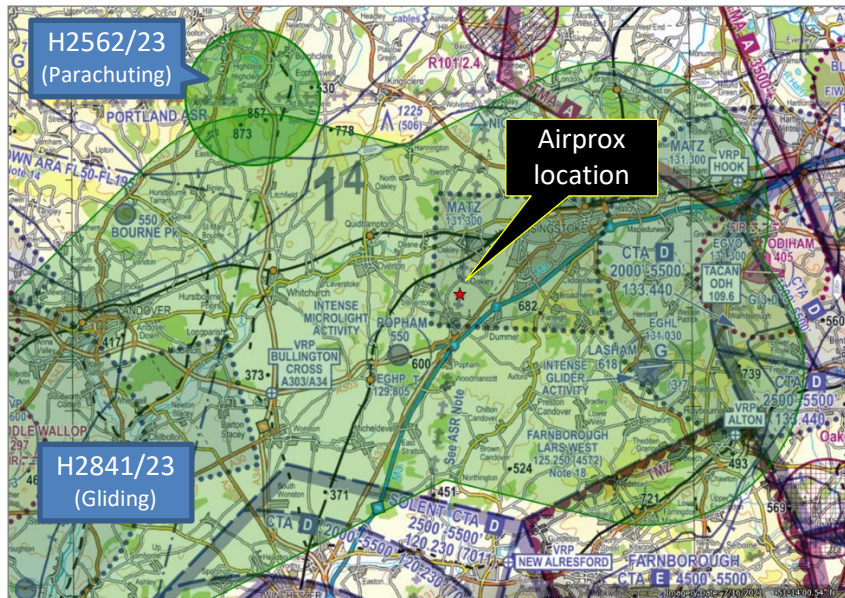
Figure 1 – The areas covered by NOTAMS

The NOTAM for a parachute display at Highclere:

The NOTAM for a glider competition at Lasham:

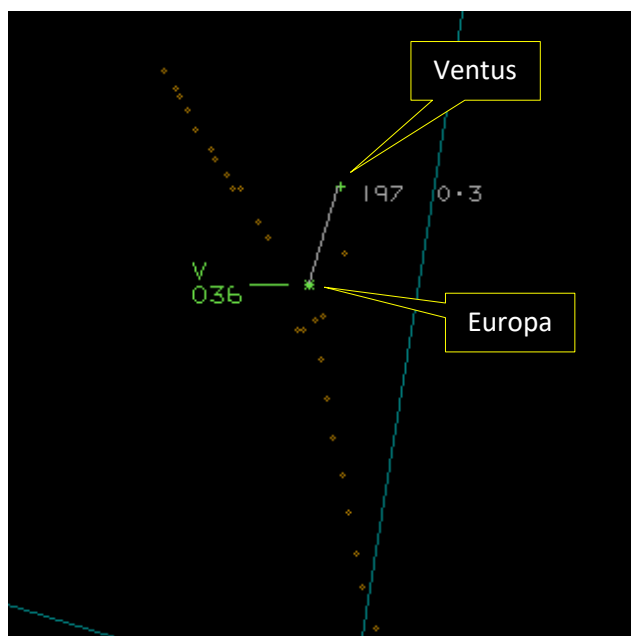
An analysis of the NATS radar replay was undertaken and the Europa could be positively identified from Mode S data (see Figure 2). The pilot of the Ventus kindly supplied GPS track data for their flight. The aircraft positions could not be accurately plotted from the radar returns. Consequently, the diagram has been constructed, and the separation at CPA determined, from the GPS data and an interpolation of the radar data.

Figure 2 - CPA at 1359:30.
