AIRPROX REPORT No 2024058

Date: 21 Apr 2024 Time: 1116Z Position: 5141N 00024E Location: 1NM SW Chelmsford

PART A: SUMMARY OF INFORMATION REPORTED TO UKAB

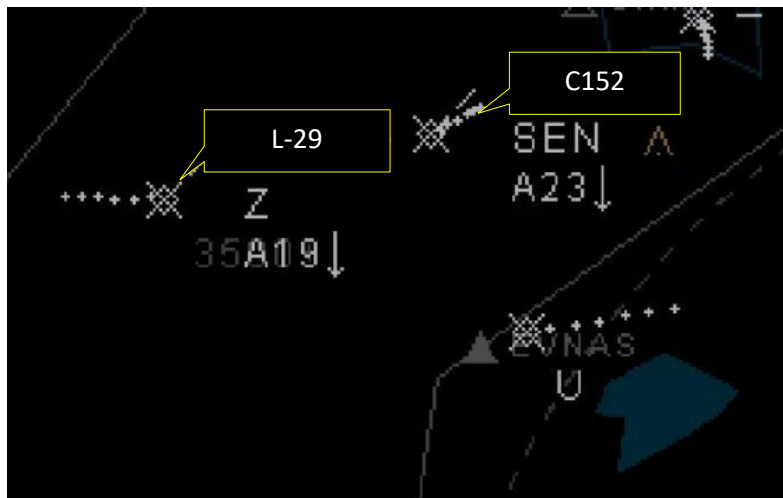
Figure 1 – Southend Radar at 1115:10

At 1115:10 (Figure 1), the recorded surveillance data indicated that [the L-29] was 6NM west of [the C152] tracking eastbound, indicating 1900ft altitude unverified, descending, and squawking the Mode Alpha code 7000.¹ At this time, [the C152] was indicating 2300ft altitude, also in a descent, and was squawking the Mode Alpha code 5050.²

¹ On the RDS 1600 radar display, 7000 codes are presented as 'Z.'

² On the RDS 1600 radar display, 5050 codes are presented as 'SEN'.

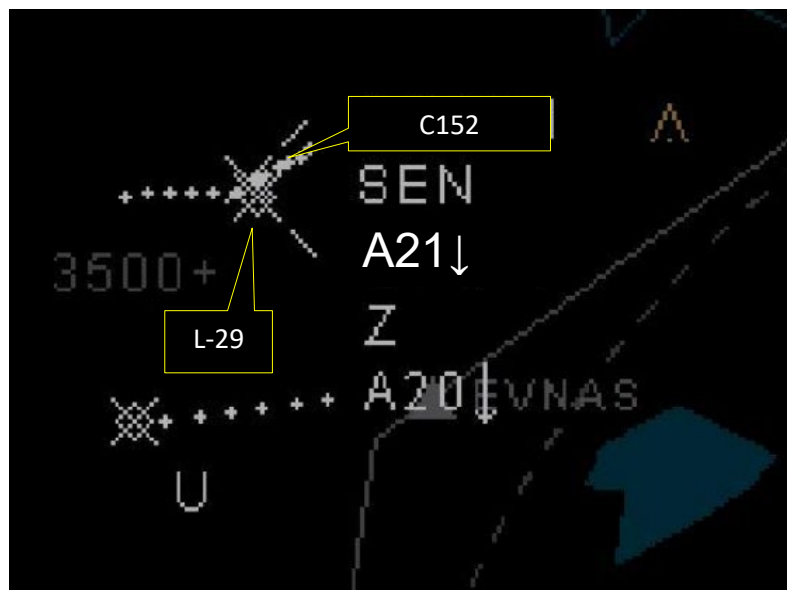
Figure 2 (CPA) – Southend Radar at 1115:50

At 1115:50, (Figure 2) CPA occurred. [The C152's] Mode C was indicating 2100ft altitude, unverified, and descending, and [the L-29] was indicating 2000ft altitude, unverified, and also descending.
