AIRPROX REPORT No 2024185

Date: 03 Aug 2024 Time: 1316Z Position: 5143N 00206W Location: 1.6NM NE of Aston Down

PART A: SUMMARY OF INFORMATION REPORTED TO UKAB

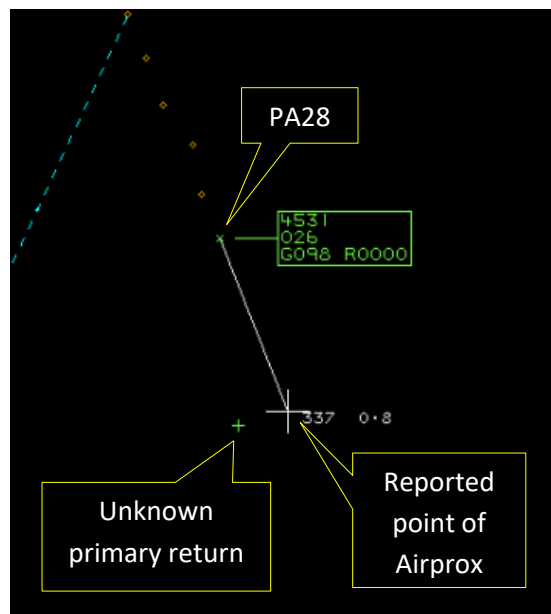
An analysis of the NATS radar replay was undertaken and neither aircraft could be positively identified using Mode S data. However, the PA28 was visible indicating altitude with Mode C selected and a further primary target was also seen at 1315:11 close to the reported point of the Airprox. The primary return may have been the ASW27 but this could not be confirmed because there were also other gliders in the vicinity (Figure 1).

Figure 1 – Time 1315:10 NATS radar depiction of the PA28

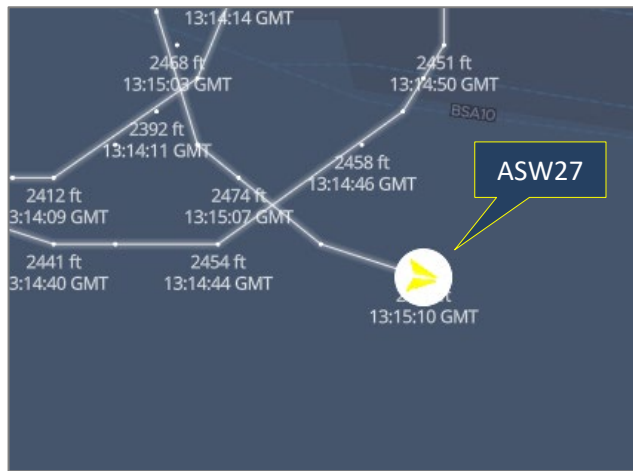
Analysis of ADS-B data sources depicted the position of the ASW27 with the PA28 not visible on that data source (Figure 2).

Figure 2 – Time 1315:10 ADS-B depiction of the ASW27.

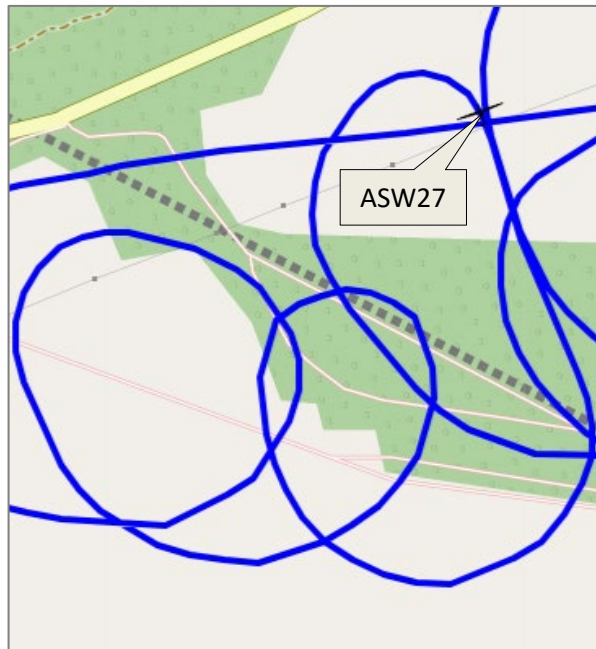
Both aircraft's navigation files were examined and the closest horizontal separation was seen as approximately 0.05NM from 1315:28 to 1315:30, with the ASW27 altitude having increased slightly at 1315:30 (Figures 3 & 4). This was assessed to be the closest point of approach.

Figure 3 – Time 1315:30 ASW27 position

At CPA, the ASW27 navigation data displayed a height of 1880ft above its launch site which was calculated to be an altitude of 2540ft on a setting of 1013hPa, with the local area QNH of 1011hPa.

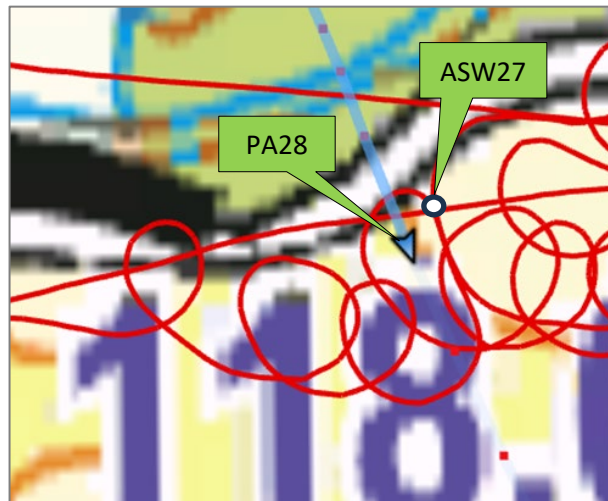
Figure 4 – Time 1315:30 PA28 position

The PA28 navigation file displayed no accurate altitude information, so the recorded altitude was taken from the radar replay as 2600ft on 1013hPa, which agrees with the PA28 pilot's reported altitude of 2500ft on 1011hPa. However, the PA28 was temporarily recorded at 2700ft at 1314:50, 40sec before CPA and may therefore have been higher than the reported altitude at CPA.

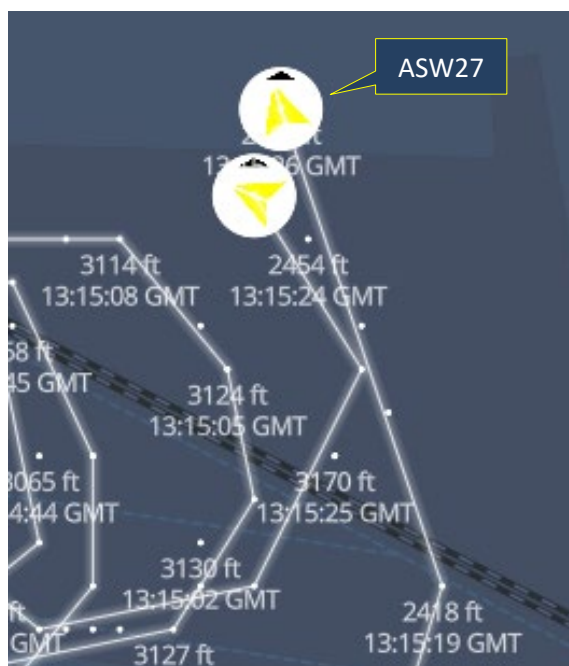
Figure 5 – Time 1315:30

It was notable that another glider was also operating in the vicinity at the time of CPA, 700ft higher than the ASW27 and in a similar position to the PA28 (Figure 5).
