**AIRPROX REPORT No 2024188**

Date: 04 Aug 2024 Time: 1509Z Position: 5138N 00039W Location: Knotty Green

**PART A: SUMMARY OF INFORMATION REPORTED TO UKAB**

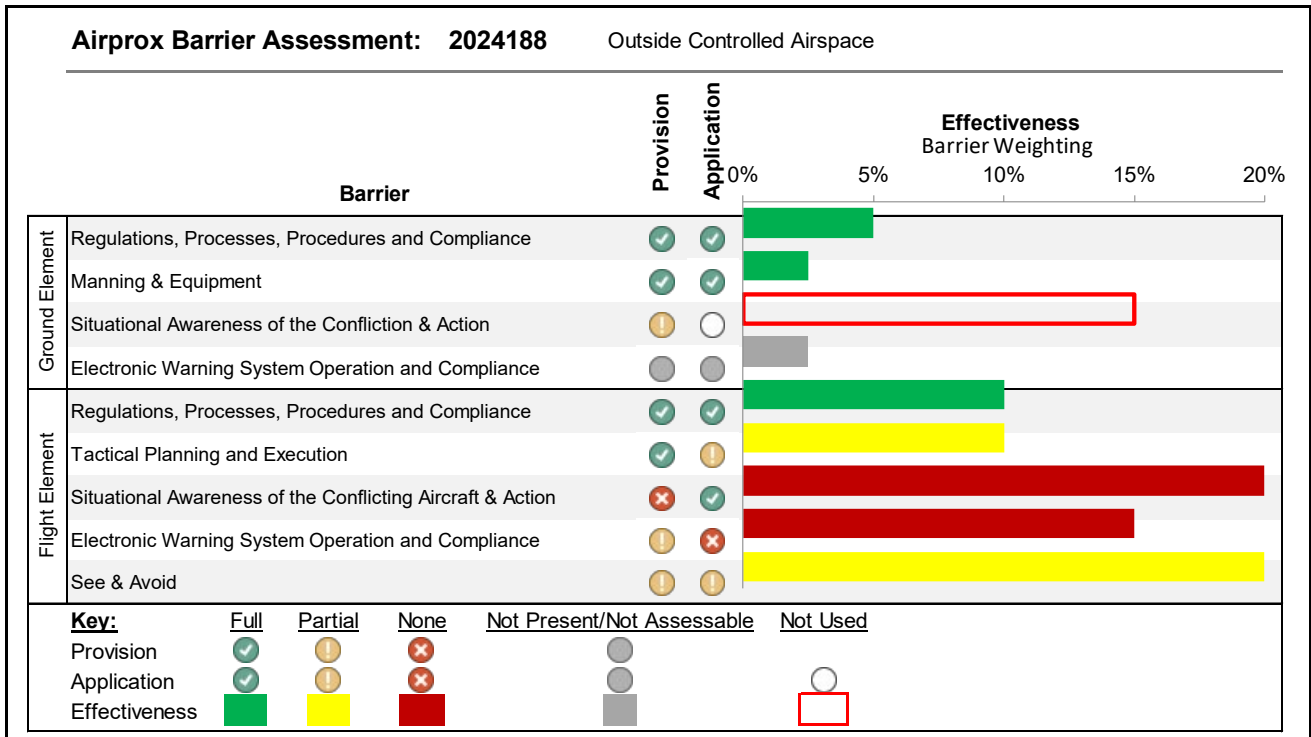
**Electronic Warning System Operation and Compliance** were assessed as **ineffective** because the G109's electronic conspicuity equipment had not alerted when it would have been expected to have done so.

**See and Avoid** were assessed as **partially effective** because the C172 pilot had not sighted the G109 and the G109 pilot only sighted the C172 at a late stage.
