**AIRPROX REPORT No 2024197**

Date: 29 Jul 2024 Time: 1354Z Position: 5204N 00152W Location: 2.5NM southeast of Evesham

**PART A: SUMMARY OF INFORMATION REPORTED TO UKAB**

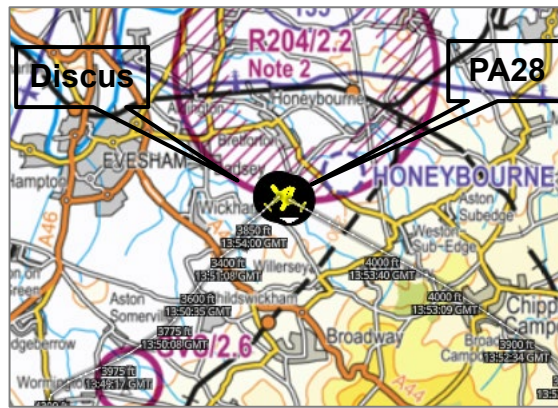
Figure 2: CPA1354:25 ~50ftV/<0.1NM H (images taken from the CAAs Airspace Analyser Tool)

The Discus did not show on radar. The pilot had carried and utilised an electronic conspicuity unit which allowed the sharing of a GPS-based track file, an image from which is shown at Figure 5. Both aircraft were tracked to and beyond CPA on an ADS-B display platform with images from that system shown at Figures 3 and 4. As the time interval between refresh is 10sec, the images capture CPA minus 5sec and CPA plus 5sec. Both aircraft showed on the CAA's Airspace Analyser Tool, with an image captured at CPA shown at Figure 2. The picture at page 1 was generated using a combination of radar and GPS-derived data.
