**AIRPROX REPORT No 2024231**

Date: 04 Sep 2024 Time: 1341Z Position: 5300N 00113W Location: 2.5NM NW Nottingham city

**PART A: SUMMARY OF INFORMATION REPORTED TO UKAB**

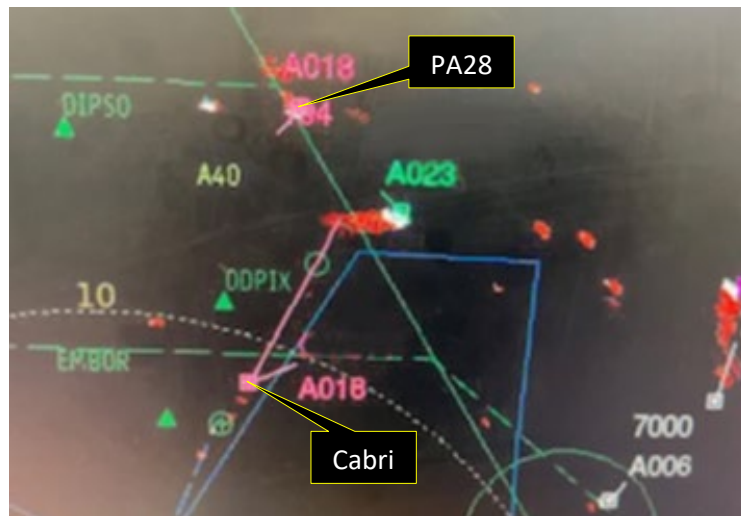
Figure 1 - 1339:30

- 1335:50 RAD: "[Cabri C/S] that's you leaving controlled airspace now, Basic Service". The pilot of the Cabri read back Basic Service. ([Cabri C/S] was indicating A012, [PA28 C/S] indicated A022)
- 1339:00 RAD conducted an overtake/descent manoeuvre with [two inbound aircraft].
- 1339:30 [Cabri C/S] indicated A018, [PA28 C/S] indicated A018. They were on conflicting tracks towards Hucknall (Figure 1).

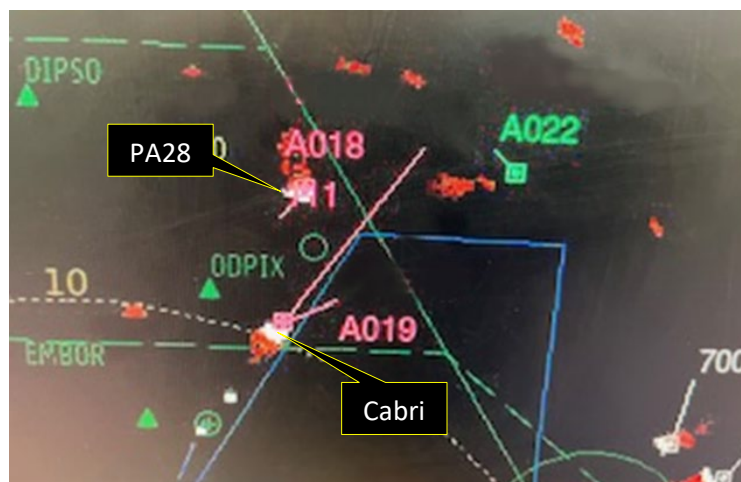
Figure 2 – 1340:35

- 1340:35 [Cabri C/S] indicated A019, [PA28 C/S] indicated A018 (Figure 2).

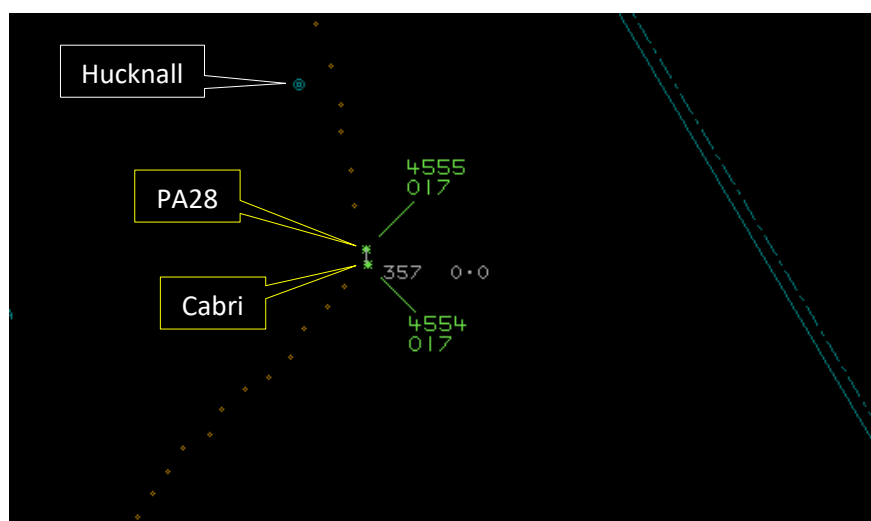
Figure 3 - CPA at 1341:22

An analysis of the NATS radar replay was undertaken and both aircraft could be positively identified from Mode S data (Figure 3). Both aircraft were depicted as flying at Flight Levels. A suitable correction was made to determine their altitudes. The diagram was constructed and the separation at CPA determined from the radar data.

The Cabri and PA28 pilots shared an equal responsibility for collision avoidance and not to operate in such proximity to other aircraft as to create a collision hazard.<sup>2</sup> If the incident geometry is considered as converging then the PA28 pilot was required to give way to the Cabri.<sup>3</sup>

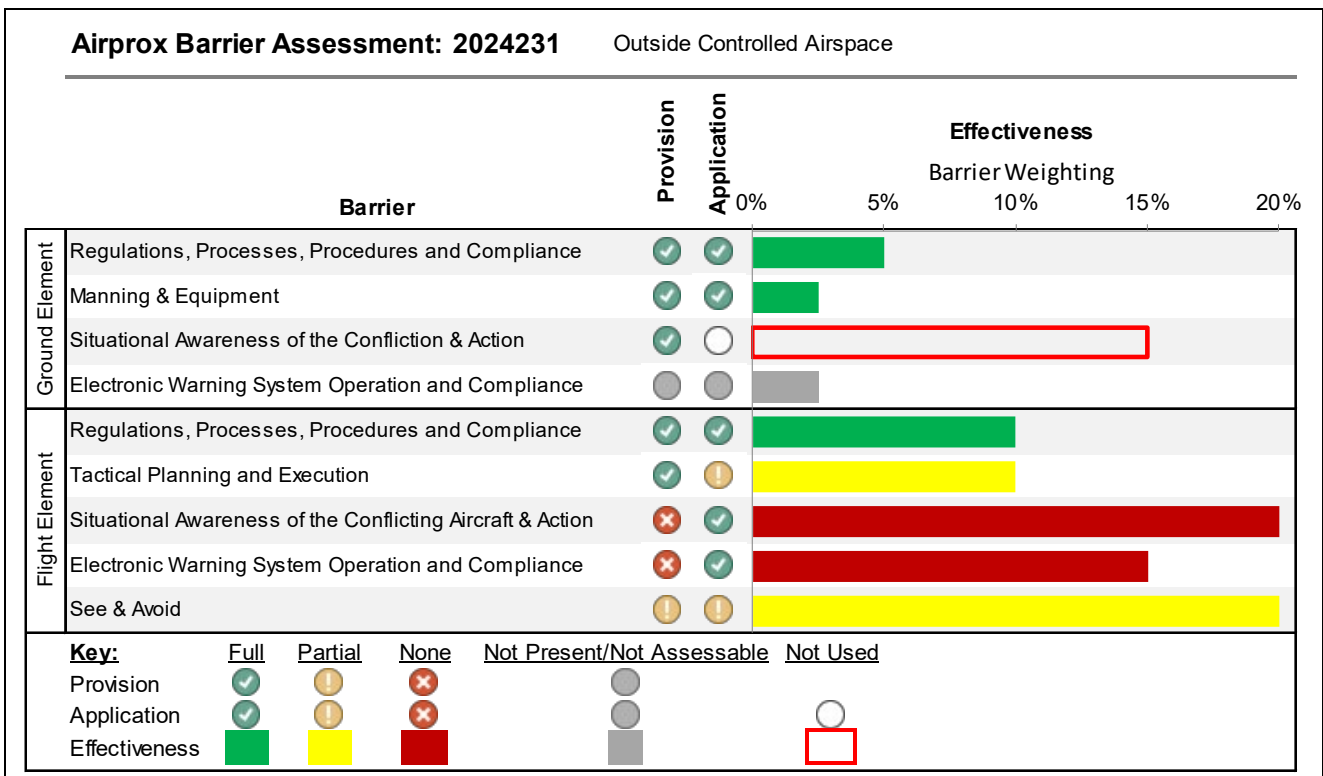
**Electronic Warning System Operation and Compliance** were assessed as **ineffective** because the EC equipment fitted to the PA28 would not have been expected to have detected the presence of the Cabri.

**See and Avoid** were assessed as **partially effective** because both pilots had visually acquired the other aircraft late.
