AIRPROX REPORT No 2024095

Date: 08 May 2024 Time: 1445Z Position: 5139N 00015W Location: 3NM E Elstree

PART A: SUMMARY OF INFORMATION REPORTED TO UKAB

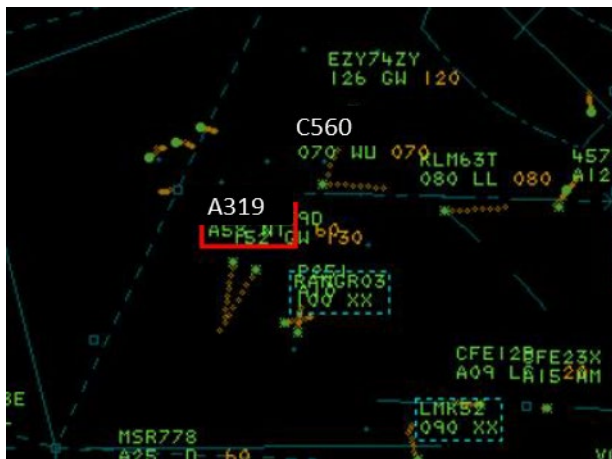
Figure 1 Direct excerpt from TC NW position radar replay (Note: Track Data Block highlighted in red by Investigations)

At 1444:33, the TC NW controller instructed the pilot of [A319 C/S] to climb to FL110 (Figure 1).

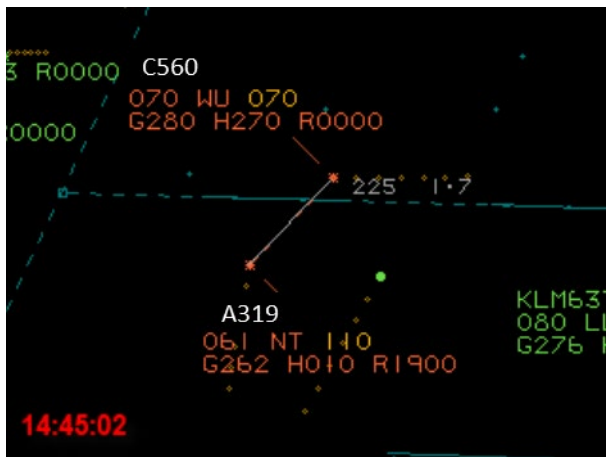
Figure 2.

High-level Short Term Conflict Alert (STCA) activated between [A319 C/S] and [C560 C/S] at 1445:00. Separation minima between [C560 C/S] and [A319 C/S] were eroded at 1445:02. (Figure 2)

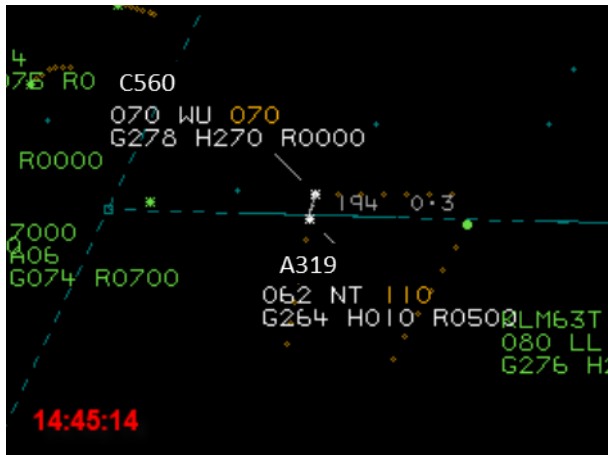
Figure 3

Minimum separation between [C560 C/S] and [A319 C/S] occurred at 1445:14, measured on the Multi-Track radar as 0.3NM and 800ft, where 3NM or 1000ft were required. (Figure 3)
