## AIRPROX REPORT No 2021080

Date: 11 Jun 2021 Time: 1329Z Position: 5121N 00032W Location: Fair Oaks

### PART A: SUMMARY OF INFORMATION REPORTED TO UKAB

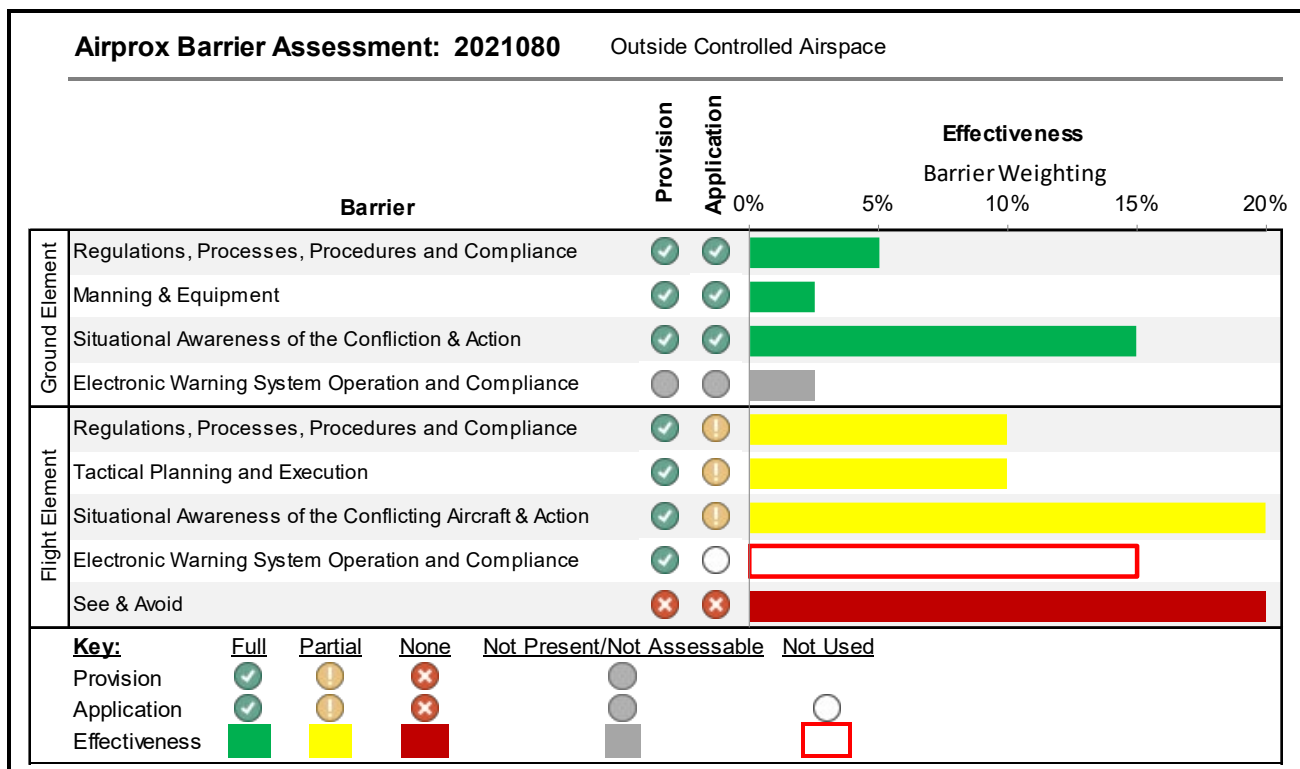
**Situational Awareness of the Conflicting Aircraft and Action** were assessed as **partially effective** because although the R100 pilot knew the PA28(1) was ahead, they did not check its positioning prior to turning onto base.

**See and Avoid** were assessed as **ineffective** because the R100 was distracted by the PA28(2) and did not see the PA28(1) and it was an effective non-sighting by the PA28(1) pilot who did not see the R100 until very late in the encounter.
