AIRPROX REPORT No 2021092

Date: 23 Jun 2021 Time: 0914Z Position: 5305N 00239W Location: 16NM SE Liverpool

PART A: SUMMARY OF INFORMATION REPORTED TO UKAB

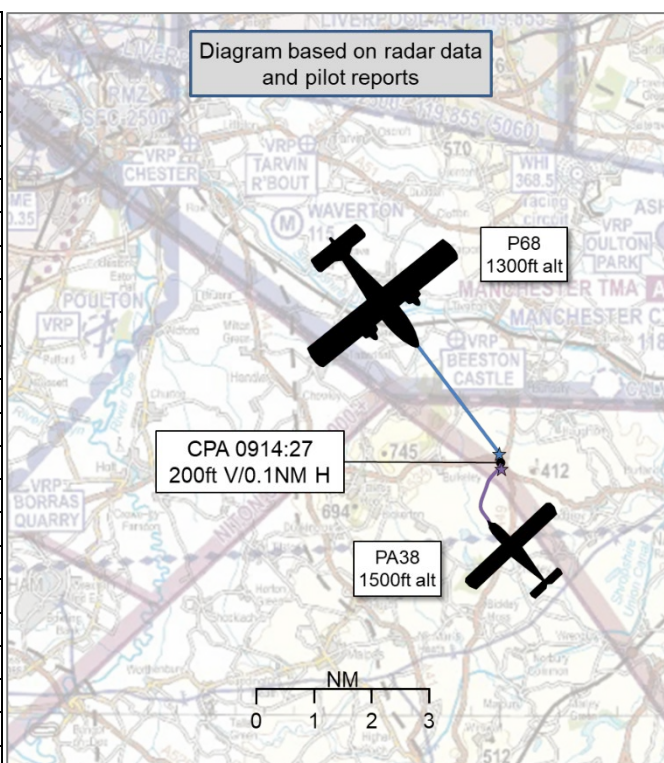
Recorded	Aircraft 1	Aircraft 2
Aircraft	P68	PA38
Operator	Civ Comm	Civ FW
Airspace	London FIR	London FIR
Class	G	G
Rules	VFR	VFR
Service	Basic	Basic
Provider	Liverpool	Liverpool
Altitude/FL	1300ft	1500ft
Transponder	A, C	A, C
Reported		
Colours	White, Blue	Red
Lighting	Nav, Beacon, strobe	Anti-Col
Conditions	VMC	VMC
Visibility	>10km	>10km
Altitude/FL	1300ft	↓2000ft-1500ft
Altimeter	QNH (1024hPa)	QNH (1024hPa)
Heading	175°	010°
Speed	130kt	90kt
ACAS/TAS	Not fitted	Not fitted
Separation		
Reported	100-200ft V/<1NM H	0ft V/0.5-1km H
Recorded	200ft V/0.1NM H
