**AIRPROX REPORT No 2021123**

Date: 20 Jul 2021 Time: 1335Z Position: 5155N 00209W Location: Gloucestershire ATZ

**PART A: SUMMARY OF INFORMATION REPORTED TO UKAB**

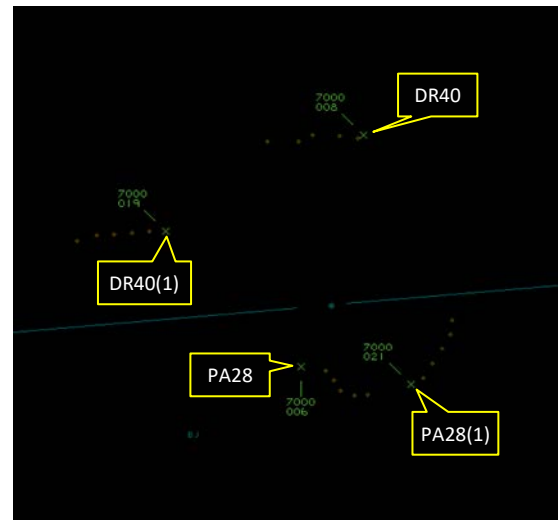
Figure 6 – 1333:05

At **1332:08** the Tower controller asked the PA28(1) [pilot] if they were "*in the overhead, or just about 1 mile to the east of the field?*" The pilot reported "*just about to become overhead*". Then, at **1332:24**, the PA28(1) [pilot] reported in the overhead and was instructed to report descending on the deadside (Figure 5). At **1332:40** the Tower controller again asked the PA28(1) [pilot] to confirm their position as now being on the deadside, which was confirmed by the pilot. Five seconds later, on the Approach frequency, the PA28 [pilot] reported in the crosswind position. Having missed the callsign of the PA28, the Approach controller asked the aircraft calling to repeat their call, but there was no response. At **1333:05** the Approach controller asked the PA28 [pilot] to report their range (Figure 6).

The PA28 pilot reported “*in your overhead and turning into the downwind for 27*”. The Approach controller replied “*you were asked to report at 5 miles, I need to transfer to Tower, they’ve got other traffic. Keep a good lookout, there’s traffic in the circuit – contact Tower (freq)*”. The pilot replied “*er keep a good look-out. We were already in the circuit.*”

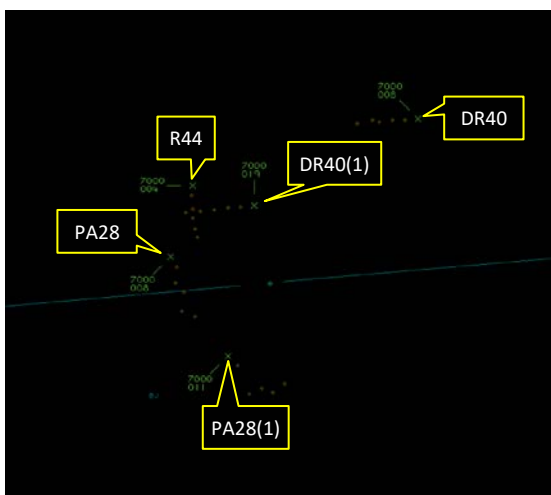
Figure 7 – 1333:40

The Tower controller advised the DR40(1) pilot that there was a PA28 descending on the deadside and instructed them to also report descending on the deadside. The pilot of the DR40(1) reported being visual with that traffic. At **1333:40** the pilot of the PA28 made their first call on the Tower frequency with their abbreviated callsign only; “*downwind now for 27*” (Figure 7). The Tower controller advised them that they were Number 2 and to follow the DR40 turning base. The PA28 pilot reported having that traffic in sight. At **1334:15** DR40(1) [pilot] reported descending deadside, adding that there was glider activity in the overhead at 3000ft (Figure 8).
