## AIRPROX REPORT No 2021143

Date: 03 Aug 2021 Time: 1532Z Position: 5159N 00131W Location: IVO Oxford

### PART A: SUMMARY OF INFORMATION REPORTED TO UKAB

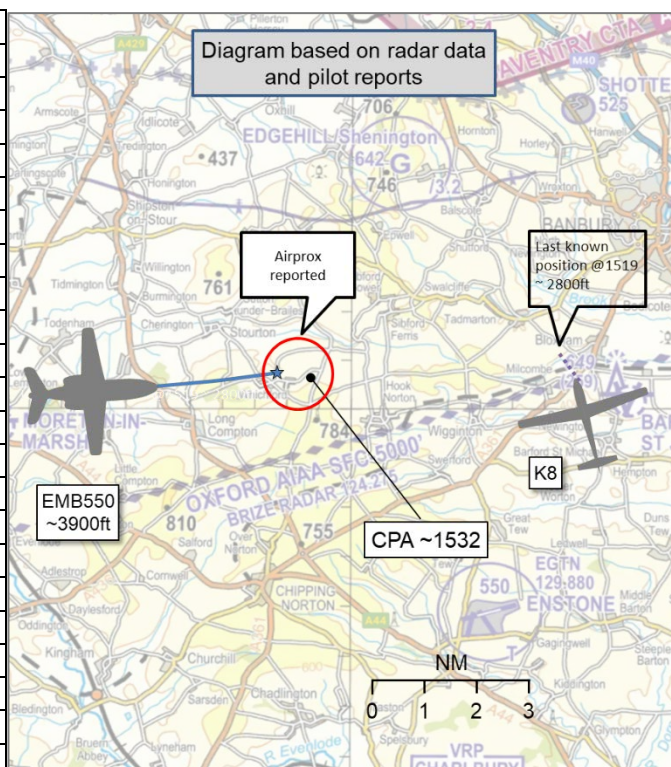
Recorded	Aircraft 1	Aircraft 2
Aircraft	EMB550	K8
Operator	CAT	Civ Gld
Airspace	London FIR	London FIR
Class	G	G
Rules	IFR	VFR
Service	Traffic	None
Provider	Oxford	
Altitude/FL	~3900ft	NK
Transponder	A, C, S	Not fitted
<b>Reported</b>		
Colours	NR	White, Blue
Lighting	NR	None
Conditions	IMC	VMC
Visibility	NR	>10km
Altitude/FL	2300ft	2500-3500ft
Altimeter	QNH (1012hPa)	QFE
Heading	East	Northerly
Speed	190kt	45-55kt
ACAS/TAS	TCAS II	Not fitted
Alert	TA	N/A
<b>Separation at CPA</b>		
Reported	200ft V	300ft V/150m H
Recorded	NK
