**AIRPROX REPORT No 2021122**

Date: 18 Jul 2021 Time: 0934Z Position: 5203N 00100W Location: Silverstone

**PART A: SUMMARY OF INFORMATION REPORTED TO UKAB**

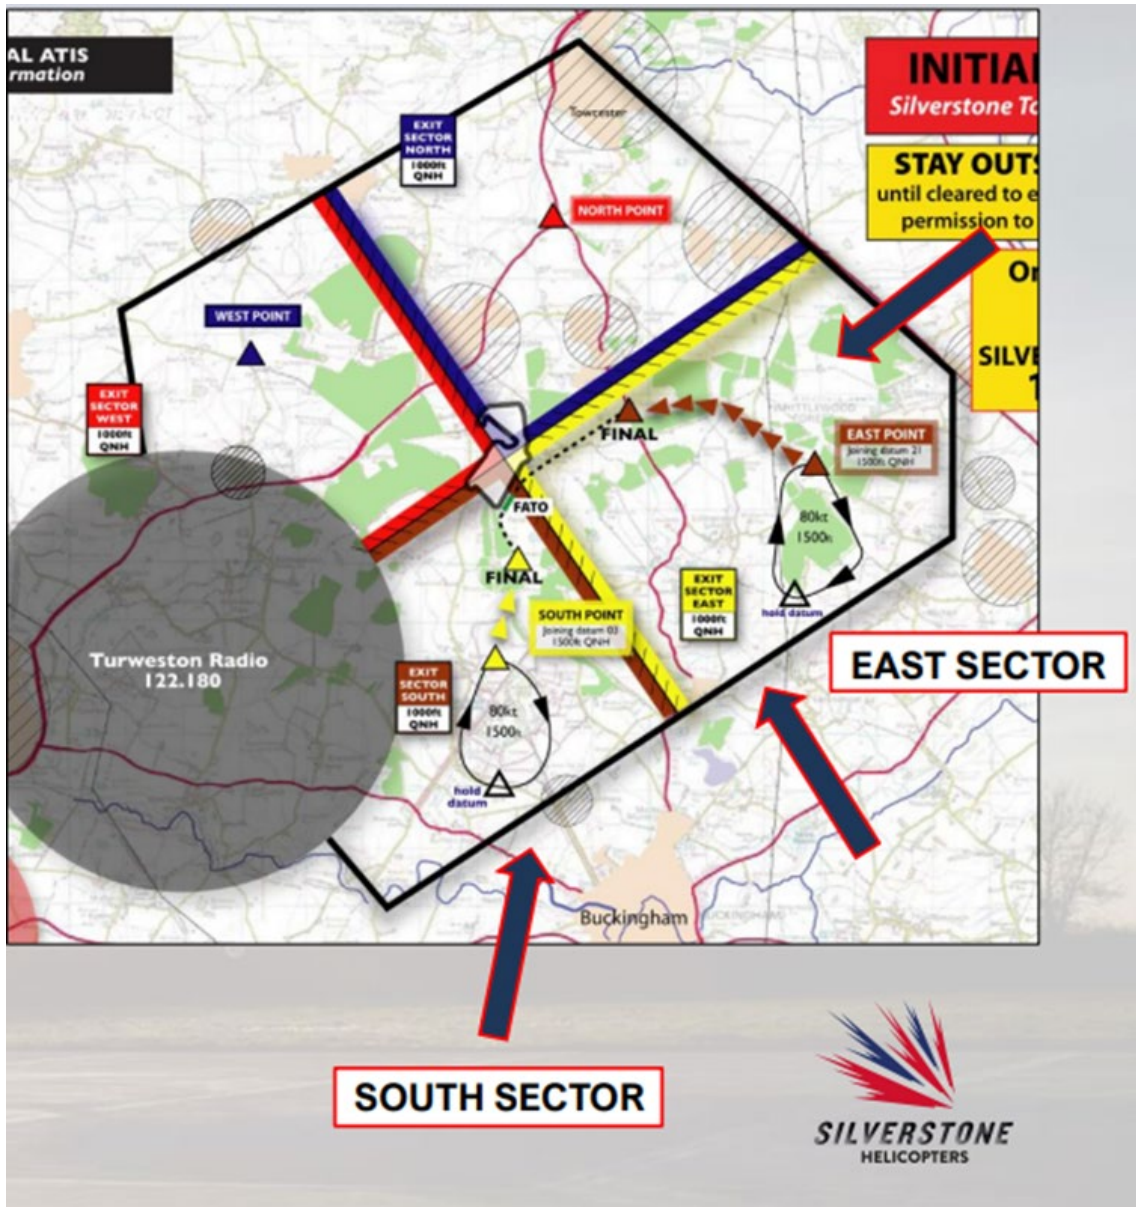
Figure 11 – Airspace (taken from the pilot briefing pack)

The requirement for pilots to report their position, level, and track on initial RTF contact with the Tower controller was not included within the pilot brief for the event. The Tower controller had no way of knowing whether the A109 and EC55 pilots had joined via South Point or via the Hold datum, or whether the 80kt speed limit was being exceeded. To enable the controllers to establish the order of approach for the helicopters, they would have been wholly reliant upon the timings of the pilot reports at South Point.

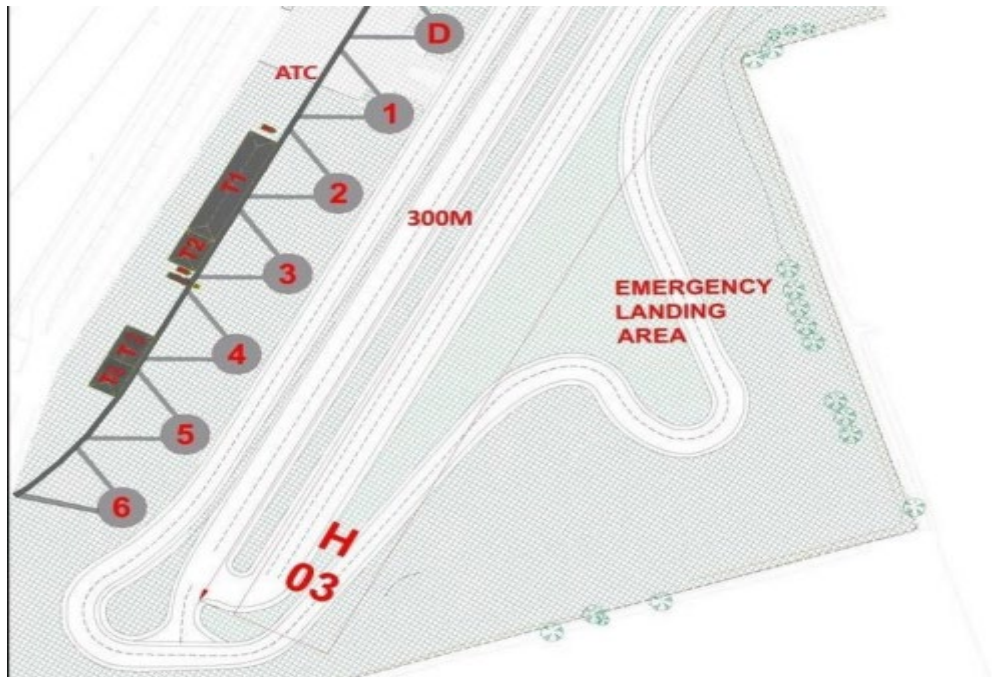
Figure 12 – Pad Layout

When looking at the role of the controller, members noted that they had reported not being able to see any perspective when looking at the helicopters on the approach. Without any radar, this meant that the controllers were unable to visually determine the order of the helicopters and were reliant upon the pilots following the procedures correctly and reporting accurately. The busy nature of the event with its almost continuous RT and constant procession of helicopters inbound meant that the controller had no way of knowing whether or not the pilots had adhered to the procedures. The controller had no situational awareness that the A109 and EC155 were likely to come into conflict and did not detect the conflict when it happened (**CF2, CF3**).
