AIRPROX REPORT No 2021185

Date: 16 Sep 2021 Time: 1045Z Position: 5140N 00016W Location: Borehamwood

PART A: SUMMARY OF INFORMATION REPORTED TO UKAB

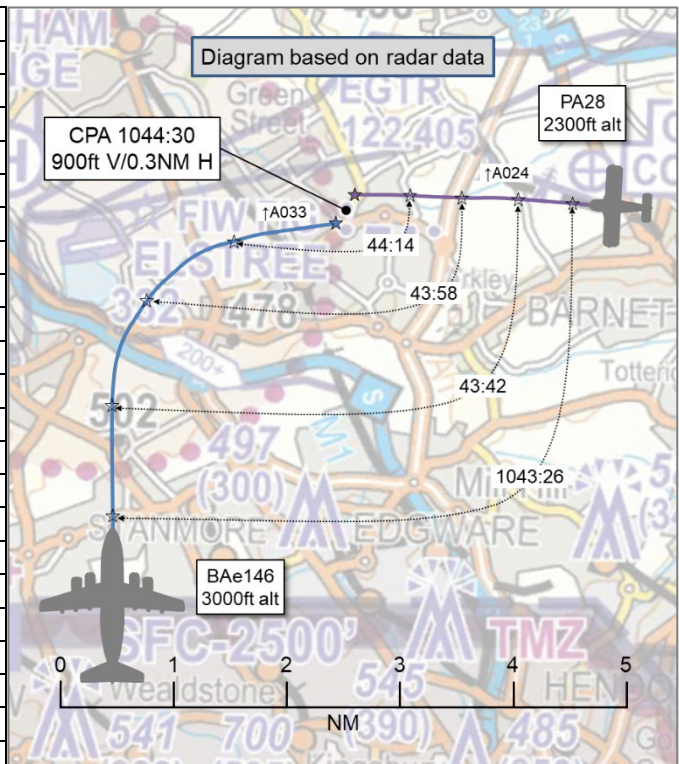
THE BAE146 PILOT reports that, whilst being vectored for the ILS to RW25 at RAF Northolt, the TCAS warned of "Traffic" and soon after issued the command to "Climb, Climb". Immediate actions in accordance with the checklist were carried out during which a small GA single-engine aircraft was seen passing down the left-hand side of the aircraft on a near reciprocal heading, not far below their altitude. Once clear of the conflict the BAe146 was descended back down to 3000ft and the approach was continued with no further anomalies.

The Northolt Radar controller was positioning the BAe146 following a handover from Heathrow Approach. The BAe146 was descended to 3000ft Northolt QNH and the pilot was passed Traffic Information on the PA28 which was transiting at 2300ft, outside controlled airspace. The BAe146 pilot was advised that they would be separated by classification of airspace. Traffic Information was updated which was followed by the BAe146 pilot responding to a TCAS RA. Separation was noted by the controller as 600ft.
