**AIRPROX REPORT No 2021234**

Date: 13 Nov 2021 Time: 1223Z Position: 5139N 00012E Location: Stapleford visual circuit

**PART A: SUMMARY OF INFORMATION REPORTED TO UKAB**

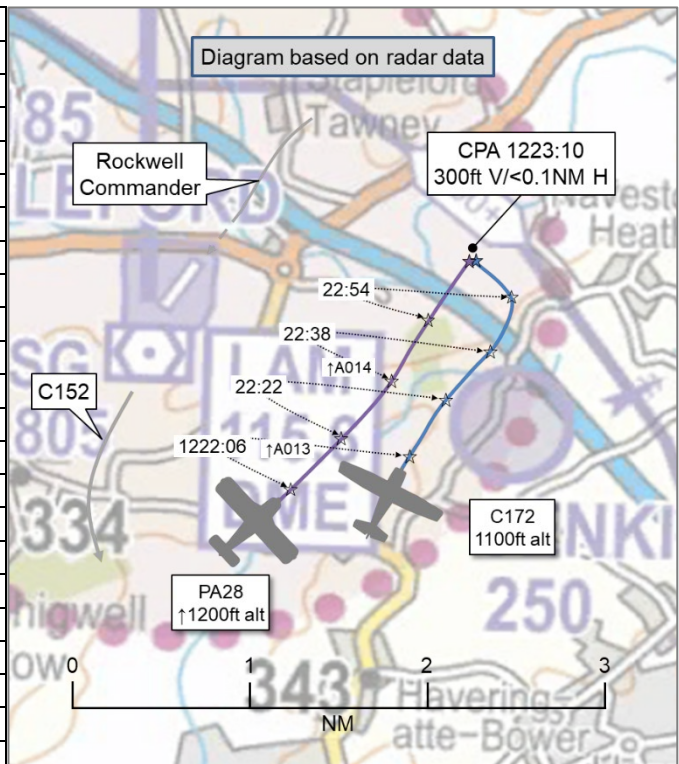
| Recorded | Aircraft 1 | Aircraft 2 |
|---|---|---|
| Reported | 50ft V/0m H | 150ft V/0m H |
| Recorded | 300ft V/<0.1NM H | |
