## AIRPROX REPORT No 2020047

Date: 27 May 2020 Time: 1424Z Position: 5046N 00412W Location: Halwill, Devon

### PART A: SUMMARY OF INFORMATION REPORTED TO UKAB

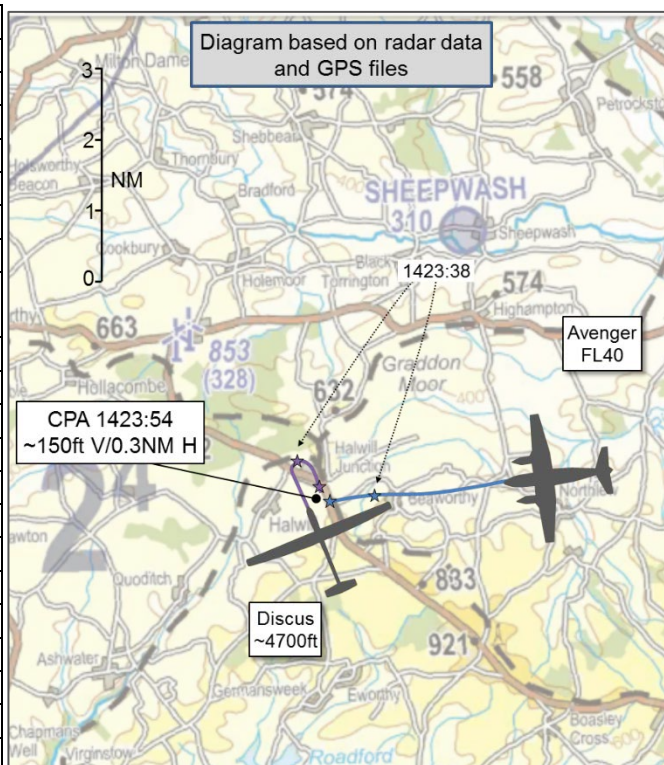
**THE AVENGER PILOT** reports that a glider was observed to pass at the same level and approximately 200m to the right and behind the Avenger. The glider was first sighted in the 3 o'clock position as it was passing astern; it was too late to take any avoiding action. There was nothing observed on the TCAS and no warning from ATC.

**THE DISCUS PILOT** reports that they had been flying for a few hours heading north at approximately 4500ft and decided to return to Brent Tor. After looking right, a turn of 30° of bank was commenced. On rolling out on a heading of 180° they saw the other aircraft passing in front of the glider, from east to west, at approximately 150kts. It was at a similar level and approximately 400m ahead. The glider pilot slowed down by conducting a small climb of about 100ft, by which time the other aircraft was already well out to the west, so they increased speed on the same heading. Although the relative speed difference was a concern, the separation was not an issue from a gliding perspective.

<sup>1</sup> Separation estimated by comparing glider GPS data with radar trace.
