**AIRPROX REPORT No 2020084**

Date: 31 Jul 2020 Time: 1124Z Position: 5136N 00022W Location: 3NM N Northolt

**PART A: SUMMARY OF INFORMATION REPORTED TO UKAB**

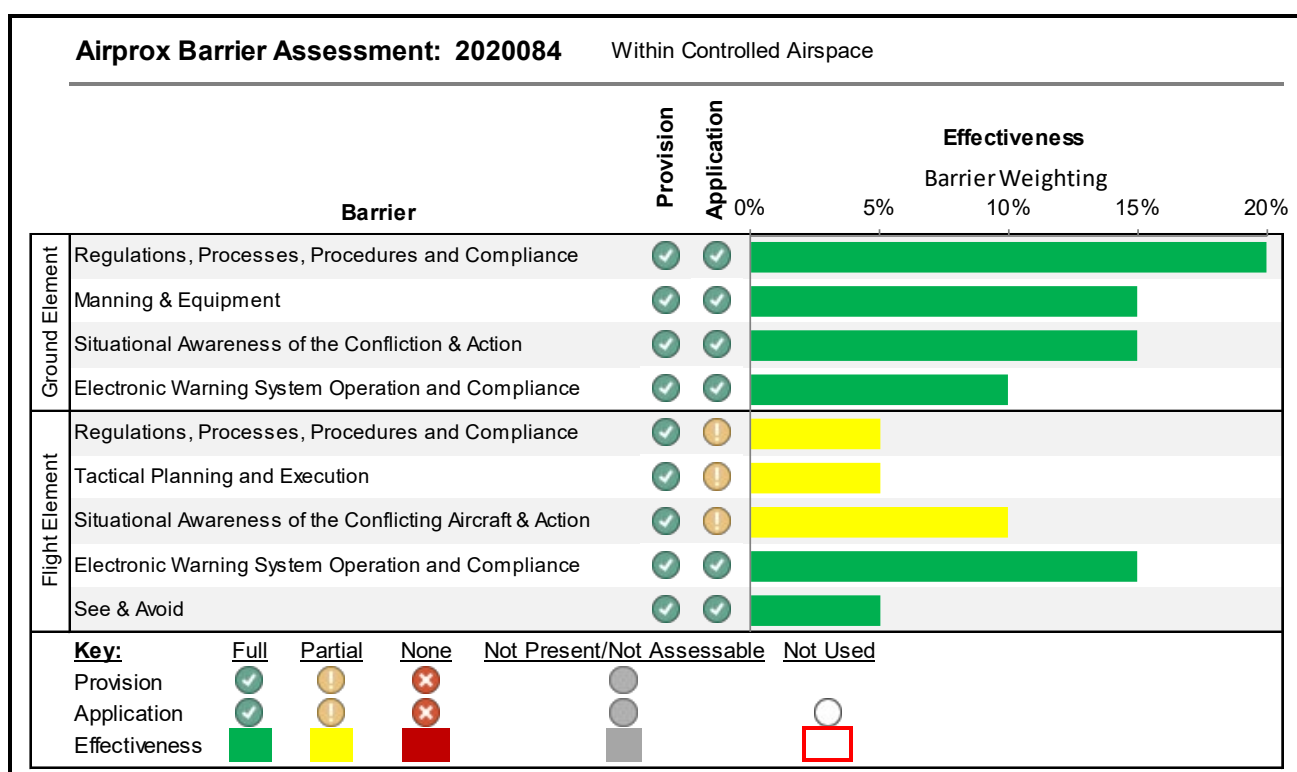
**Tactical Planning and Execution** was assessed as **partially effective** because the C680 was not at 3000ft by the CTR boundary.

**Situational Awareness of the Conflicting Aircraft and Action** were assessed as **partially effective** because the C680 pilot did not assimilate that the PA46 would be detected by the TCAS and cause an RA.
