## AIRPROX REPORT No 2020085

Date: 02 Aug 2020 Time: 1315Z Position: 5153N 00210W Location: Gloucestershire ATZ

### PART A: SUMMARY OF INFORMATION REPORTED TO UKAB

An Airprox was reported when two C42s flew into proximity at Gloucestershire Airport at 1315Z on Sunday 2<sup>nd</sup> August 2020. Both pilots were operating under VFR in VMC, both pilots in receipt of an Aerodrome Control Service from Gloster Tower.

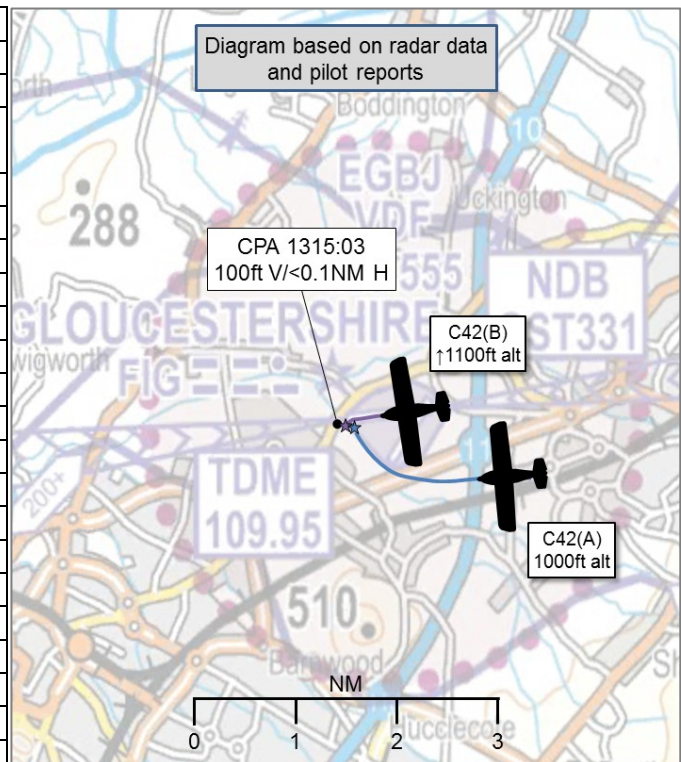
Recorded	Aircraft 1	Aircraft 2
Aircraft	C42(A)	C42(B)
Operator	Civ FW	Civ FW
Airspace	Gloucestershire ATZ	Gloucestershire ATZ
Class	G	G
Rules	VFR	VFR
Service	ACS	ACS
Provider	Gloster	Gloster
Altitude/FL	1000ft	1100ft
Transponder	A, C	A, C
<b>Reported</b>		
Colours	White, Blue	Not reported
Lighting	Not reported	Not reported
Conditions	VMC	VMC
Visibility	>10km	NK
Altitude/FL	1000ft	1000ft
Altimeter	QFE (1016hPa)	QFE (1016hPa)
Heading	300°	270°
Speed	70kt	70kt
ACAS/TAS	Not fitted	Not fitted
<b>Separation</b>		
Reported	0ft V/50ft H	Not seen
Recorded	100ft V/<0.1NM H

**THE C42(A) PILOT** reports that they were cleared to descend deadside in the overhead. At the end of RW27 they turned right onto crosswind and were informed by ATC that an aircraft would climb out behind them. The aircraft climbed out in front of them which caused them to take avoiding action to the right. The C42 [C/S provided] was right in front of them by about 50ft in the climb.
