AIRPROX REPORT No 2020086

Date: 18 Jul 2020 Time: 1349Z Position: 5137N 00026E Location: Billericay

PART A: SUMMARY OF INFORMATION REPORTED TO UKAB

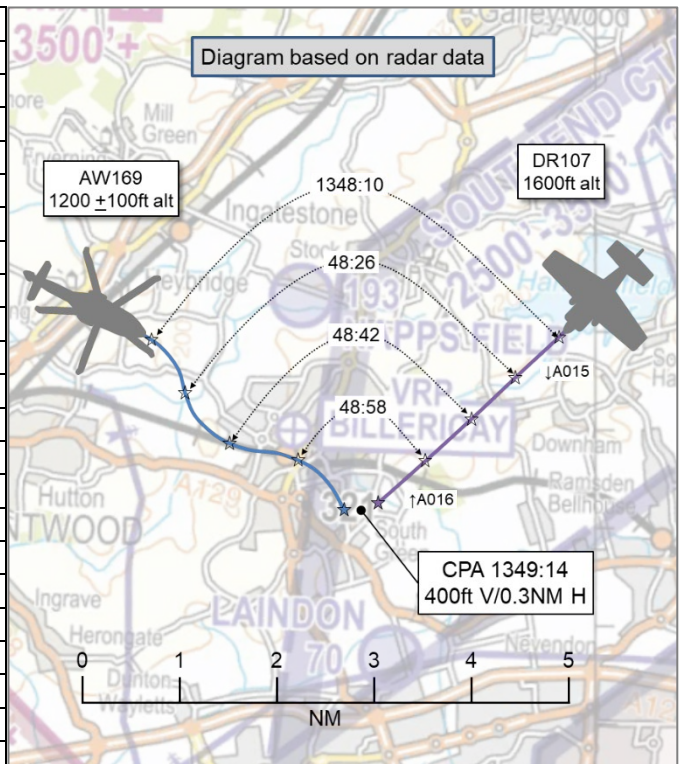
Recorded	Aircraft 1	Aircraft 2
Aircraft	AW169	DR107
Operator	HEMS	Civ FW
Airspace	London FIR	London FIR
Class	G	G
Rules	VFR	VFR
Service	Basic	Listening Out
Provider	Southend Radar	Southend Radar
Altitude/FL	1200ft	1600ft
Transponder	A, C, S	A, C, S
Reported		
Colours	Red/yellow	Red/white
Lighting	Strobes, nav lights	NR
Conditions	VMC	VMC
Visibility	>10Km	10Km
Altitude/FL	1200ft	1700ft
Altimeter	QNH	QNH
Heading	100°	230°
Speed	140kt	140kt
ACAS/TAS	TCAS II	Not fitted
Alert	RA	N/A
Separation		
Reported	100ft V/500m H	200ft V/300m H
Recorded	400ft V/0.3NM H
