**AIRPROX REPORT No 2020094**

Date: 08 Aug 2020 Time: 1012Z Position: 5222N 00128W Location: Coventry

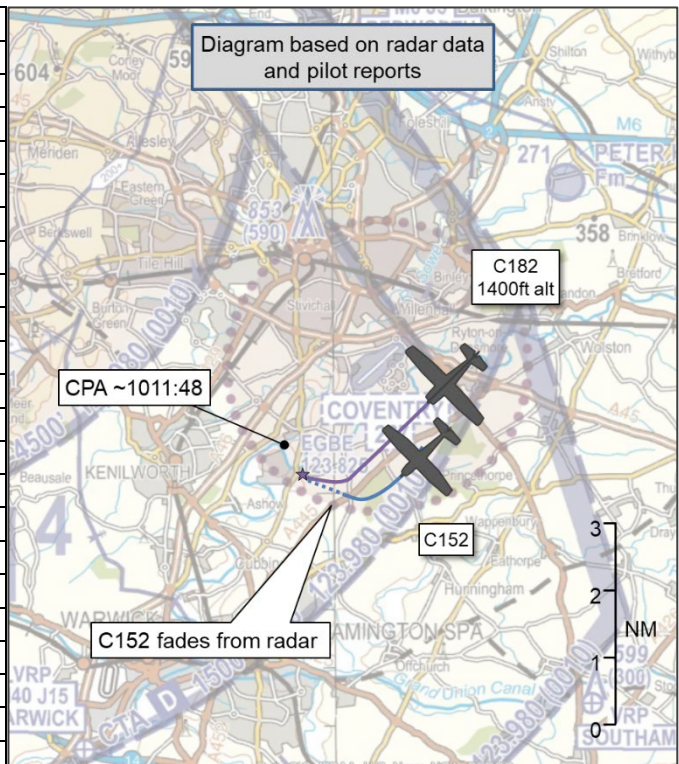
**THE C152 PILOT** reports that on an instructional sortie in the visual circuit, a C182 was also in the visual circuit behind the C152, but gradually catching up on every circuit. The AFISO kept advising the other pilot about traffic ahead and the pilot acknowledged each time. The C152 instructor was demonstrating an approach to the student, setting up for the approach on base leg with one aircraft ahead on final. As requested by the AFISO, because of the one ahead, they reported turning base, a few seconds later the C182 pilot also reported turning onto base and was asked by the AFISO whether they had the C152 in sight, to which they replied “negative”. On hearing the exchange, the Instructor looked back and spotted the C182 in their 4 o’clock position, initiating the approach set-up and catching up rapidly as they also set up their approach and slowed down. They were unable to communicate so the instructor rapidly increased their descent and power, keeping an eye on the C182 all the time. It then crossed from their 4 o’clock to the 11 o’clock approximately 200ft above. They were now able to communicate that they had the C182 in sight and were making a rapid descent. The C182 pilot reported going around and the C152 pilot was able to recover the approach.

**THE C182 PILOT** reports joining the Coventry circuit on right-base for RW05, from the Southam VRP. A number of circuits were flown at 1300ft QNH, (1000ft above aerodrome level) conducting multiple touch-and-go and go-around approach on RW05. Each time they reported downwind and, at the appropriate time, turned onto right-base to initiate the approach, starting the descent after establishing on base. When on the 3rd or 4th circuit, they heard another pilot calling downwind ahead of them. Although they tried to see the aircraft and establish its exact position in relation to their position, they were unable to make visual contact and believed that it was well ahead. Once established on right-base they heard the other pilot reporting that they had an aircraft flying above them. As the C182 pilot was unable to make visual contact with the other aircraft, they immediately initiated a go-around and turned right on runway heading. They then looked behind and for the first time sighted the other aircraft on right-base behind and below them.
