## **AIRPROX REPORT No 2020106**

Date: 26 Aug 2020 Time: 1127Z Position: 5156N 00125W Location: Enstone

### **PART A: SUMMARY OF INFORMATION REPORTED TO UKAB**

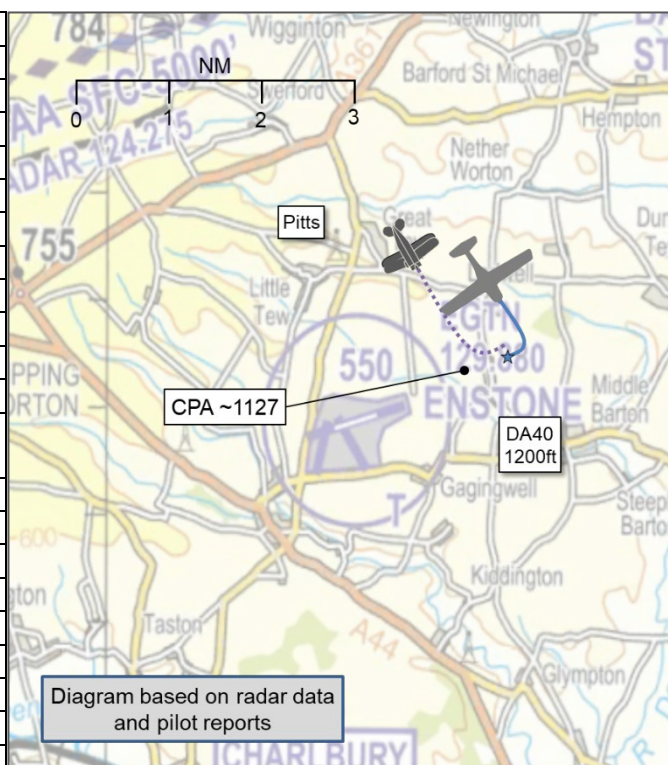
**THE PITTS PILOT** reports that there are three parallel runways at Enstone. They were flying in a Pitts S-2B and approaching the (RH) circuit from the west, with the intention of landing on the most northerly (grass) airstrip, RW26. The radio traffic was heavy, and they understood there were also aircraft in the circuit intending to land on the centre bitumen runway. The Pitts S-2B has no flaps, so the approach speed is relatively fast - approx 85-90 knots - compared to many other light aircraft. The pilot sits behind
