AIRPROX REPORT No 2020141

Date: 13 Sep 2020 Time: 1044Z Position: 5328N 00226W Location: Manchester/Barton circuit

PART A: SUMMARY OF INFORMATION REPORTED TO UKAB

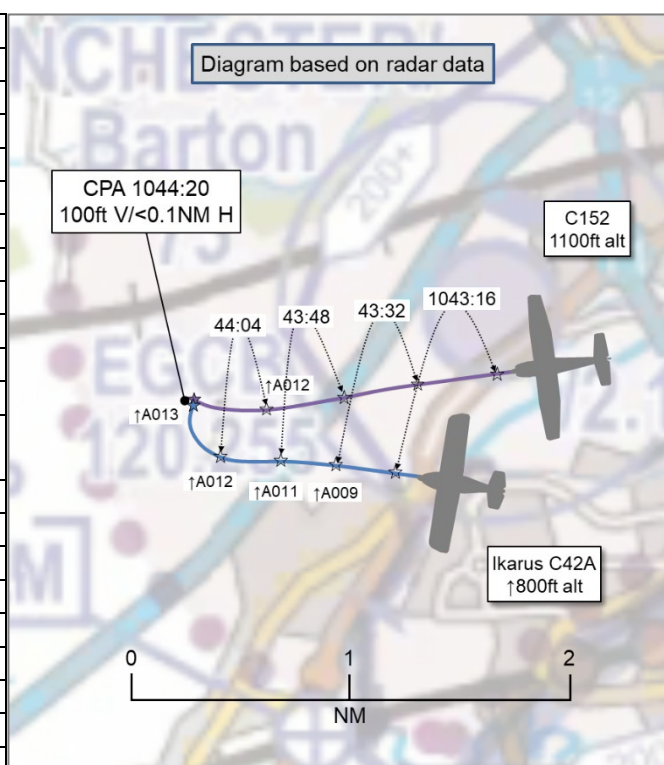
| Recorded | Aircraft 1 | Aircraft 2 |
|---|---|---|
| Reported | 30ft V/10m H | 30ft V/10m H |
| Recorded | 100ft V/<0.1NM H | |

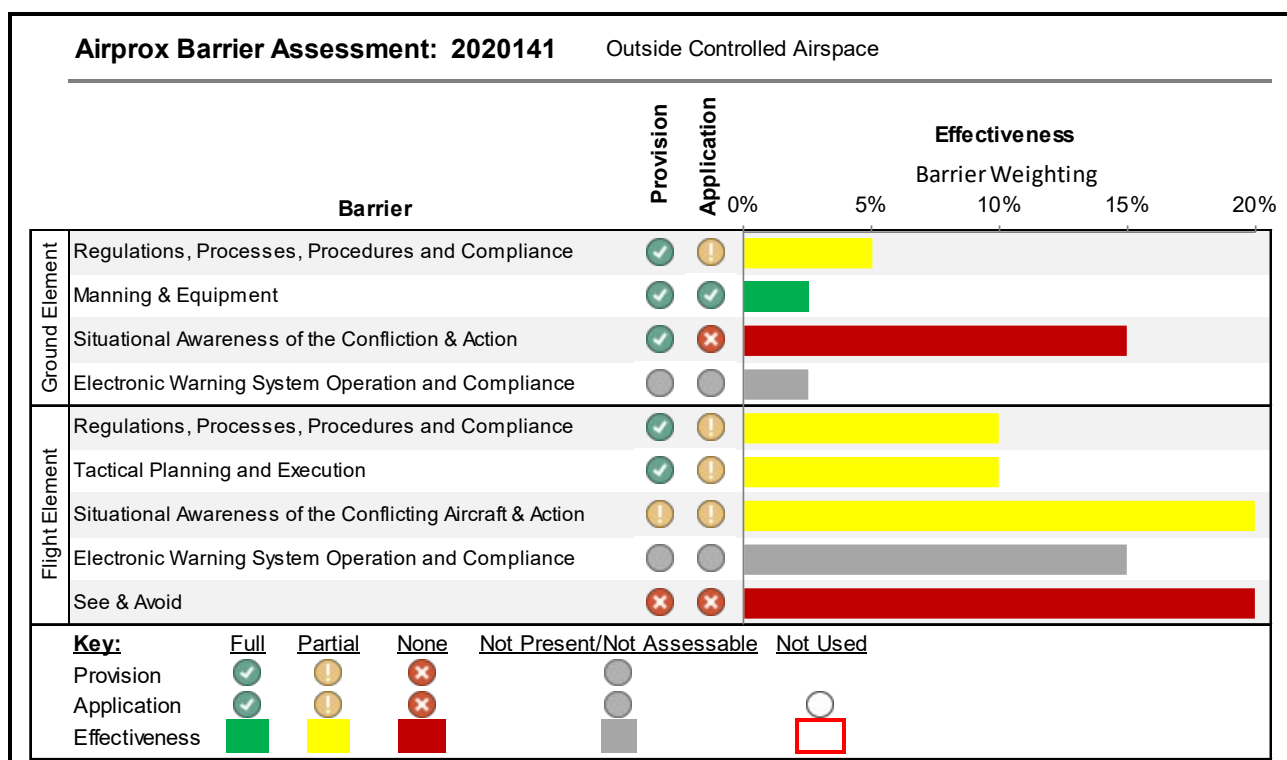
Situational Awareness of the Conflicting Aircraft and Action were assessed as **partially effective** because neither pilot had situational awareness of the relative position of the other aircraft.

See and Avoid were assessed as **ineffective** because neither pilot saw the other aircraft in time to materially affect the separation between the 2 aircraft.
