AIRPROX REPORT No 2020160

Date: 04 Nov 2020 Time: 1232Z Position: 5119N 00102W Location: 6NM W Odiham

PART A: SUMMARY OF INFORMATION REPORTED TO UKAB

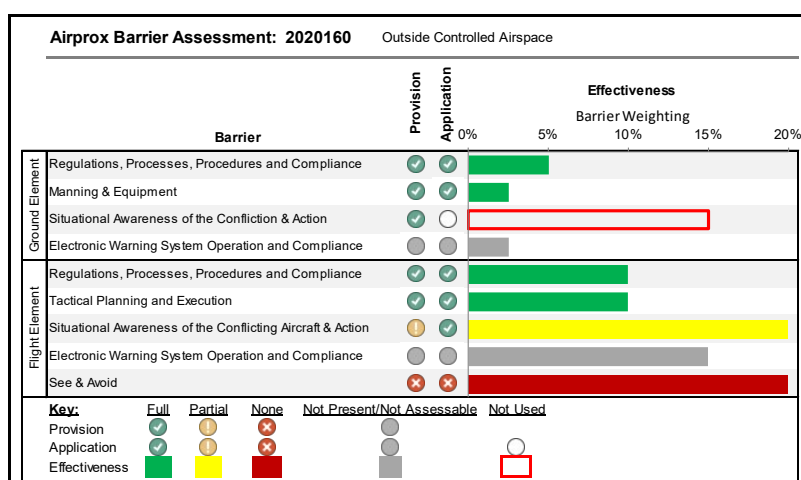
Situational Awareness of the Conflicting Aircraft and Action were assessed as **partially effective** because neither pilot had specific situational awareness about the other.

See and Avoid were assessed as **ineffective** because the PA28 pilot did not see the C42 and the C42 pilot didn't see the PA28 in time to materially affect the separation.
