AIRPROX REPORT No 2019051

Date: 03 Apr 2019 Time: 1744Z Position: 5428N 00545W Location: 15nm SE Belfast Aldergrove

PART A: SUMMARY OF INFORMATION REPORTED TO UKAB

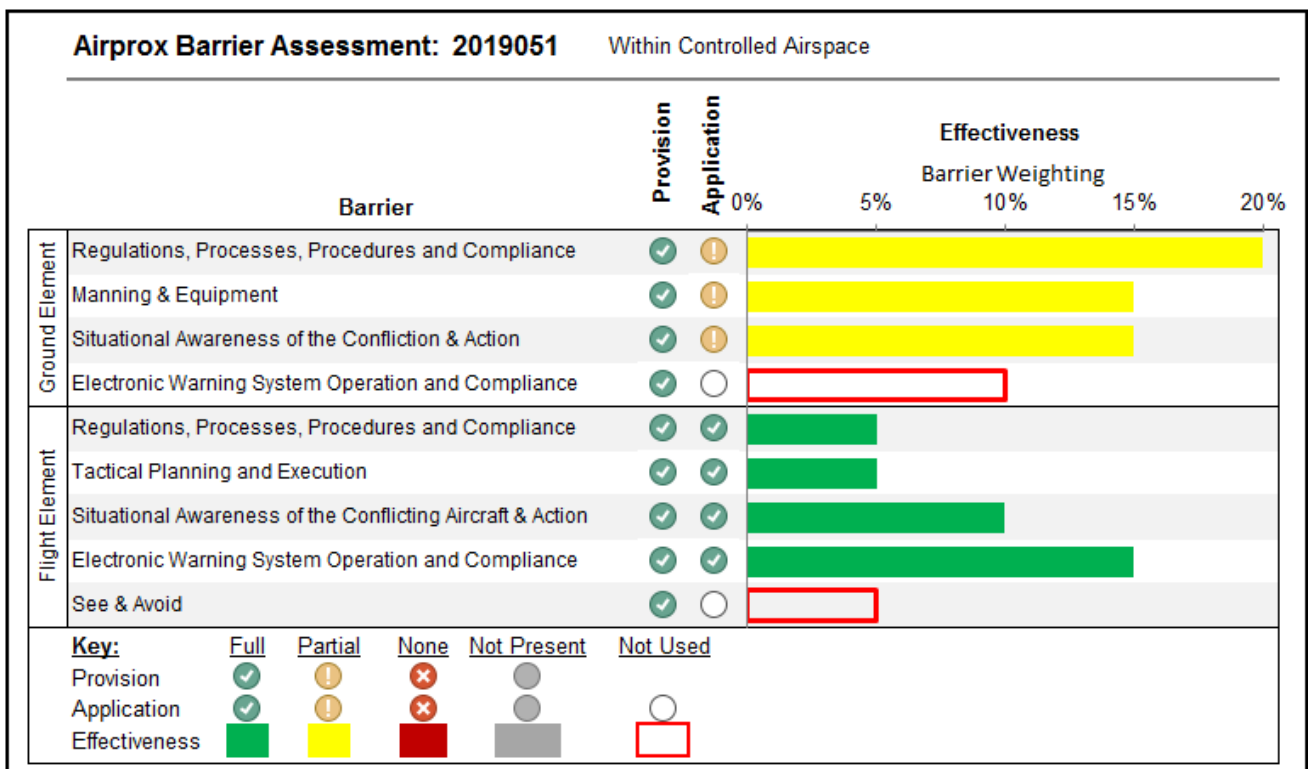
Manning and Equipment were assessed as **partially effective** because the OJTI did not monitor his trainee’s actions closely enough.

Situational Awareness and Action were assessed as **partially effective** because the Aerodrome controller warned the Approach Radar controller of the potential proximity of the two aircraft before the latter controller had taken any action. The subsequent headings issued by the controller only partially resolved the situation.
