AIRPROX REPORT No 2019096

Date: 12 May 2019 Time: 1211Z Position: 5156N 00126W

Location: Enstone Airfield

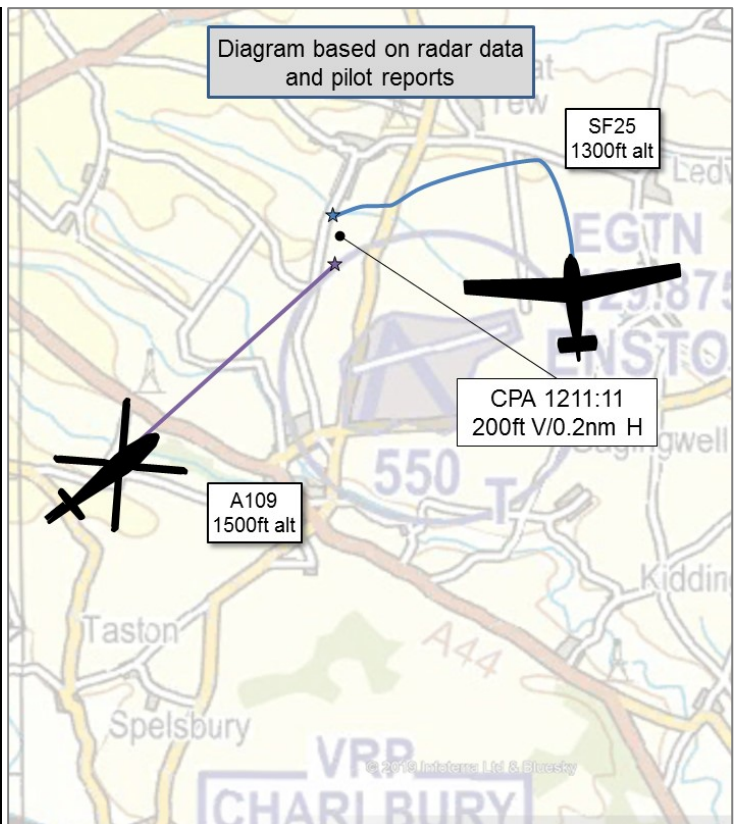
Recorded	Aircraft 1	Aircraft 2
Aircraft	SF25	A109
Operator	Civ Gld	Civ Helo
Airspace	Enstone	London FIR
Class	G	G
Rules	VFR	VFR
Service	AGCS	Basic
Provider	Enstone Radio	Brize Norton
Altitude/FL	1300ft	1500ft
Transponder	A, C	A, C, S
Reported		
Colours	Red, White	Cream, Blue
Lighting	Strobe, Wing	Nav, Anti-Col
Conditions	VMC	VMC
Visibility	10km	>10km
Altitude/FL	850ft	1500ft
Altimeter	NK (1017hPa)	QNH
Heading	260°	050°
Speed	80kt	150kt
ACAS/TAS	FLARM	Not reported
Alert	None	N/K
Separation		
Reported	50-100ft V/0.1nm H	Not seen
Recorded	200ft V/0.2nm H

THE SF25 MOTOR GLIDER PILOT reports that he was on a training sortie at Enstone using RW08LH, circuit height 800ft (600ft for microlights); they were on their third circuit for RW08, late downwind. The instructor spotted a helicopter in their 11 o'clock, about 50-100ft below at very close range. Not a great deal of avoiding action could be taken due to the closing speed; FlightRadar24 shows the helicopter at 150kts and the Motor-glider at 70kts. They climbed as soon as the helicopter was spotted. In his opinion the helicopter was inside the Enstone circuit, traveling in the opposite direct to circuit traffic, not talking to Enstone Radio and at a height that jeopardised the circuit traffic. He thought it would be beneficial if Enstone was marked as intense gliding/motor gliding [UKAB note: Enstone is in the UKAIP as a Training Aerodrome as below and is correspondingly marked on Aeronautical Charts with a 'T' and contact frequency].
