AIRPROX REPORT No 2019136

Date: 05 Jun 2019 Time: 1353Z Position: 5400N 00025W Location: Driffield

PART A: SUMMARY OF INFORMATION REPORTED TO UKAB

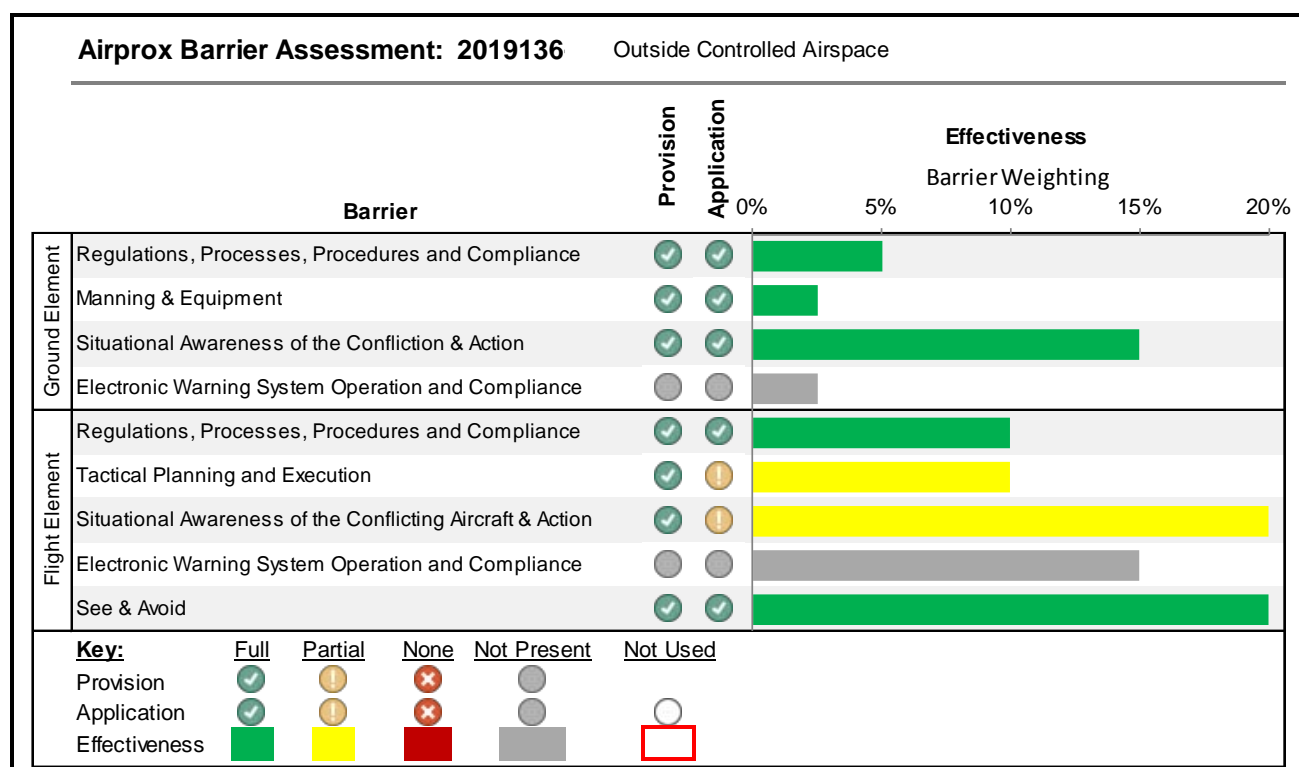
Tactical Planning and Execution were assessed as **partially effective** because the PA28 pilot did not appear to have heeded the NOTAM about the Typhoons operating in the vicinity.

Situational Awareness of the Conflicting Aircraft and Action were assessed as **partially effective** because the Typhoon pilot could have moved to an area well away from the PA28 until it had passed through his exercise area.
