**AIRPROX REPORT No 2019154**

Date: 23 Jun 2019 Time: 1055Z Position: 5012N 00127W Location: 12nm N GARMI

**PART A: SUMMARY OF INFORMATION REPORTED TO UKAB**

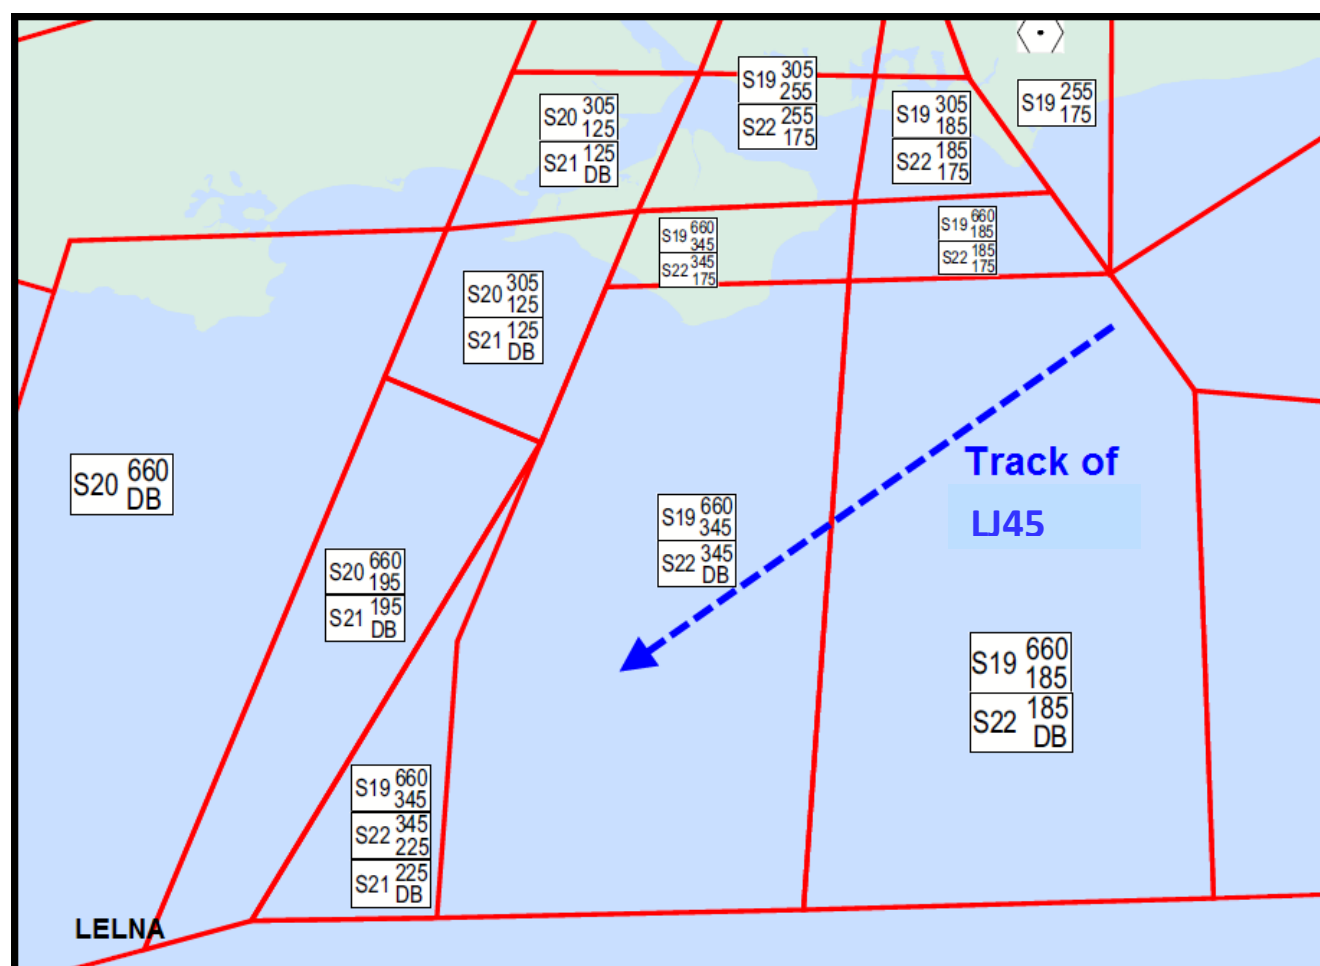
Figure 7.

When the LJ45 was clear of the B737 the S22T effectively repeated their mistake by again climbing the LJ45, this time into the path of the A319 which was effectively following the standard northbound route. The S22T stated that following the earlier confliction with the B737, it was now their intention to climb the LJ45 once clear of the B737. The S22T relayed in the initial interview that their plan, prior to the split, had been to route the A319 further east toward position AVANT, thus avoiding the LJ45 and this may have been why they had therefore discounted it as traffic. Again this was symptomatic of the lack of structured thinking and re-planning during the splitting process that had led to their flawed mental picture. The S22T should have coordinated this climb with the S19T whilst the LJ45 was still in S19's airspace. When asked why they had not, the S22T stated that it had just not occurred to them. They reiterated that with hindsight the mental picture was still that it was their airspace. This should therefore not be considered a non-conformance, more a symptom of the preceding error of failing to re-plan after the split.

Sector map displaying the S19, 20, 21, 22 interface with the vertical sector delineations displayed. (Figure 7.)
