AIRPROX REPORT No 2019159

Date: 24 Jun 2019 Time: 1809Z Position: 5046N 00150W Location: Beaulieu

PART A: SUMMARY OF INFORMATION REPORTED TO UKAB

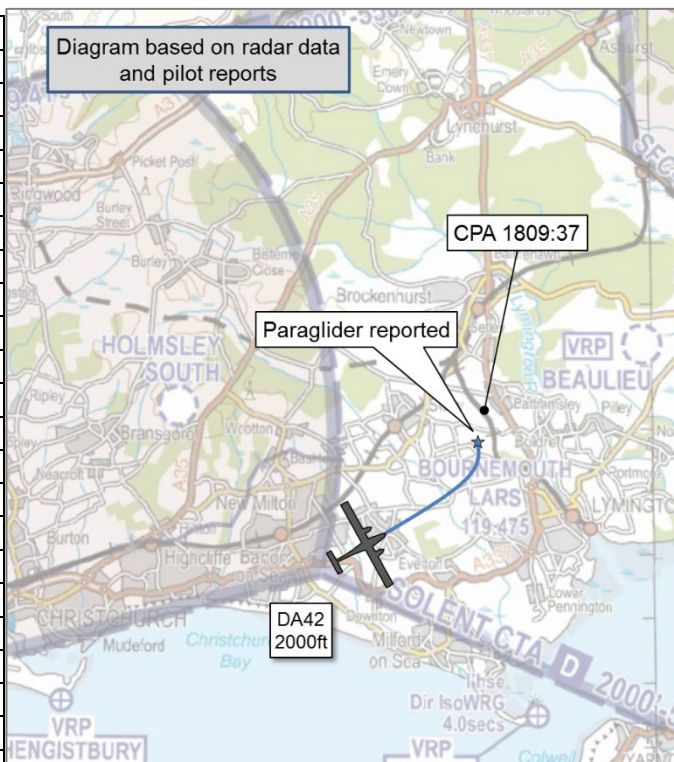
THE DA42 PILOT reports he was receiving a Traffic Service and being radar vectored from the South for an ILS approach at Bournemouth RW26, at 2000ft. He was the handling pilot undergoing IF training, simulated IMC. Having tracked downwind, ATC vectored him onto the base turn. They were cleared to establish on the localiser from the left and advised to call when established. On tracking towards the localiser, the Captain spotted traffic in the 11 o'clock slightly below heading in the same direction. At this point he looked up to see the traffic approximately 100ft at the 11 o'clock position. The Captain took immediate control of aircraft, turned to the right and once safe separation was established they resumed original heading. There was no TAS read out. He observed the traffic to be a small white microlight [reported as a paraglider on the RT] aircraft. It did not appear to have any navigational lights or strobes. The Captain advised Bournemouth ATC of the situation and details were passed. ATC were not aware of the traffic and the microlight pilot was not speaking to Bournemouth. They continued on the original heading and established on the localiser to make an ILS recovery to Bournemouth.
