AIRPROX REPORT No 2019161

Date: 26 Jun 2019 Time: 2201Z Position: 5120N 00151W Location: IVO Salisbury Plain

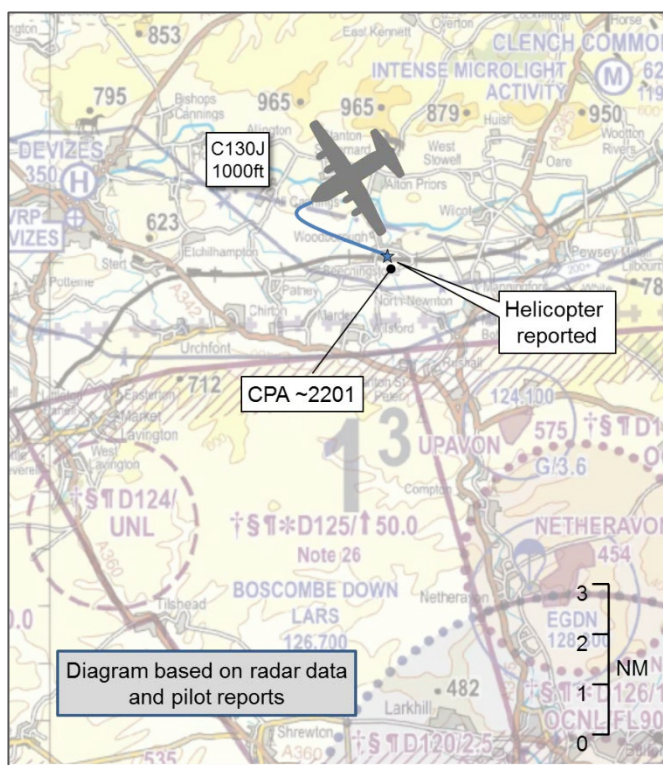
THE C130 PILOT reports he was carrying out a low level air-drop serial on Salisbury Plain. Whilst turning downwind, the crew noticed a strobe light coming directly towards them. The aircraft, assumed to be a helicopter, was assessed to be about 500ft below and was an extremely late spot due to the fact they were rolling out from a turn and the helicopter strobes were initially hidden within the lighting of a town. The aircraft seemed not to be squawking, nor was the pilot talking to Salisbury Ops. Prior to switching to Salisbury Ops, the crew had transmitted on NATO Low-Level frequency stating their intentions. The radio frequencies being used at the time were both UHF, Salisbury Ops to maintain situational awareness on a Wildcat immediately to the south of the drop zone within D128, and the drop frequency. Salisbury Ops had no SSR return and confirmed that there were no aircraft that they were talking to in the vicinity of the C130. The crew were not expecting to see any aircraft at this time in this area having consulted CADS prior to walking to the aircraft. Having subsequently checked CADS after landing there was no aircraft logged in the area other than the aircraft to the south.
