**AIRPROX REPORT No 2019188**

Date: 10 Jul 2019 Time: 1255Z Position: 5233N 00020E Location: SW Marham

**PART A: SUMMARY OF INFORMATION REPORTED TO UKAB**

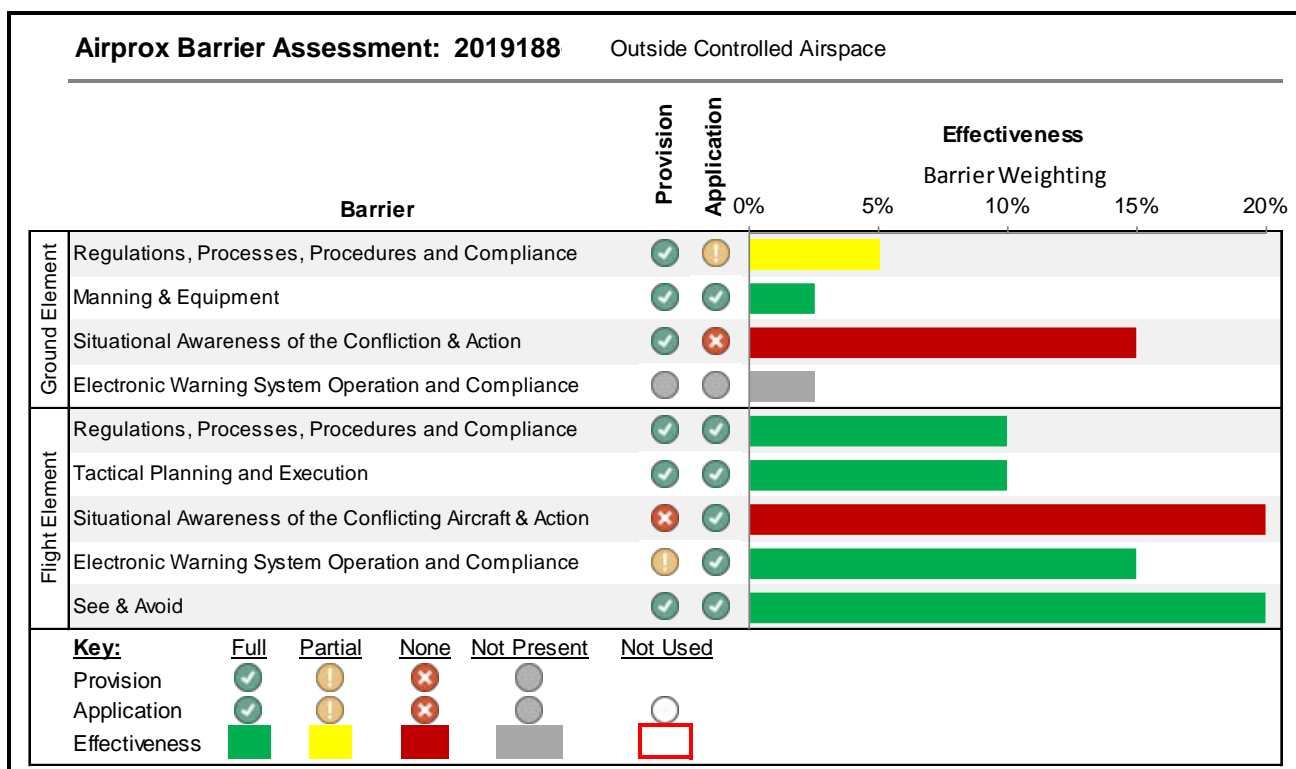
**Situational Awareness of the Conflicting Aircraft and Action** were assessed as **ineffective** because the Typhoon pilot did not know that the Voyager was 10nm behind him.
