## AIRPROX REPORT No 2019187

Date: 07 Jul 2019 Time: 0945Z Position: 5133N 00018W Location: London

### PART A: SUMMARY OF INFORMATION REPORTED TO UKAB

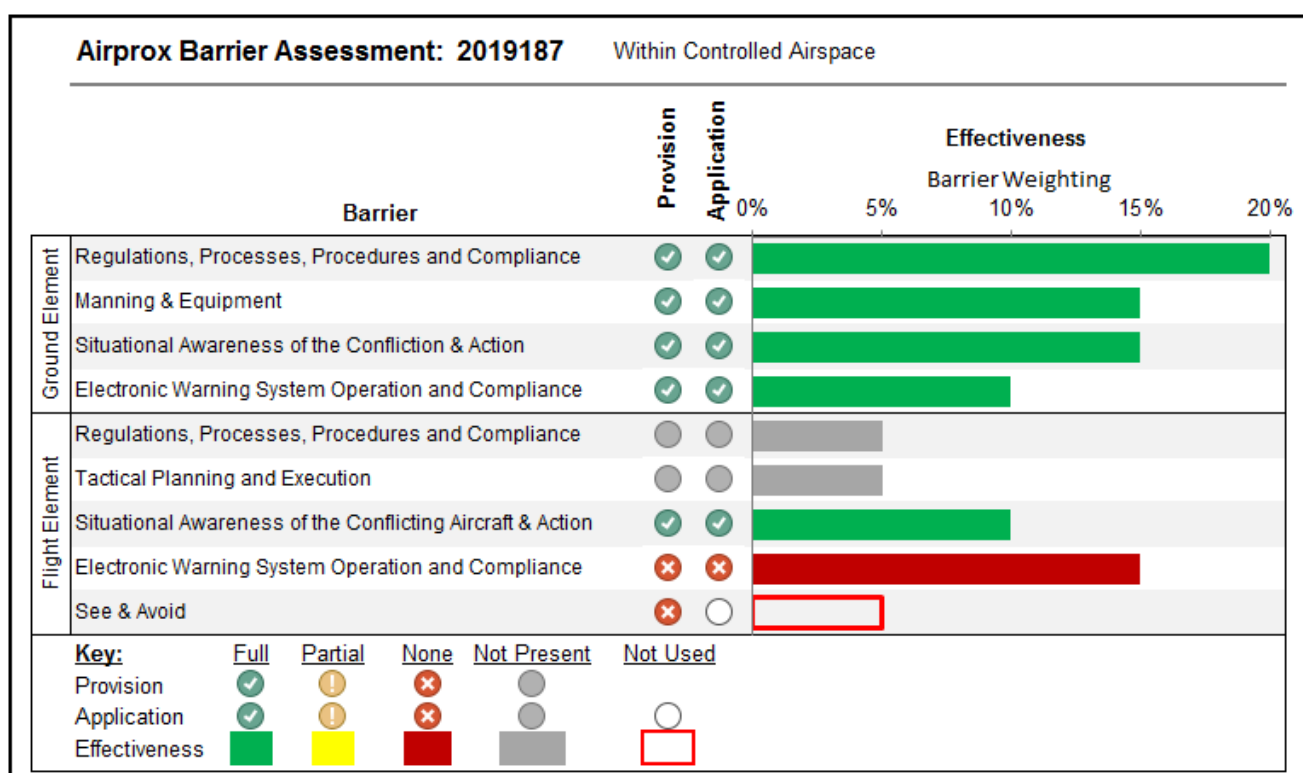
In assessing the effectiveness of the safety barriers associated with this incident, the Board concluded that without positive confirmation that the track was an aircraft it was not possible to assess many of the safety barriers other than to comment that:

**Electronic Warning System Operation and Compliance** were assessed as **ineffective** because the B747 TCAS was incompatible with the suspected unknown aircraft, which was not transponding.

**See and Avoid** were assessed as **not used** because of the separation range and because the B747 was in cloud.
