**AIRPROX REPORT No 2019192**

Date: 09 Jul 2019 Time: 1050Z Position: 5153N 00210W Location: Gloucestershire Airport

**PART A: SUMMARY OF INFORMATION REPORTED TO UKAB**

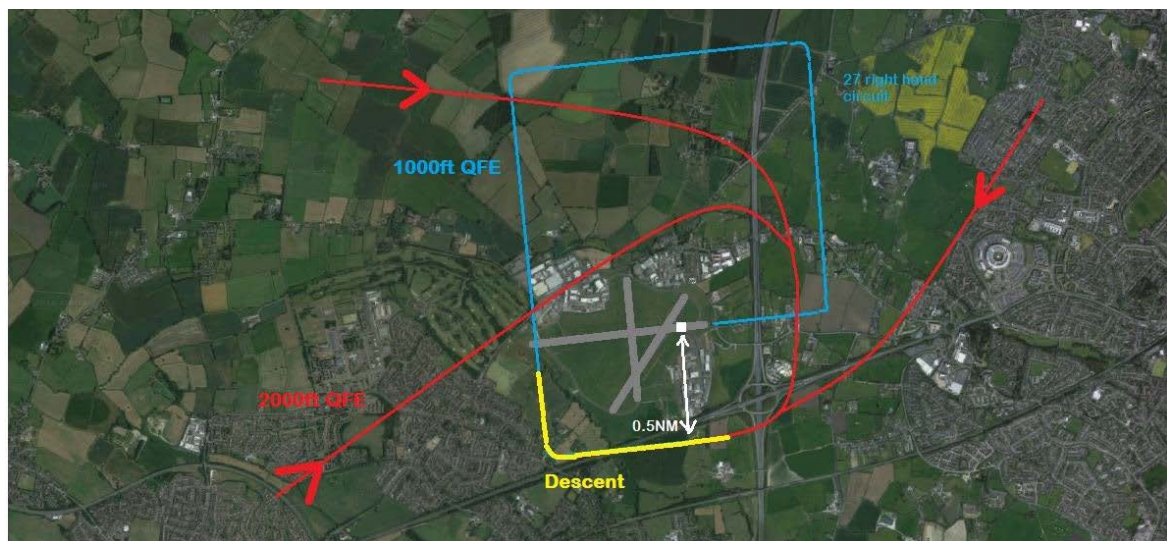
*The picture below shows three typical overhead joining profiles for a right-hand circuit on Runway 27. The blue circuit phase is simply indicative, its shape and size will depend on other traffic:*

**Recommendation:** Gloucester considers reviewing fixed-wing and rotary-wing circuit separation.
