AIRPROX REPORT No 2019207

Date: 12 Feb 2019 Time: 1902Z (Night) Position: 5152N 00001E Location: 2NM SW Stansted Airport

PART A: SUMMARY OF INFORMATION REPORTED TO UKAB

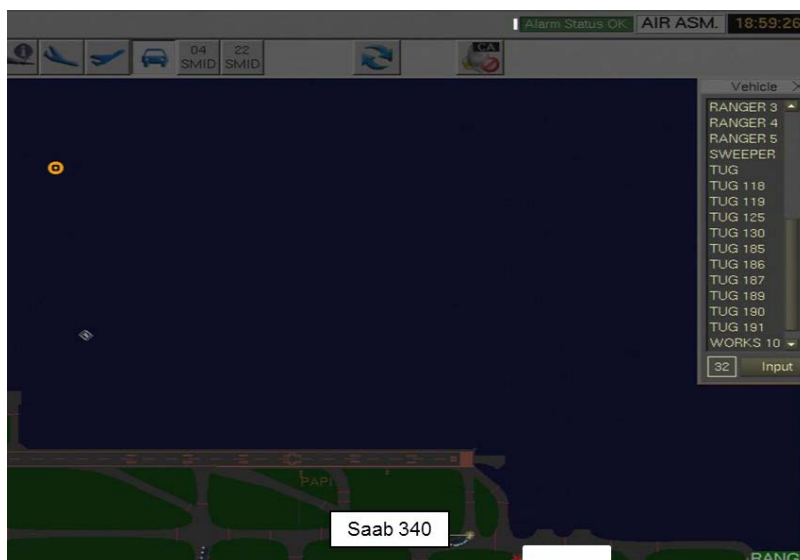
Figure 4.

18:59:02	[Saab 340 C/S]	Tower [Saab 340 C/S] we're ready to depart here
18:59:04	AIR	[Saab 340 C/S] Tower thank you. Expedite line up via Romeo 1. Traffic four and a half miles.
18:59:09	[Saab 340 C/S]	Expediting line up [Saab 340 C/S]
18:59:21	AIR	[Saab 340 C/S] from Romeo 1 cleared immediate take off, runway 22, 210 degrees, niner knots
Note		[See Figure 3 below]
18:59:28	[Saab 340 C/S]	Cleared immediate take off [Saab 340 C/S] [See Figure 4 below]
[18:59:54]		[A320 C/S] AFDAS alarm indicating too high [See Figure 5 below]

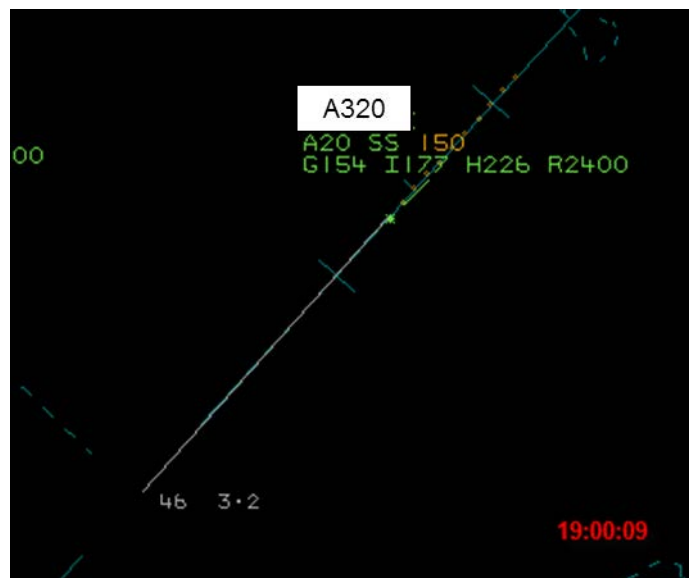
Figure 6.

At about 3.5nm, the SS INT attempted to transfer [A320 C/S] to the tower; a number of things occurred almost simultaneously. The tower had rung to ask about the [A320 C/S], SS INT said that it was coming over but the tower could see it initiating a go-around at about 2.5nm and requested that it be turned left mentioning that they had a departure rolling. [A320 C/S] came in on the INT frequency going around and was given a left turn and climb. [Saab 340 C/S] was recorded airborne at 19:00:34 in EFPS, the ASMGCS suggests that [Saab 340 C/S] was airborne at 19:00:26, the disparity could be due to workload at this time.

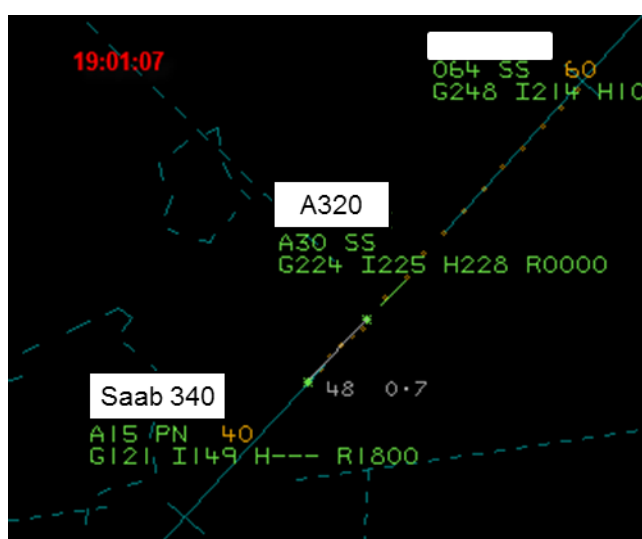
Figure 7

This instruction was [not followed] on two occasions by [A320 C/S] as the aircraft continued on runway heading coming increasingly close to the departing [Saab 340 C/S]. In spite of the eventual proximity, 0.26nm and 500', [A320 C/S] did not report a TCAS RA.
