AIRPROX REPORT No 2019303

Date: 16 Oct 2019 Time: 1348Z Position: 5159N 00215W Location: 7NM NW Gloucester

PART A: SUMMARY OF INFORMATION REPORTED TO UKAB

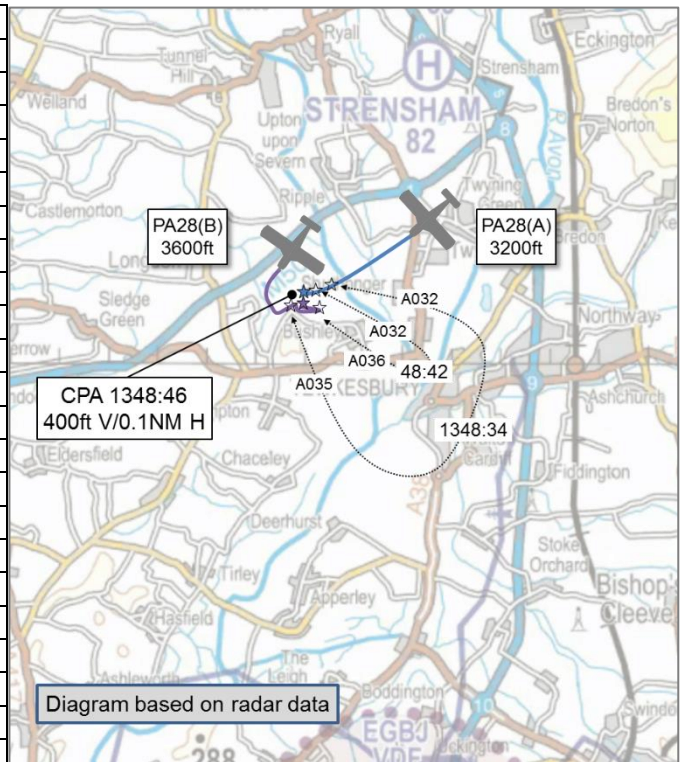
Recorded	Aircraft 1	Aircraft 2
Aircraft	PA28(A)	PA28(B)
Operator	Civ FW	Civ FW
Airspace	London FIR	London FIR
Class	G	G
Rules	VFR	VFR
Service	None	Basic
Provider		Gloucester
Altitude/FL	3200ft	3600ft
Transponder	A, C	A, C
Reported		
Colours	Beige, Orange	Red, White
Lighting	Strobes, Nav	
Conditions	VMC	VMC
Visibility	>10km	
Altitude/FL	3000ft	NR
Altimeter	QNH (1003hPa)	NK
Heading	240°	NR
Speed	100kt	NR
ACAS/TAS	Not fitted	Unknown
Alert	N/A	Unknown
Separation		
Reported	100ft V/ 0.25- 0.5NM H	NR
Recorded	400ft V/0.1NM H
