**AIRPROX REPORT No 2018050**

Date: 12 Apr 2018 Time: 1218Z Position: 5358N 00215W Location: 2nm SE RIBEL

**PART A: SUMMARY OF INFORMATION REPORTED TO UKAB**

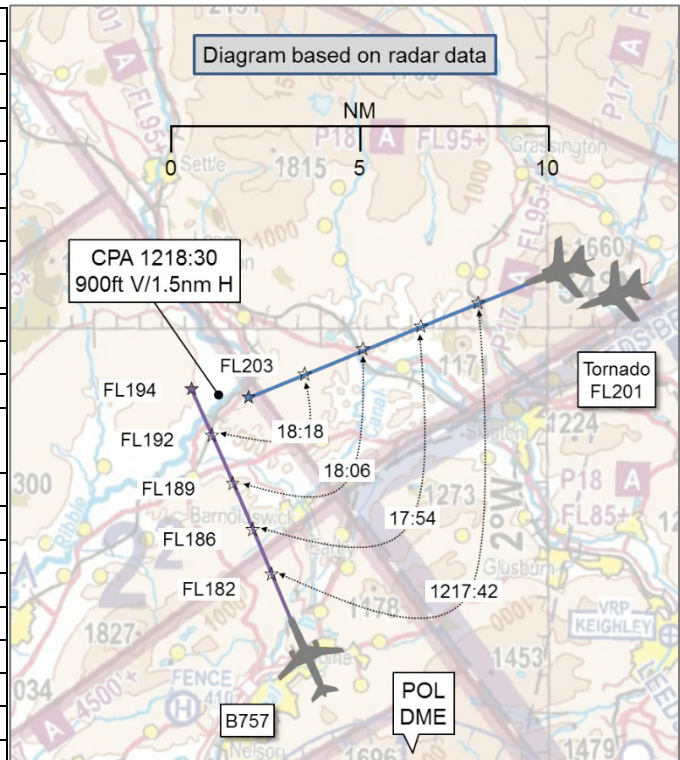
Recorded	Aircraft 1	Aircraft 2
Aircraft	Tornado x 2	B757
Operator	HQ Air (Ops)	CAT
Airspace	London FIR	Airway
Class	C	A
Rules	IFR	IFR
Service	Radar Control	Radar Control
Provider	Warton	Scottish
Altitude/FL	FL203	FL194
Transponder	A,C,S	A,C,S
<b>Reported</b>		
Colours	Grey	Company
Lighting	NK	Nav, strobe, position
Conditions	NK	IMC
Visibility	10km	NK
Altitude/FL	FL200	FL188
Heading	250°	360°
Speed	400kt	290kt
ACAS/TAS	TCAS II	TCAS II
Alert	RA	RA
<b>Separation</b>		
Reported	NK	Not seen
Recorded	900ft V/1.5nm H
